LIMITED OCCURRENCE INVESTIGATION REPORT – FINAL

Reference Number	CA18/2/3/10632						
Classification	Accident	Date	31 January 2026		Time	1013Z	
Type of Operation	Training (Part 141)						
Location							
Place of Departure	Rand Airport (FAGM), Gauteng Province		Place of Intended Landing		Rand Airport (FAGM), Gauteng Province		
Place of Occurrence	Rand Airport (FAGM) perimeter fence, beyond Runway 35, Gauteng Province						
GPS Co-ordinates	Latitude	26°14'07.1" S	Longitude	28°08'52.0" E	Elevation	5 432ft	
Aircraft Information							
Registration	ZS-OFU						
Make; Model; S/N	Cessna; 172N (Serial Number: 172-72775)						
Damage to Aircraft	Substantial			Total Aircraft Hours	9 853.9		
Pilot-in-command							
Licence Type	Commercial Pilot Licence (CPL)		Gender	Male		Age	23
Licence Valid	Yes	Total Hours	580		Total Hours on Type	324.2	
Total Hours 30 Days	26.6		Total Flying on Type Past 90 Days	70			
People on board	2+1	Injuries	0	Fatalities	0	Other (on ground)	0

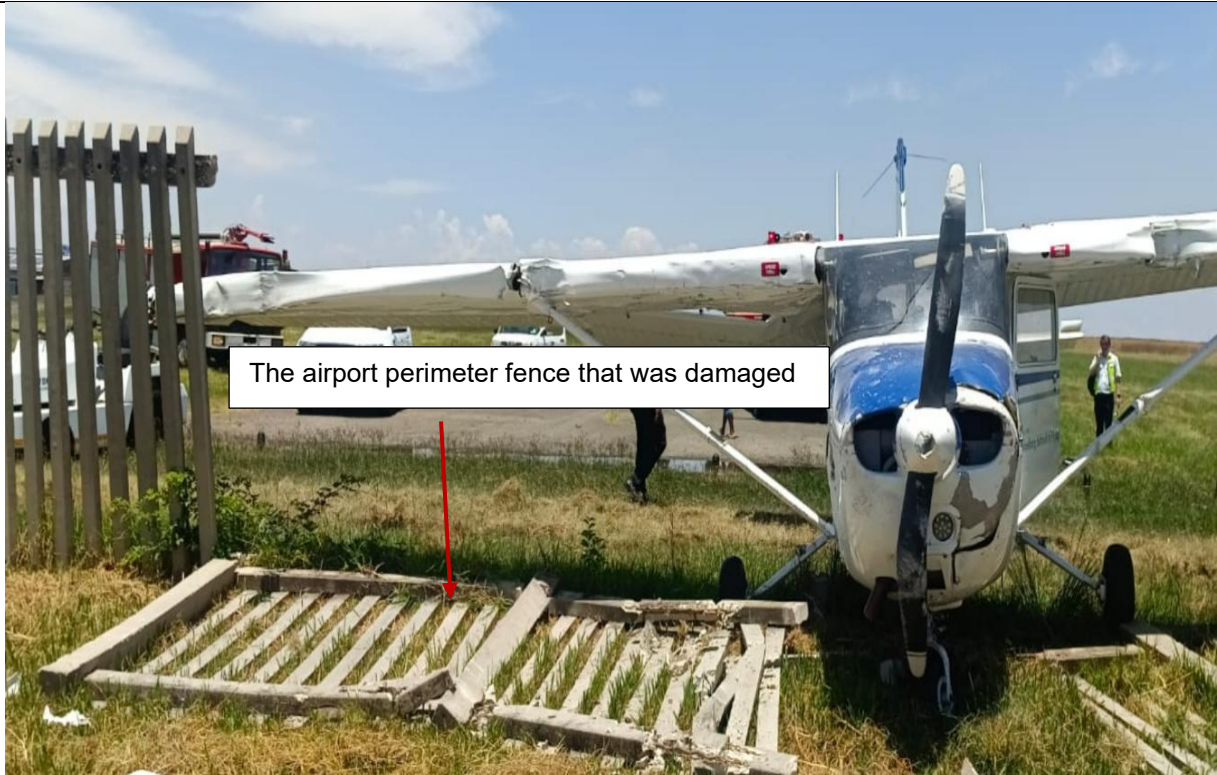
As the aircraft climbed to approximately 50 feet (ft) above ground level (AGL), the FI noticed that it was struggling to climb farther, yet the engine parameters remained within the green arch (normal). After the aircraft had passed the intersection of RWY 35 and RWY 29, the FI decided to take control of the aircraft and elected to abort take-off. The FI reduced the throttle and, subsequently, retarded the power before landing the aircraft on RWY 35. During the landing roll at approximately 70 kts with the flaps set at 10 degrees, the FI engaged the brakes and the aircraft initially decelerated; however, there was insufficient runway remaining to bring it to a safe stop. The aircraft overran the threshold of RWY 11 (opposite) and impacted the airport's perimeter fence (beyond the end of the runway). The aircraft was substantially damaged; third-party damage was limited to the airport perimeter fence. Approximately 98.4L of Avgas remained in the aircraft's fuel tanks. The FI in the right front seat and the SP were not injured; however, the FI in the back seat sustained minor injuries.

Figure 2: The front view of the aircraft in its resting position after the accident. (Source: Operator)

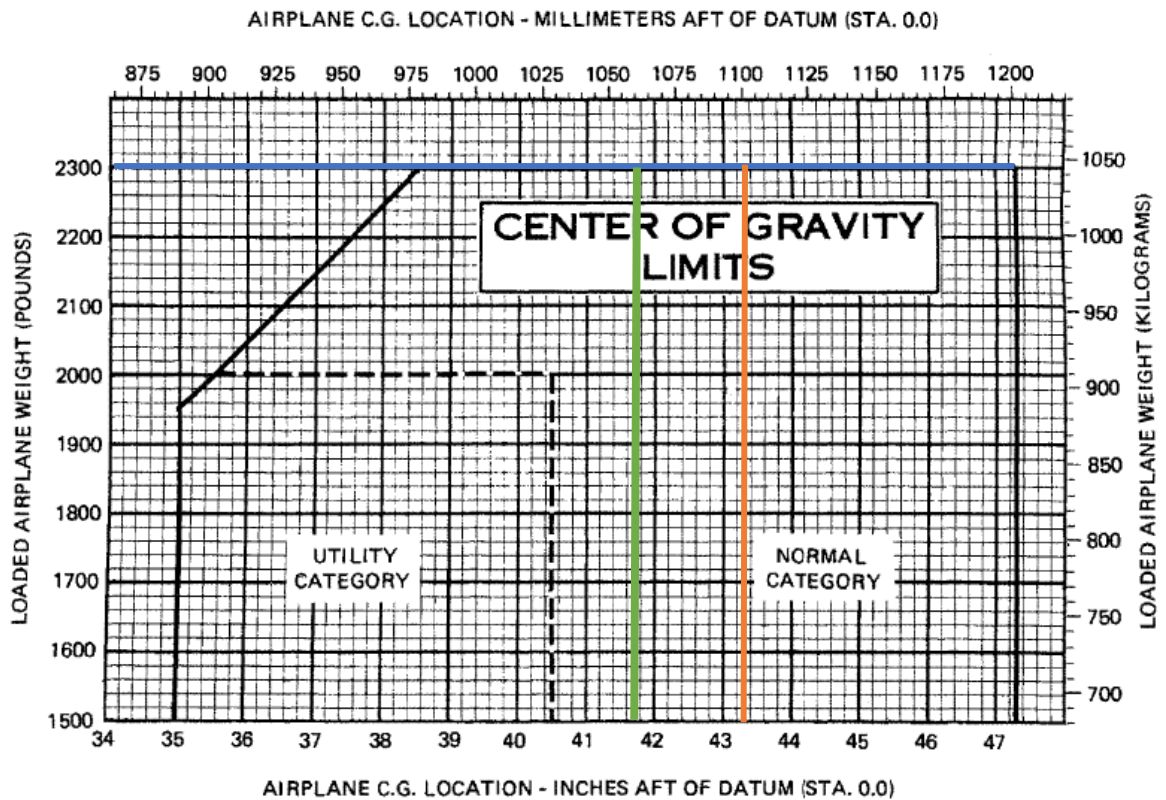
Figure 6-8. Center of Gravity Limits

Figure 4: Graph indicating centre-of-gravity limits. (Source: POH)

Based on the Weight and Balance calculations and centre-of-gravity (CG) results, the aircraft's CG was determined to be too forward. The calculated take-off weight for the flight carrying three passengers was 2 234.73 pounds (lbs), as obtained from both the load sheet and the supporting weight and balance calculations above. Although this weight remained within the allowable limit by 64.27 lbs, the forward CG condition could adversely affect aircraft handling characteristics. An excessively forward CG increases longitudinal stability but may result in heavier control forces, reduced elevator authority during rotation and flare, and longer take-off and landing distances.

- 2.7. The aircraft's centre-of-gravity (CG) was determined to be too forward, placing the aircraft close to its operational limits, increasing take-off and landing distances. However, the aircraft's take-off weight remained within the maximum permissible limit of 2 300 lbs by a margin of 64.27 lbs.

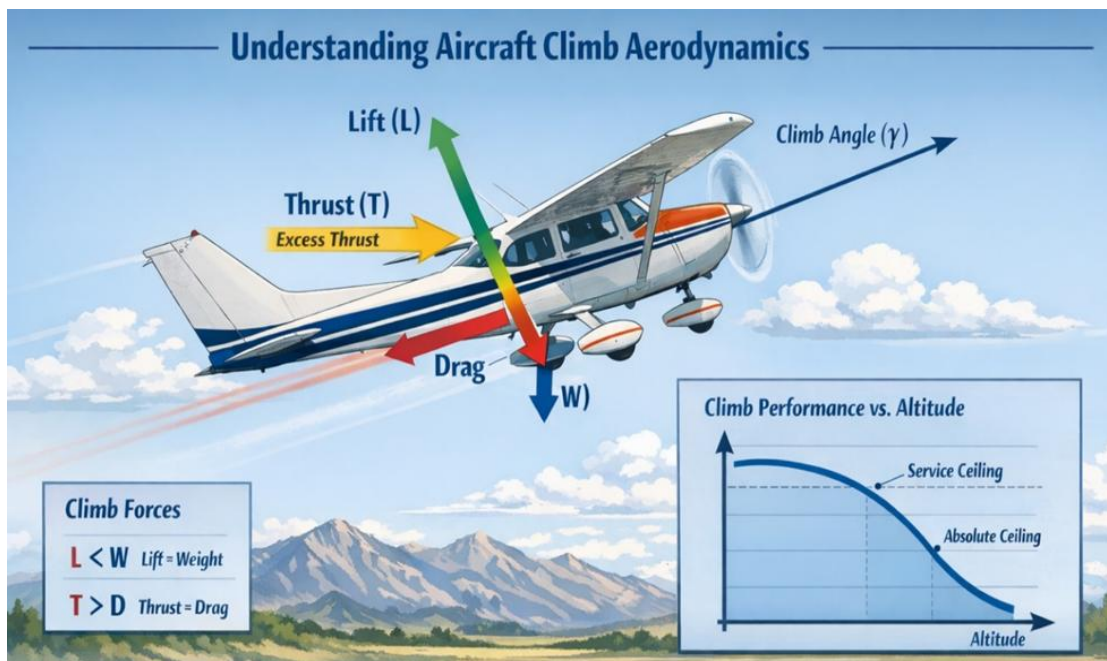
Figure 6: A diagrammatic representation of an aircraft climb based on aerodynamics. (Source: Aerodynamics of Flight)

Aerodynamically, the aircraft was operating at a weight close to the maximum allowable limit which significantly affected its aerodynamic performance during climb. A heavier aircraft requires greater lift to overcome its weight, resulting in a higher angle-of-attack and increased induced drag. As

altitude increases and air density reduces, engine power, propeller efficiency and lift capability also decrease, further degrading climb performance. Under these conditions, the low climb speed caused the aircraft's airspeed to decay below the recommended best rate-of-climb speed (Vy), leaving insufficient excess thrust to sustain the climb and reducing the aircraft's ability to support its weight aerodynamically.

The weight and degraded climb performance also adversely affected the attempted aborted landing. With limited excess power available, the pilot was unable to effectively arrest the descent and regain adequate climb performance. The increased drag associated with the higher angle-of-attack, combined with the aircraft's weight caused it (aircraft) to settle and descend instead of successfully climbing up.
