## LIMITED OCCURRENCE INVESTIGATION REPORT – FINAL

| <b>Reference Number</b> | | CA18/2/3/10642 | | | | | |
| Registration | ZU-CYG | | | | | | |
| Make; Model; S/N | Socata MS-880B Rallye (Serial Number: 5206) | | | | | | |

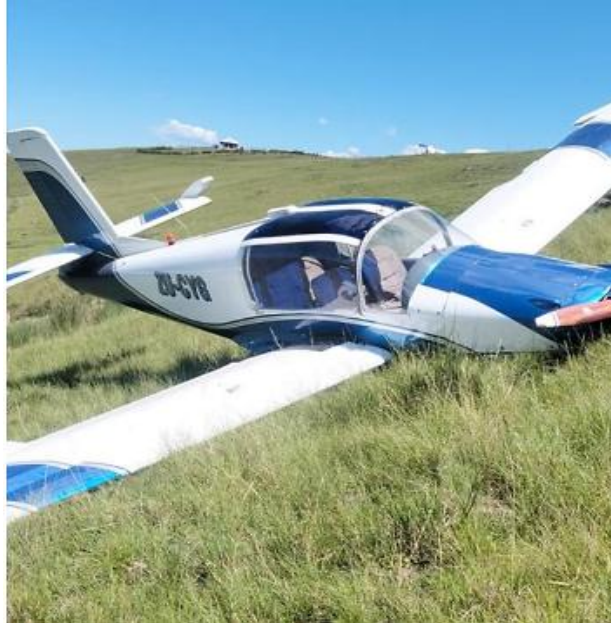
The pilot troubleshooted the anomaly by activating the auxiliary electric fuel pump and adjusting the power settings, as well as by switching on the carburettor heat and adjusting the fuel air mixture. The engine improved briefly, but lost power again. The pilot thought of returning to FAUT; however, he noticed a rapid descent of the aircraft and, thus, decided to assess the surrounding area to execute a forced landing. He identified a field ahead of the flight path. The aircraft sustained damage to the nose landing gear strut, engine cowlings, firewall and main landing gear struts during the landing sequence on an uneven grass surface. The aircraft was substantially damaged. Both occupants were not injured.

**Figure 1:** The aircraft at the accident site. (Source: Pilot)

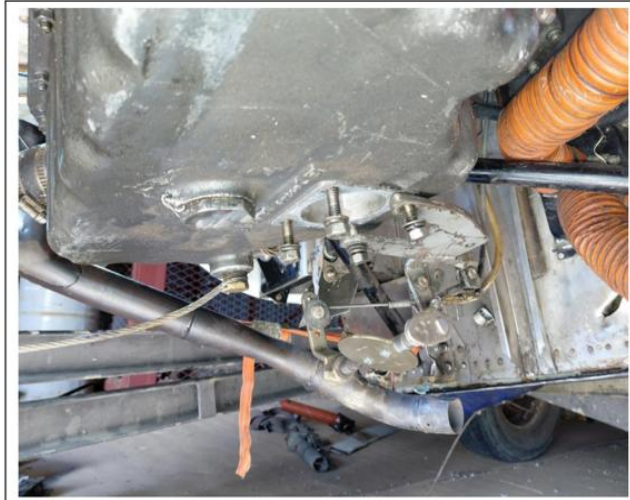
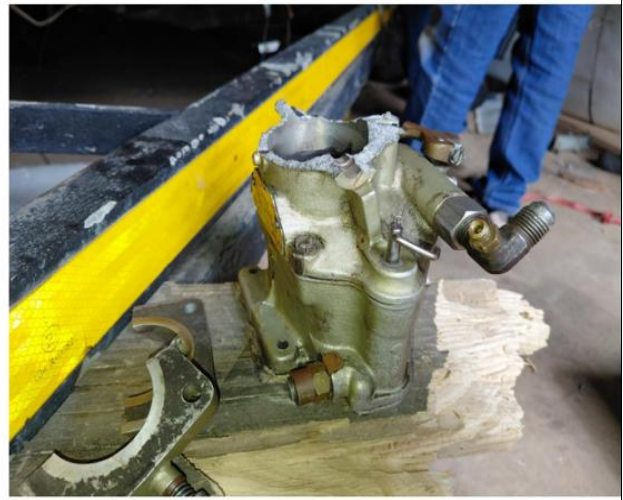
The engine was found intact, and no anomalies were identified that affected engine operation. A system inspection revealed damage to the carburettor that had broken off; this was attributed to the accident sequence. Further inspection did not reveal issues with the carburettor that could have resulted in a fuel flow restriction. There was also no water sediment found during the fuel tank inspection.

**Figures 2 and 3:** The bottom part of the engine showing carburettor mounting position (left); and the damaged carburettor after the accident (right).

11. The aircraft lost fuel pressure in-flight followed by engine power loss and was forced-landed on an uneven grass terrain which resulted in damage to the carburettor.
12. It was found that the clamp securing the fuel filter inlet fuel pipeline was loose; however, post-accident fuel system tests could not conclusively determine whether this resulted in an interrupted fuel flow during operation.

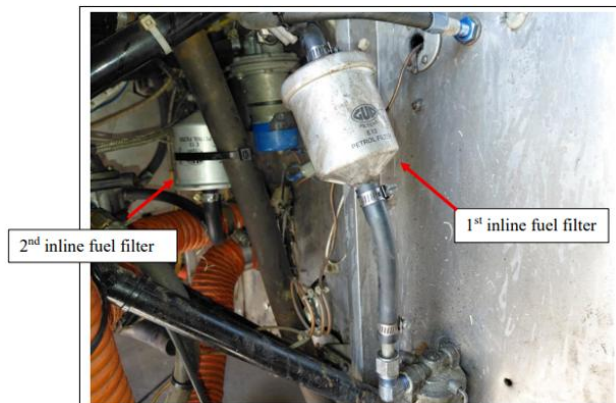
**Figure 4:** Fuel filters (gascolators).

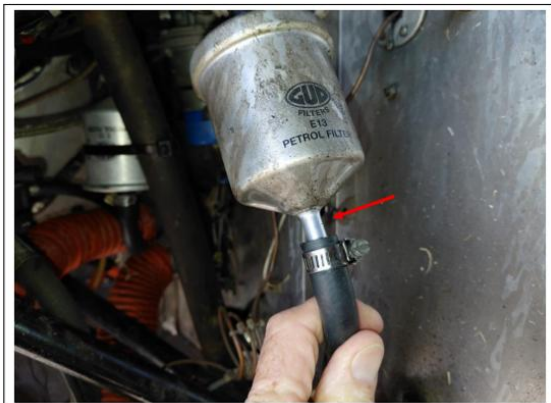
**Figure 5:** A loose inlet fuel pipeline on the left fuel filter.

The engine was equipped with two inlet fuel filters (gascolator) labelled first inline fuel filter on the left side and second inline fuel filter on the right side. The left-side fuel filter (gascolator) had a loose clamp on the inlet fuel pipeline; the clamp could be easily moved, as indicated in Figure 5. Fuel was found in both fuel filters. The left-side fuel filter inspection revealed small “fine” fragments of rubber which were not significant enough to cause fuel flow interruption (see Figure 6).

Unsuccessful forced landing on uneven terrain following loss of fuel pressure and subsequent engine power loss due to interrupted fuel flow likely caused by a loose clamp on the inlet fuel pipeline. Post-accident inspection could not conclusively determine the exact cause of fuel flow interruption.

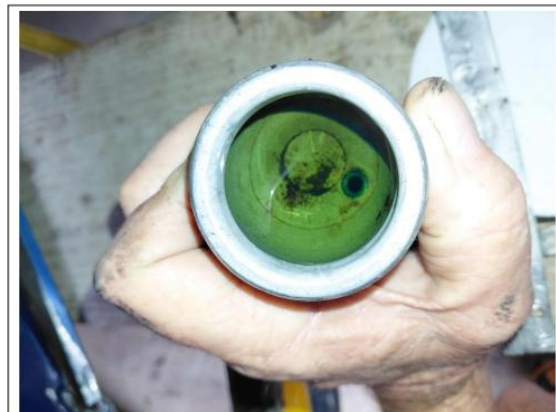
**Figure 6:** Small fragments of rubber were found in the left-side fuel filter.

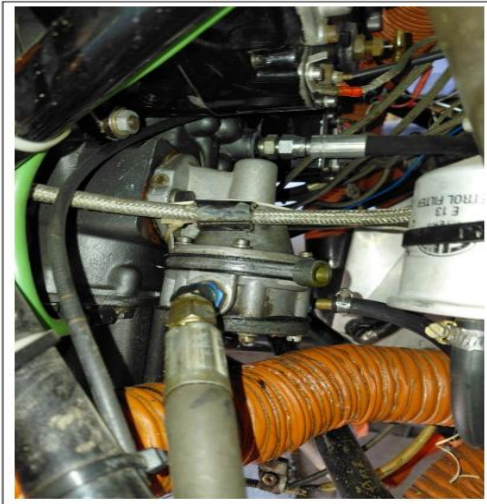
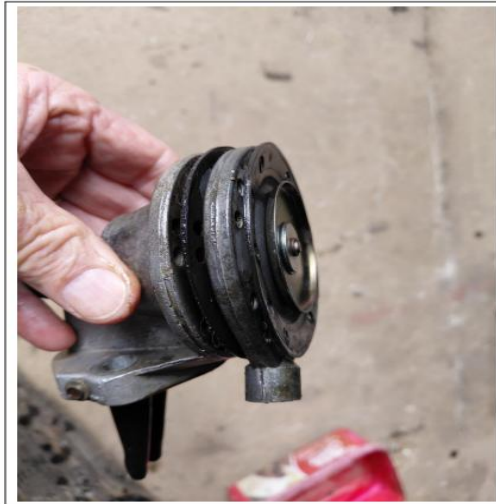
**Figures 7 and 8:** The fuel pump which was dismantled and tested.

Inspection and testing of the fuel pump found all diaphragms in good condition. Fuel system inspection found no anomalies that could have contributed to fuel transfer challenges.
