**LIMITED OCCURRENCE INVESTIGATION REPORT – FINAL**

<b>Reference Number</b>	CA18/2/3/10643						
<b>Classification</b>	Accident		<b>Date</b>	02 March 2026		<b>Time</b>	1130Z
<b>Type of Operation</b>	Private (Part 141)						
<b>Location</b>							
Place of Departure	Ultimate Heliport, Gauteng Province		Place of Intended Landing	Ultimate Heliport, Gauteng Province			
Place of Occurrence	Kromvlei Helicopter General Flying Area (GFA), Gauteng Province						
GPS Co-ordinates	Latitude	26°21'36.29" S	Longitude	28°04'43.33" E	Elevation	4971 feet	
<b>Aircraft Information</b>							
Registration	ZS-RYL						
Make; Model; S/N	Bell 407 (Serial Number: 53952)						
Damage to Aircraft	Substantial			Total Aircraft Hours	8861.0		
<b>Pilot-in-command</b>							
Licence Type	Commercial Pilot Licence (CPL)		Gender	Male		Age	37
Licence Valid	Yes	Total Hours	4473.2		Total Hours on Type	1598.4	
Total Hours 30 Days	38		Total Flying on Type Past 90 Days	115.3			
<b>People On-board</b>	2+0	<b>Injuries</b>	0	<b>Fatalities</b>	0	<b>Other (on ground)</b>	0

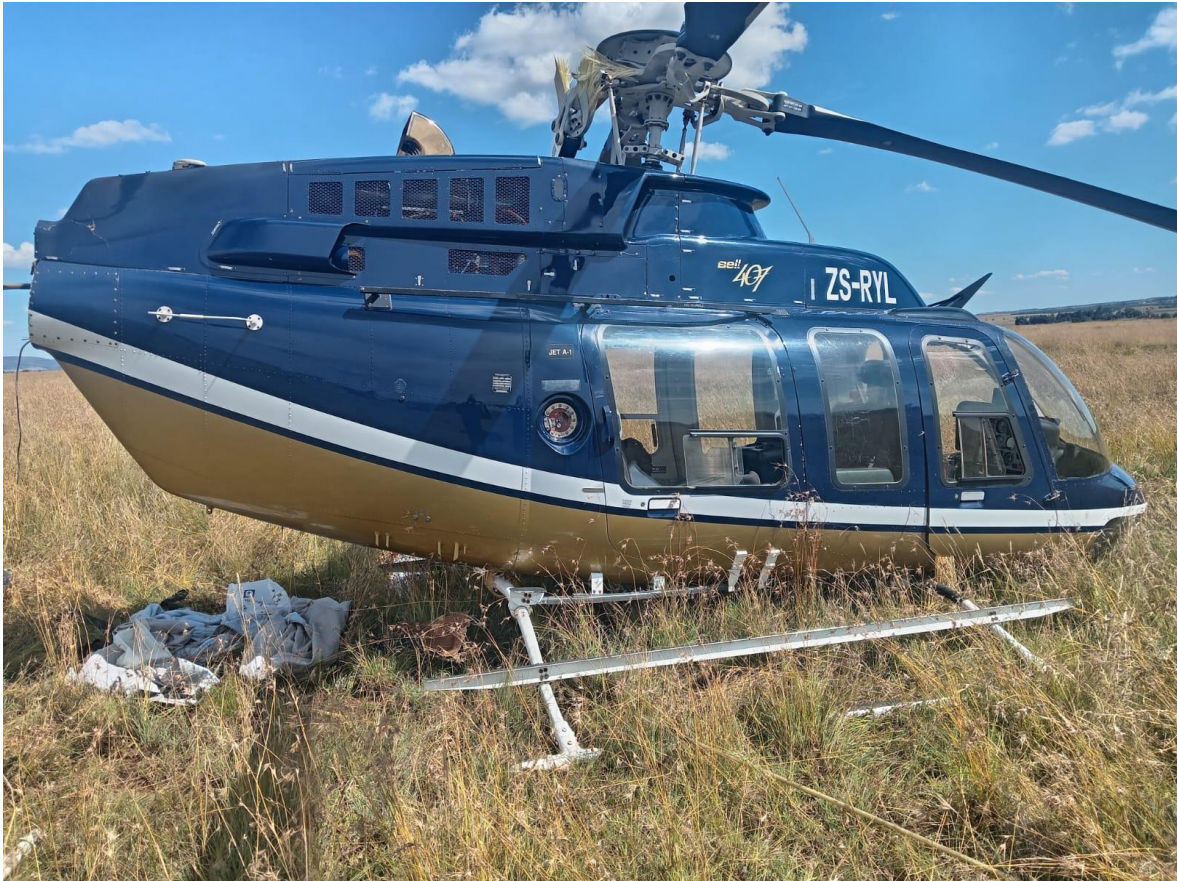
helicopter entered an uncontrolled descent and impacted the ground hard, resting on its skids; as a result, the skids became deformed, spreading sideways. Moreover, one of the rotor blades severed the tail boom. Both occupants were not injured; the helicopter sustained damage to the main rotor blades, which severed the tail boom and tail rotor, as well as the skids.

**Figure 1:** The ZS-RYL aircraft at the accident site. (Source: Operator)

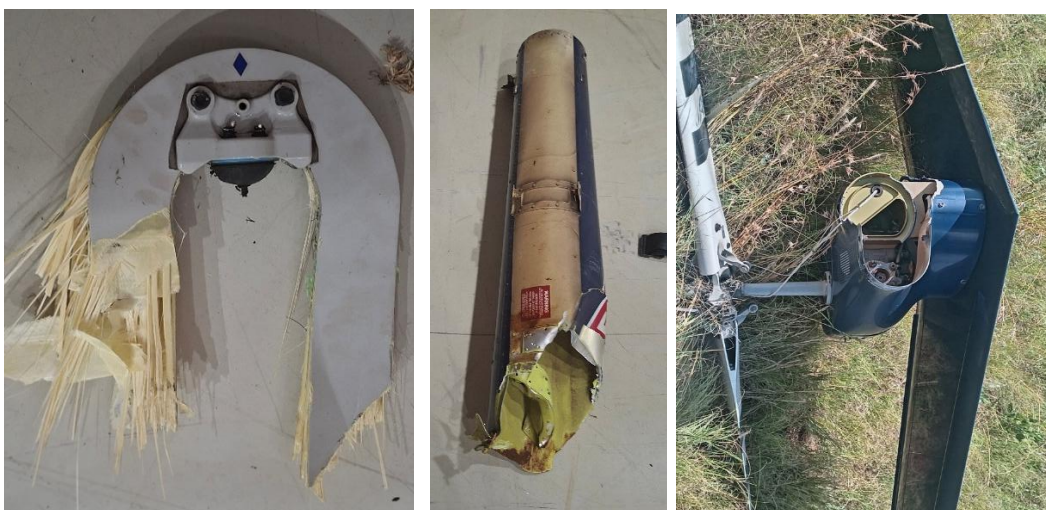
**Figures 2, 3 and 4:** The rotor blade that broke off (left), and the tail boom and tail rotor that were severed during the accident (centre and right). (Source: Operator)

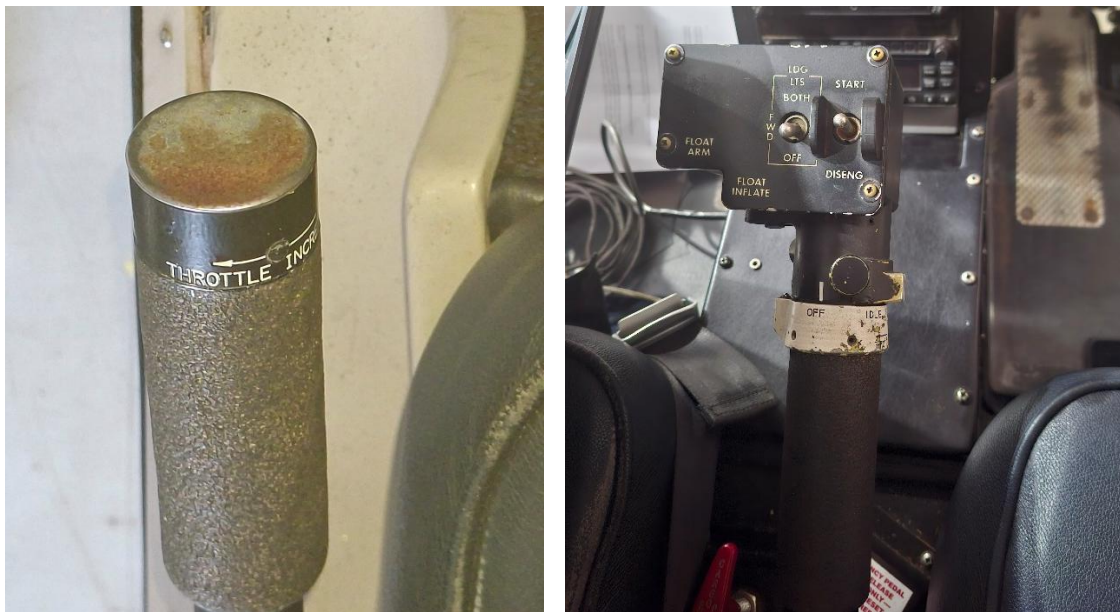
**Figures 5 and 6:** The auxiliary throttle on the left-side pilot seat (left). The throttle for the pilot seated on the right seat (right).

Aircraft Maintenance Engineers (AMEs), in the presence of the IIC, examined the auxiliary (left side) throttle movement, and it moved with restriction (was sticky); it did not move as smoothly as the main (right side) throttle. The pilots stated that they were aware of the stickiness of the throttle but had not reported the anomaly yet. When the IIC enquired from the operator's AMO about the last auxiliary throttle maintenance or its examination for free movement, the response was that it was an "on-condition item" and would only be checked if an anomaly was suspected.

- *Installed correctly*
- *Noted excessive/ beyond normal play on throttle grip*
- *No visible damage to collective assembly*
- *Travel ranges from 0 to idle detent smooth*
- *Travel ranges from Idle detent to Fly and to Max Ng (gas generator speed) stiff and binding*
- *Co-pilot (left-hand seat) collective twist grip slightly stiff but smooth in full rotation (notable difference from PIC and co-pilot throttle controls).*

- *Travel ranges from Idle detent to Fly and to Max Ng stiff and binding.*
- *Noted excessive/ beyond normal play on throttle grip.*

The helicopter landed hard during a simulated autorotation due to a delayed response of the throttle recovery attributed to a lag in the collective control lever.

- The auxiliary throttle was not regularly inspected.
- The throttle was exposed to environmental elements, contributing to corrosion.
- The deteriorating condition of the throttle was not reported.

The operator and the AMO should ensure that the auxiliary throttle is maintained in accordance with the maintenance manual, as well as stored correctly. Pilots should report any unsatisfactory operation of the auxiliary throttle.

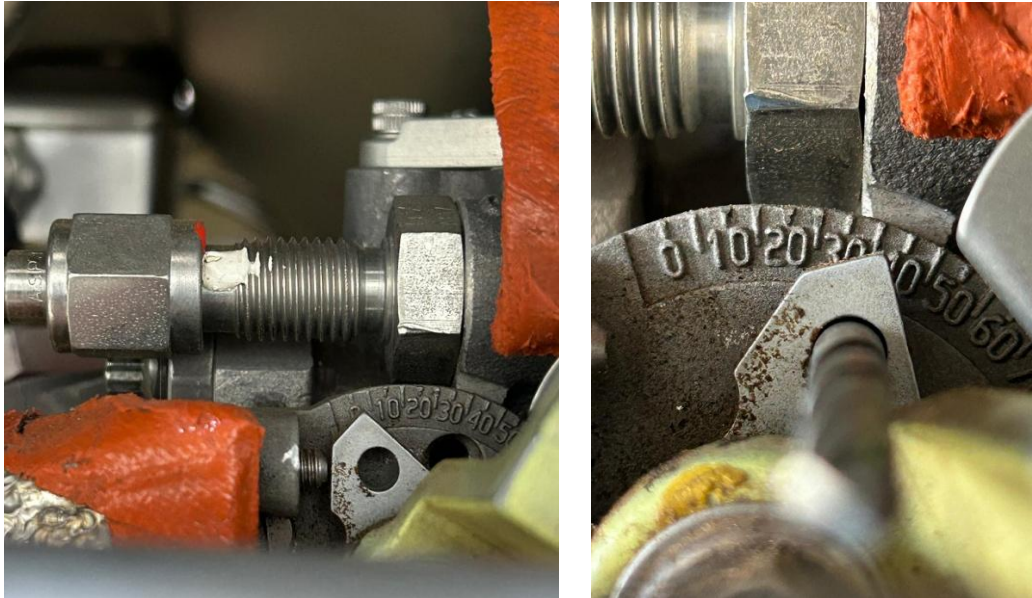
- *Fully closed: 4 degrees (not reaching stop)*
- *Idle: 38 or 39 degrees*
- *Fly: 74 degrees*
- *Full open: 95 degrees (not reaching stop by about a quarter inch)*

*NB 3.96mm rigging pin does not go into the HMU rigging hole without manipulating the throttle control arm.*

**Figures 7 and 8:** Fuel throttle gauge not reaching zero (left). A 3.99mm rigging pin is used to align the two holes (right).
