**LIMITED OCCURRENCE INVESTIGATION REPORT – FINAL**

| <b>Reference Number</b> | CA18/2/3/10646 | | | | | | |
| <b>Registration</b> | ZU-LCY | | | | | | |
| <b>Make; Model; S/N</b> | Bell; UH-1H (Serial Number: 65-09777) | | | | | | |

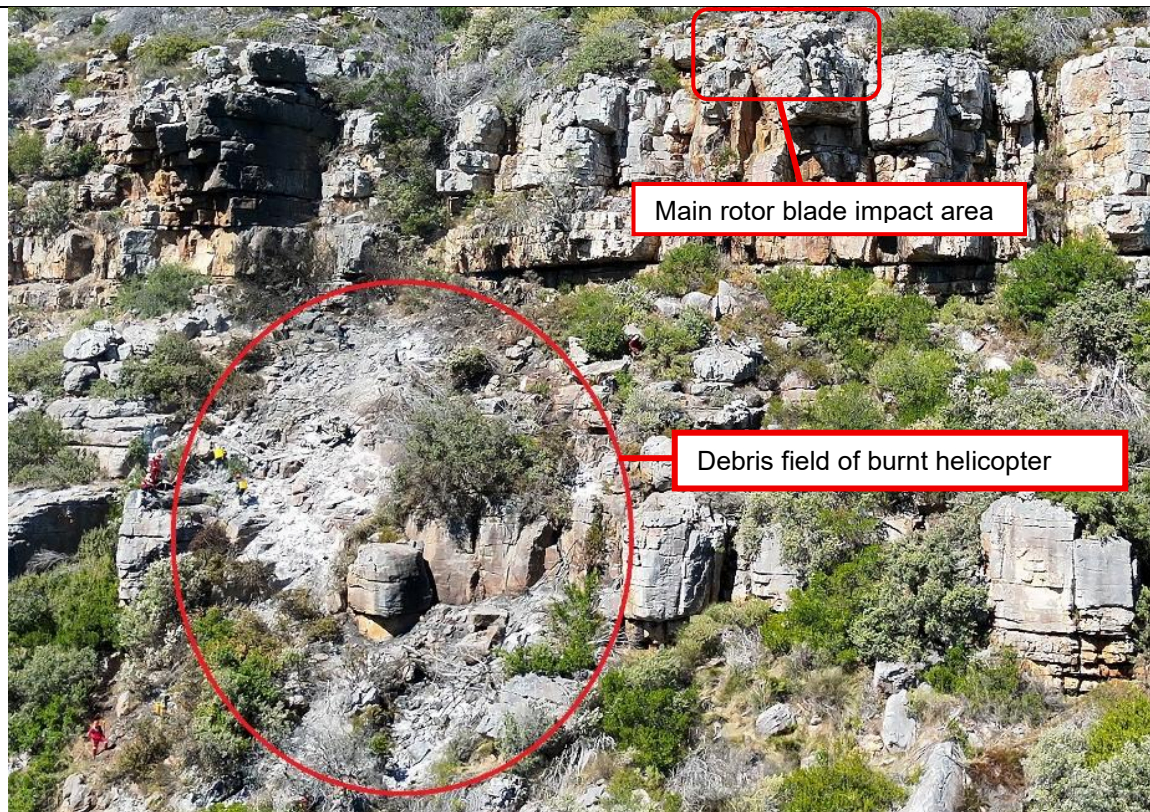
**Figure 1:** The accident scene. (Source: Cape Town Metropolitan Emergency Medical Service and Rescue)

4.3. After the rotor strike, the pilot decreased the power and the helicopter descended vertically, impacted the mountainous terrain, and rolled onto its port side.

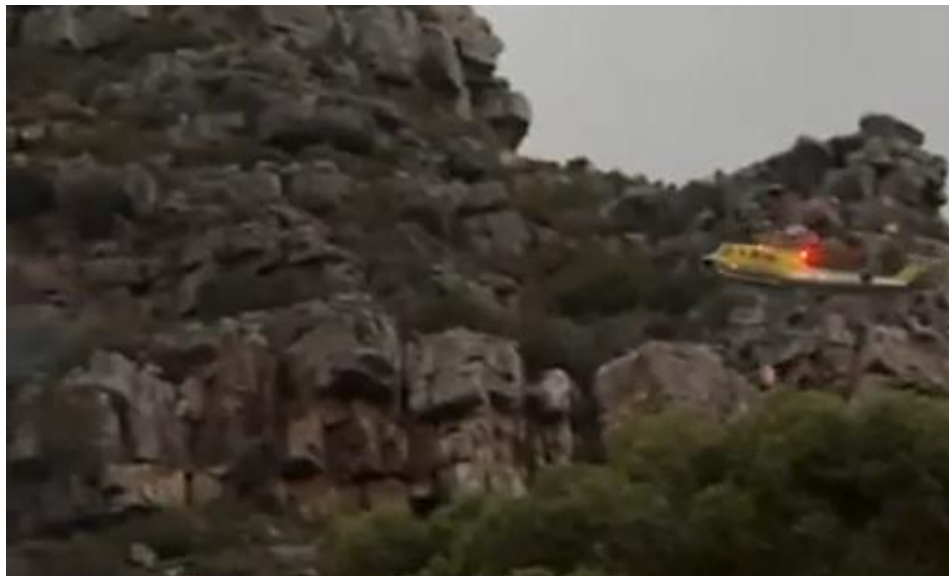
**Figure 2:** A still image from one of the supplied video footages; it shows the helicopter's approach during the third drop.

4.1. The helicopter was flown close to the mountainside during the third Bambi bucket water drop.

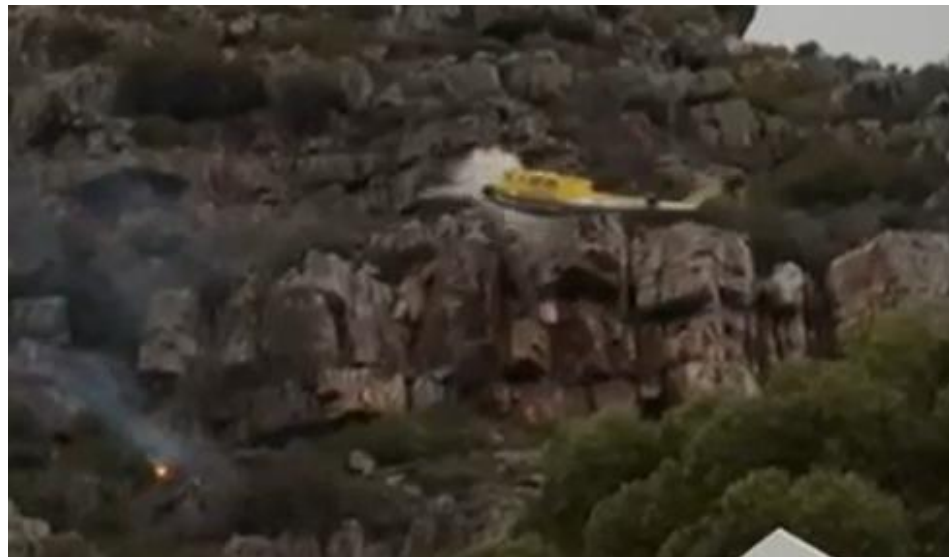
The investigating team analysed multiple videos of the accident sequence, and it was found that the main rotor blades of the helicopter struck a rocky outcrop on the north side of the mountain, followed by a puff of dust and a loud bang (see Figure 3).

**Figure 3:** A still image from one of the multiple video footages shows the moment the main rotor blades struck the rocks on the mountainside.

4.2. The helicopter's main rotor blades struck a rocky outcrop on the starboard side during approach to the drop zone.

Loss of situational awareness whilst flying close to the mountain resulted in the helicopter's main rotor blades impacting a rocky outcrop on the mountainside.

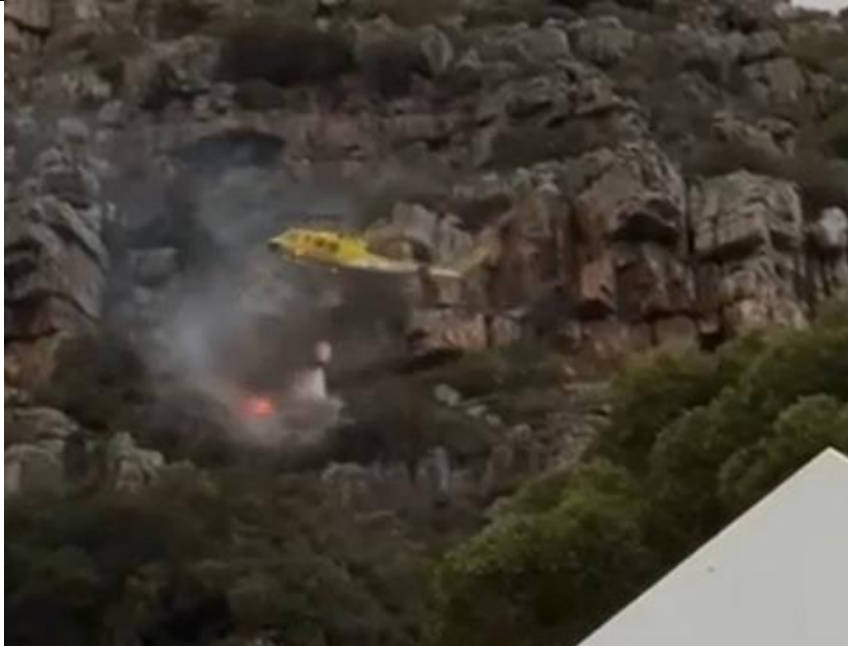
A firefighter who was first at the accident scene stated that he was present during the helicopter's first two water drops. During the third drop, he saw the helicopter shaking violently before descending vertically on the mountainside. He further stated that the engine continued to run for approximately 1 hour thereafter. The bushfire consumed the helicopter during which the engine eventually shut down.

**Figure 4:** A still image from one of the multiple video footages shows the helicopter during descent after impact.
