## LIMITED OCCURRENCE INVESTIGATION REPORT – FINAL

| <b>Reference Number</b> | | CA18/3/2/10647 | | | | | |
| <b>Registration</b> | ZS-RVU | | | | | | |
| <b>Make; Model; S/N</b> | R44; Raven II (Serial Number: 10711) | | | | | | |

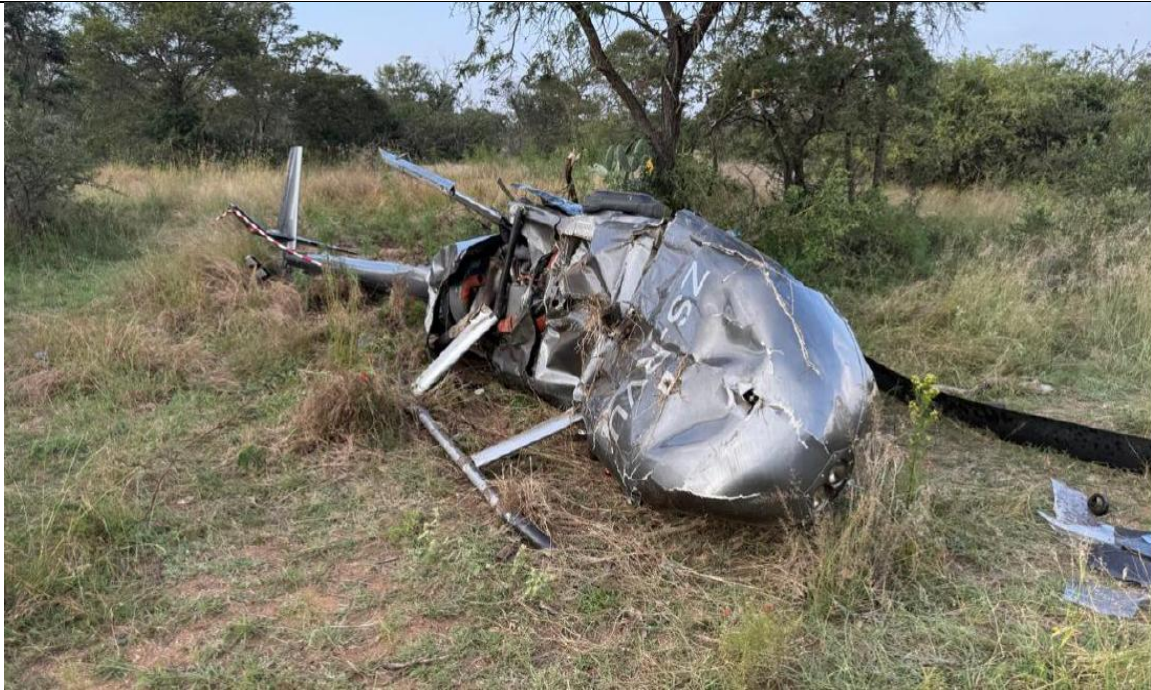
descended to a height below 400 feet (ft) above ground level (AGL). The pilot stated that after turning out of wind, the rotor system decayed to approximately 90 percent rotor revolutions per minute (rpm), and the low rotor rpm warning activated. He then attempted to recover the rotor rpm by increasing power but could not achieved this in time. The helicopter subsequently impacted the ground; it sustained substantial damage.

**Figure 2:** The wreckage at the accident site. (Source: Pilot)

| The helicopter impacted the ground after the pilot initiated a turn out of wind at low speed whilst operating within the “dead man’s curve” which reduced rotor efficiency and, subsequently, led to a loss of control and an uncontrolled descent. |

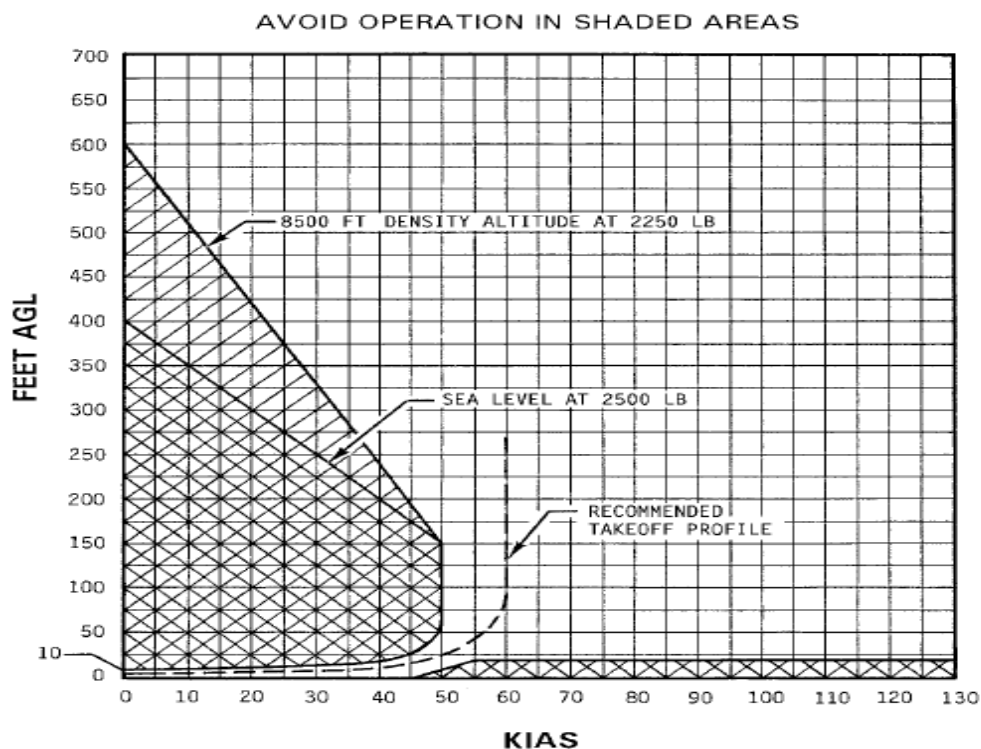
**Diagram 1:** Height-Velocity (H/V) Diagram. (Source: R44 POH)

The pilot stated that prior to the accident, the helicopter was operating below 400ft AGL and below 50 KIAS, which placed it within the shaded area of the Height/Velocity (H/V) Diagram, commonly

referred to as the “dead man’s curve”. This area represents a combination of low altitude and low airspeed from which safe recovery following an engine failure, rotor rpm decay, or loss of performance may be difficult or impossible due to insufficient height, airspeed and reaction time to complete a successful autorotation. In relation to this accident, the helicopter reportedly turned out of wind during a low-speed flight, which would have reduced translational lift and rotor efficiency. Operating within the area to avoid on the H/V Diagram meant that the helicopter had limited aerodynamic and energy margins available for recovery, and potential rotor rpm decay at low altitude likely contributed to the inability to recover from the developing situation.

2.7 The helicopter's operation (400 feet above ground level [AGL] below 50 knots indicated airspeed [KIAS]) within the "dead man's curve" during a low speed turn out of wind likely

| <p>reduced rotor efficiency and recovery capability, contributing to the loss of performance and inability to recover from the developing low rotor rpm condition.</p> <p>2.8 During the low speed (50 KIAS) left turn out of wind, the helicopter likely had reduced tail rotor and rotor efficiency. This led to an unanticipated yaw, loss of directional control and the uncontrolled descent (SN-42).</p> <p>3. <u>Meteorological Information</u></p> <p>3.1 Meteorological condition did not contribute to this accident.</p> |

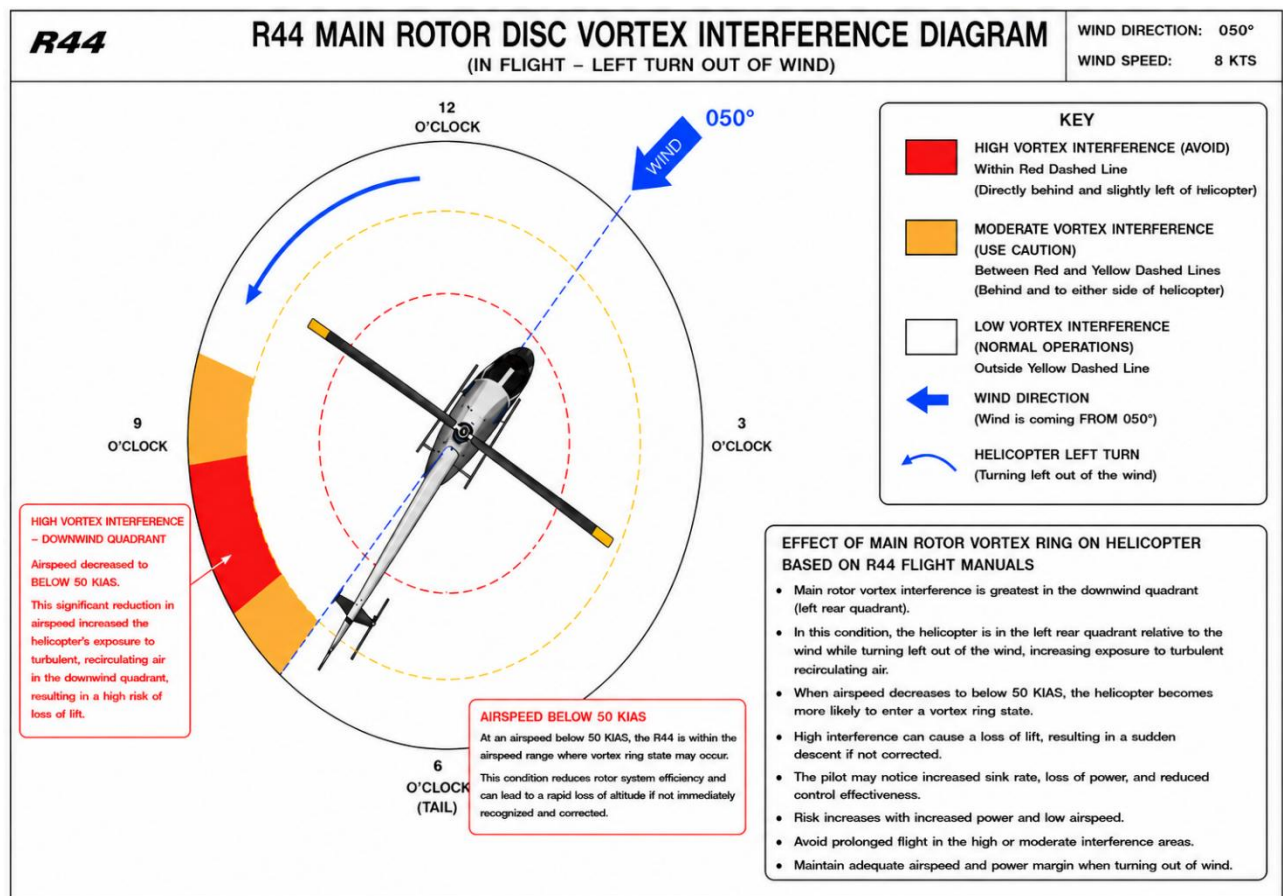
**Diagram 2:** An illustration of the main rotor disc aerodynamic interference at the time of the accident.

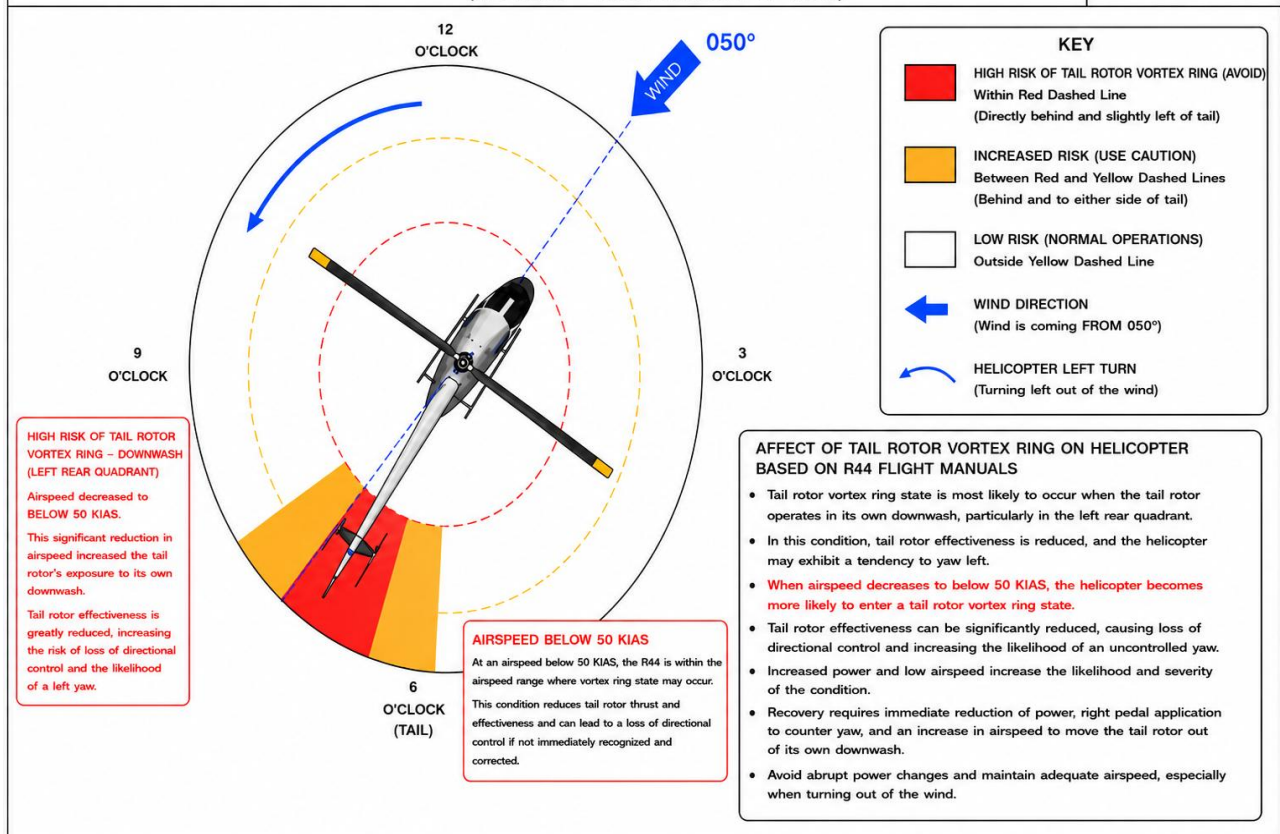
**Diagram 3:** An illustration of the tail rotor disc aerodynamic interference at the time of the accident.
