LIMITED OCCURRENCE INVESTIGATION REPORT – FINAL

Reference Number		CA18/2/3/10650								
Classification		Accident	Date		29 March 2026	Time		0630Z		
Type of Operation		Private (Part 94)								
Location										
Place of Departure		Uitspan Klein Karoo Guest Farm Airstrip near Ladismith, Western Cape Province			Place of Intended Landing		Uitspan Klein Karoo Guest Farm Airstrip near Ladismith, Western Cape Province			
Place of Occurrence		On the left side of the gravel runway at Uitspan Klein Karoo Guest Farm, Western Cape Province								
GPS Co-ordinates		Latitude	33°32'28.97" S	Longitude	021°9'11.80" E	Elevation	1 190 ft			
Aircraft Information										
Registration		ZU-ANU								
Make; Model; S/N		Skystar; Kitfox IV (Serial Number: 1712)								
Damage to Aircraft		Substantial			Total Aircraft Hours		625.4			
Pilot-in-command										
Licence Type		National Pilot Licence (NPL)		Gender		Male		Age	68	
Licence Valid		Yes		Total Hours		1 813.1		Total Hours on Type		625.4

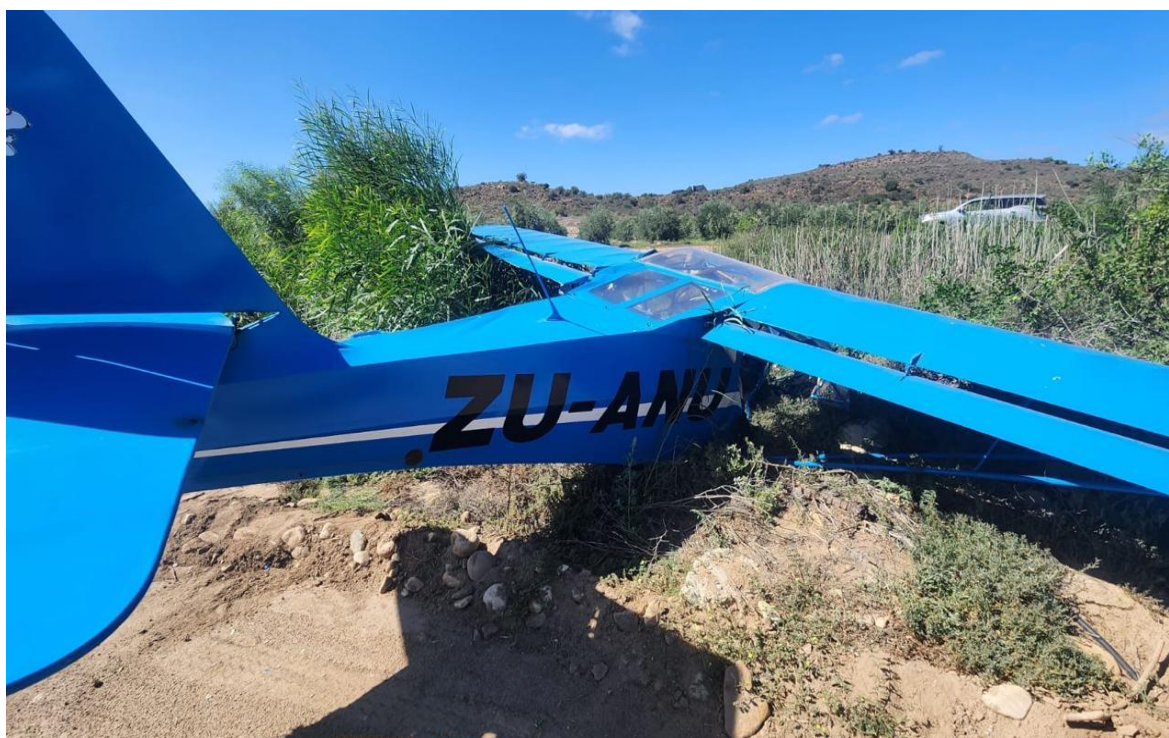
During the turn, the aircraft's left wing struck a barrier fence pole before it impacted the ground and cartwheeled; it came to rest within the farm's boundary. The aircraft was substantially damaged. The pilot sustained minor injuries, and the passenger was not injured.

Figure 2: The aircraft after it had come to rest. (Source: Pilot)

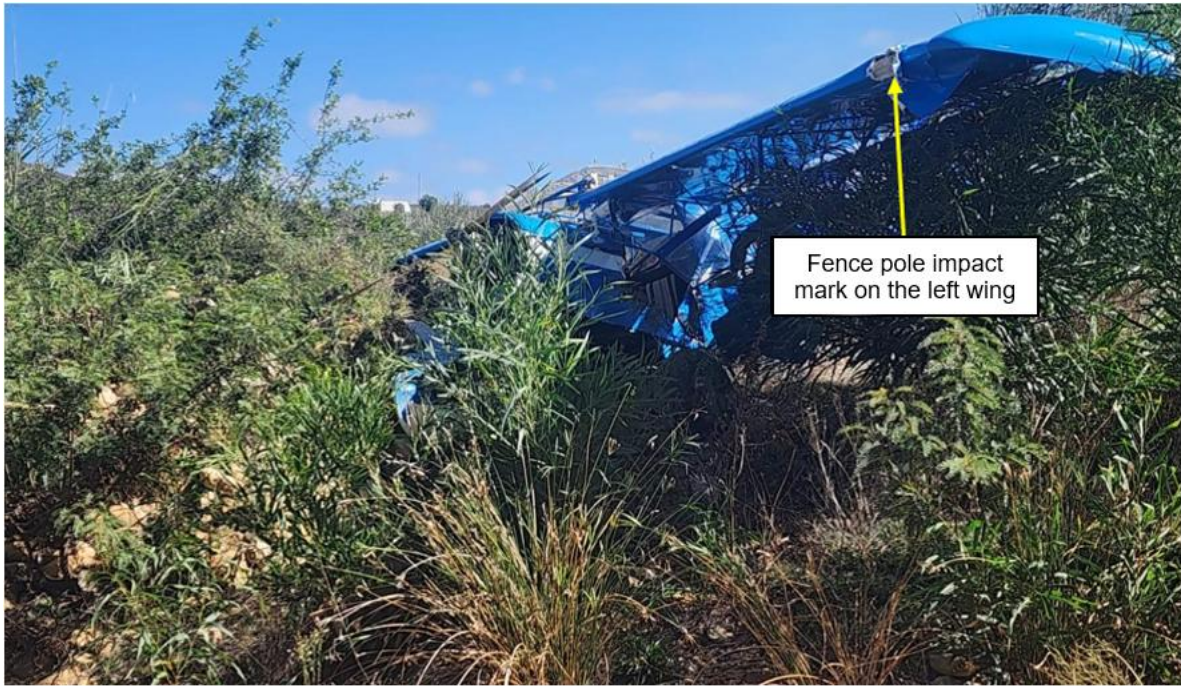
Figure 3: A side view of the aircraft after the accident. (Source: Pilot)

During take-off, the aircraft was unable to achieve a positive climb due to inadequate engine power as the installed engine did not meet the aircraft's required performance specifications. Whilst attempting to avoid the rising terrain ahead of the flight path, the pilot initiated a left turn during which the left wing struck a fence pole, and the pilot lost control of the aircraft.

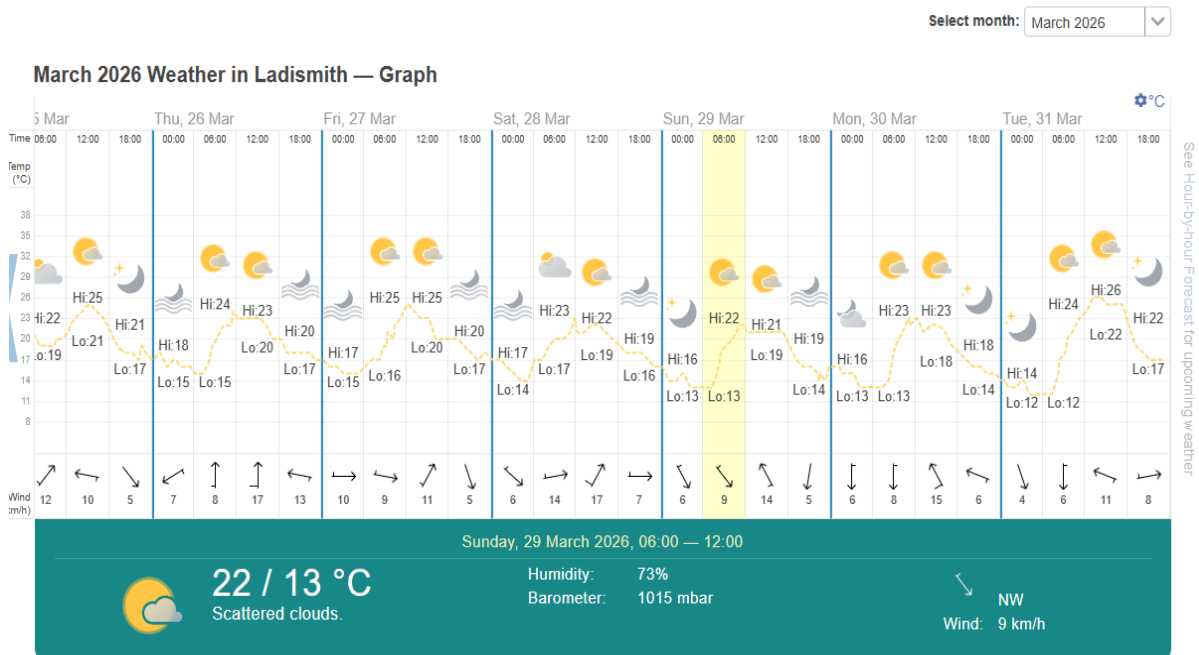
The pilot reported a downdraft encounter during the early stage of the climb. There was no official or automatic weather station available in the vicinity of the farm. The weather data in the table below was sourced from a website search of the weather conditions in the area, captured on 29 March 2026 at 0600Z, which indicated a temperature of approximately 22°C and a north-westerly wind of 5 knots (9 km/h).

Figure 4: Meteorological information around the accident site. (Source: Predictwind.com)

13. The weather conditions at the time of the flight were generally favourable with reported calm surface winds of 5kts. Although localised windshear and downdrafts could adversely affect aircraft performance at low altitude, the conditions on the day of the flight were not severe.

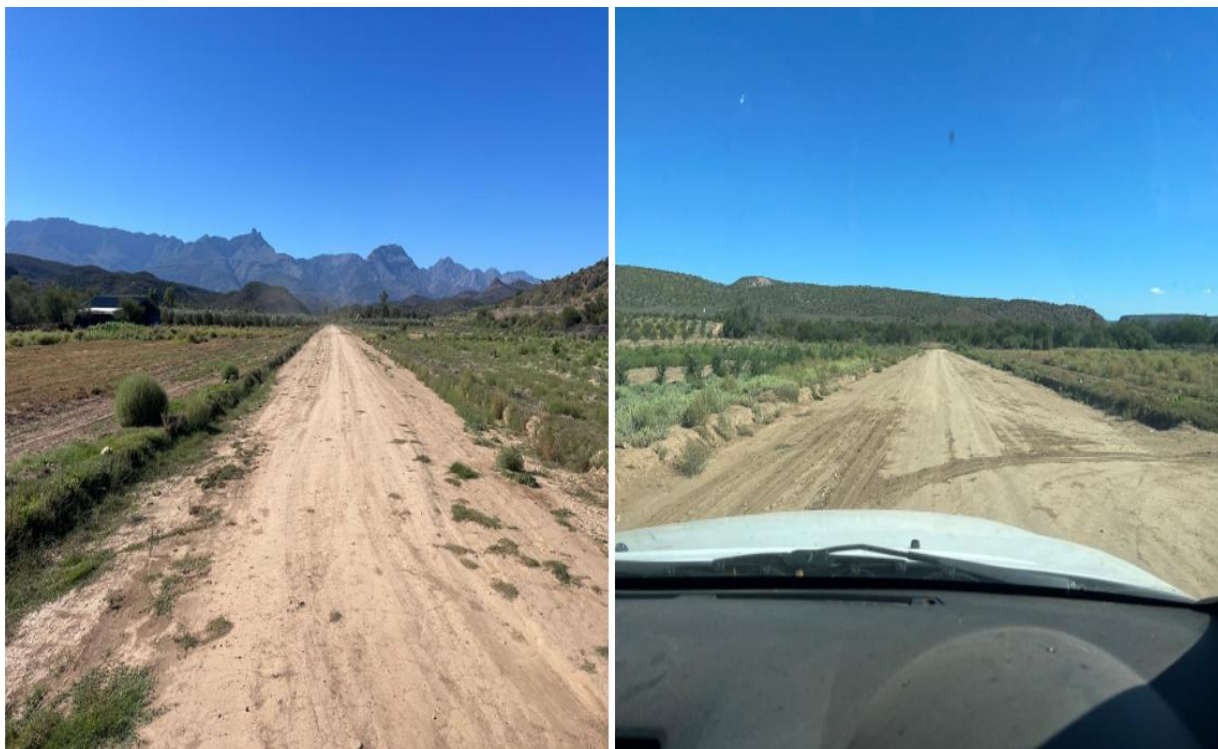
The farm airstrip is privately owned and unlicensed with a gravel-surface runway measuring approximately 470 metres (m) in length and 15m in width, and with an elevation of about 1 175ft. The airstrip is in a mountainous terrain; a mountain range with an approximate 6 000ft peak is located about 12 kilometres (km) from the runway in the take-off direction. The terrain also rises around the airstrip runway within 500m.

Figure 5: Runway view of the take-off direction along the gravel runway (left picture); runway view from the opposite end (right picture). (Source: Pilot)

14. The aircraft was operated from a gravel runway located in an area with a rising mountainous terrain where localised windshear and terrain-induced downdrafts were likely to be encountered, adversely affecting aircraft performance during take-off and initial climb phases.
