## LIMITED OCCURRENCE INVESTIGATION REPORT – FINAL

| <b>Reference Number</b> | CA18/2/3/10656 | | | | | | |
| Registration | ZU-EHX | | | | | | |
| Make; Model; S/N | Bushbaby (Serial Number: 098) | | | | | | |

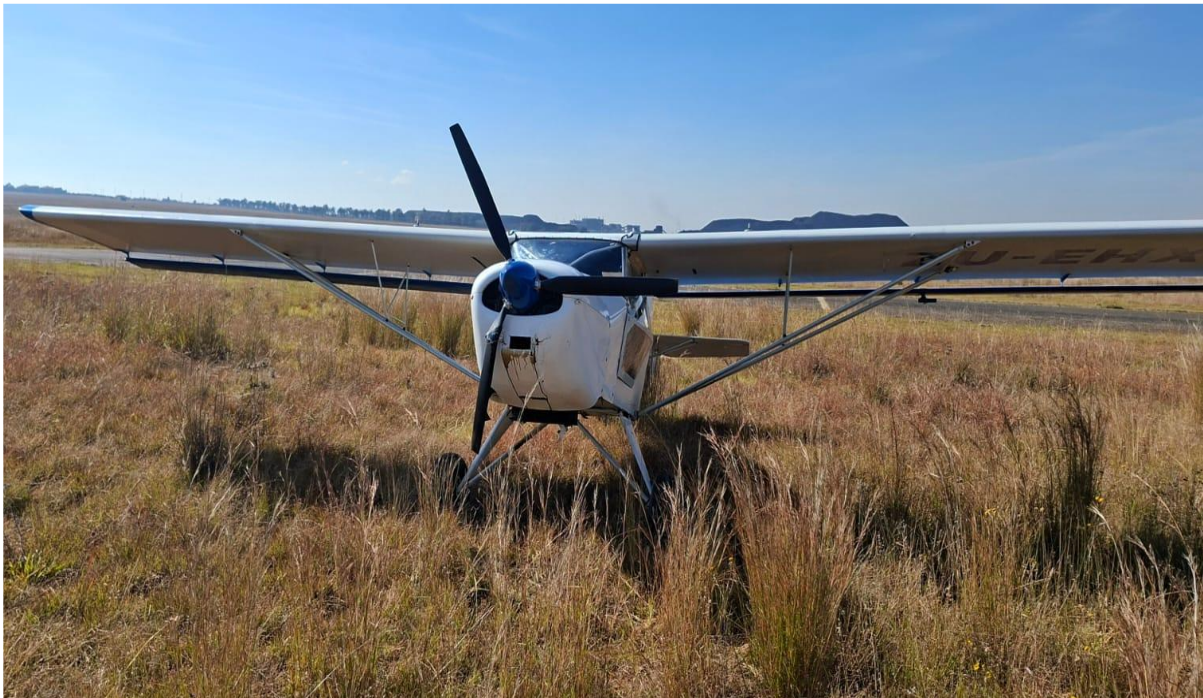
was not injured. The aircraft sustained damage to one of the propeller blades, oil line (hose) and fuselage during the accident sequence.

**Figure 2:** The aircraft at the accident site after it was recovered to an upright position.  
(Source: Pilot)

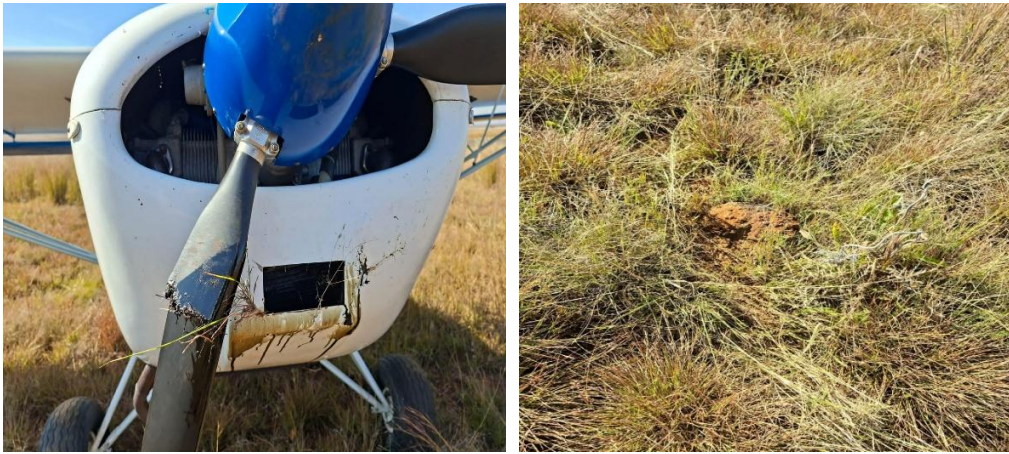
**Figures 3 and 4:** The damaged propeller blade (left picture), and the impacted anthill (right).  
(Source: Pilot)

| The aircraft touched down above the recommended speed which led to loss of directional control and a runway excursion; the aircraft impacted an anthill and nosed over. | |
