## LIMITED OCCURRENCE INVESTIGATION REPORT – FINAL

| <b>Reference Number</b> | | CA18/2/3/10663 | | | | | |
| <b>Registration</b> | | ZU-EDE | | | | | |
| <b>Make; Model; S/N</b> | | Jabiru; J430 (Serial Number: 266) | | | | | |

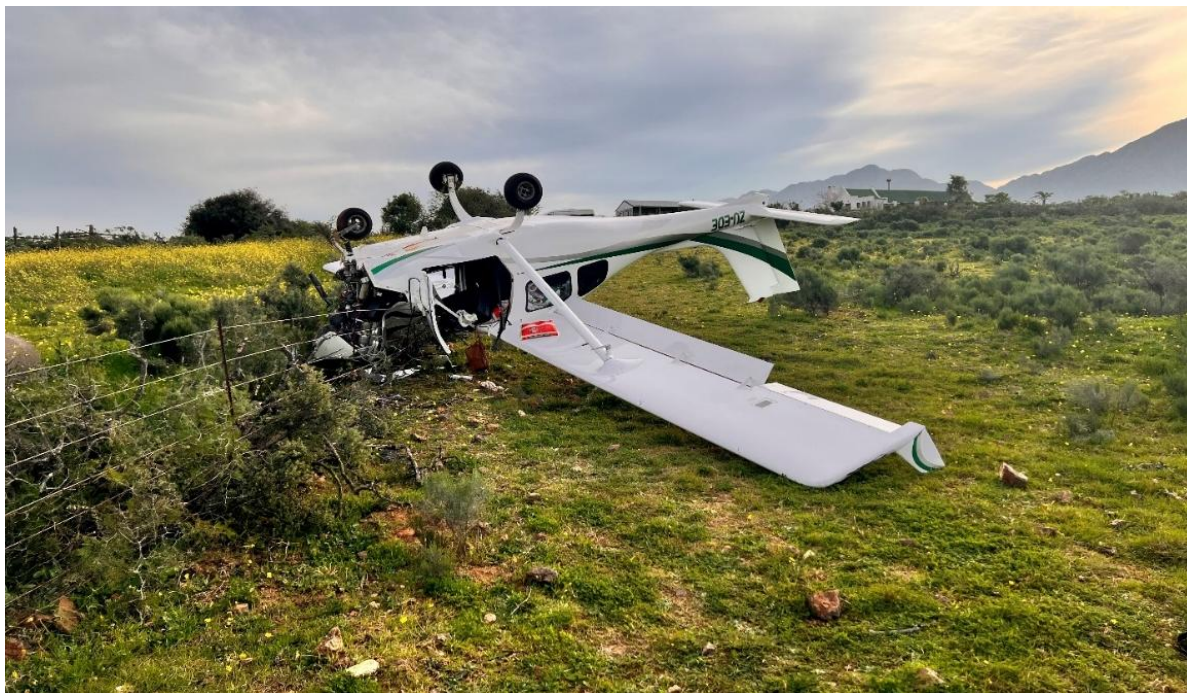
Whilst on base leg of the forced landing approach, the engine stopped and the propeller continued to windmill. The pilot selected flaps setting three and, in preparation for the touchdown, he switched off the master electrical switch, magnetos and the main fuel selector. The aircraft landed facing into the wind on a slightly rising terrain. During the landing roll, the uneven surface significantly reduced braking effectiveness despite maximum braking being applied. The aircraft rolled for approximately 500 metres (m) before it impacted a perimeter fence at an estimated groundspeed of about 85 knots (kts). After the impact, the aircraft nosed over (inverted position) before it stopped.

**Figure 2:** The wreckage at the accident site. (Source: Pilot)

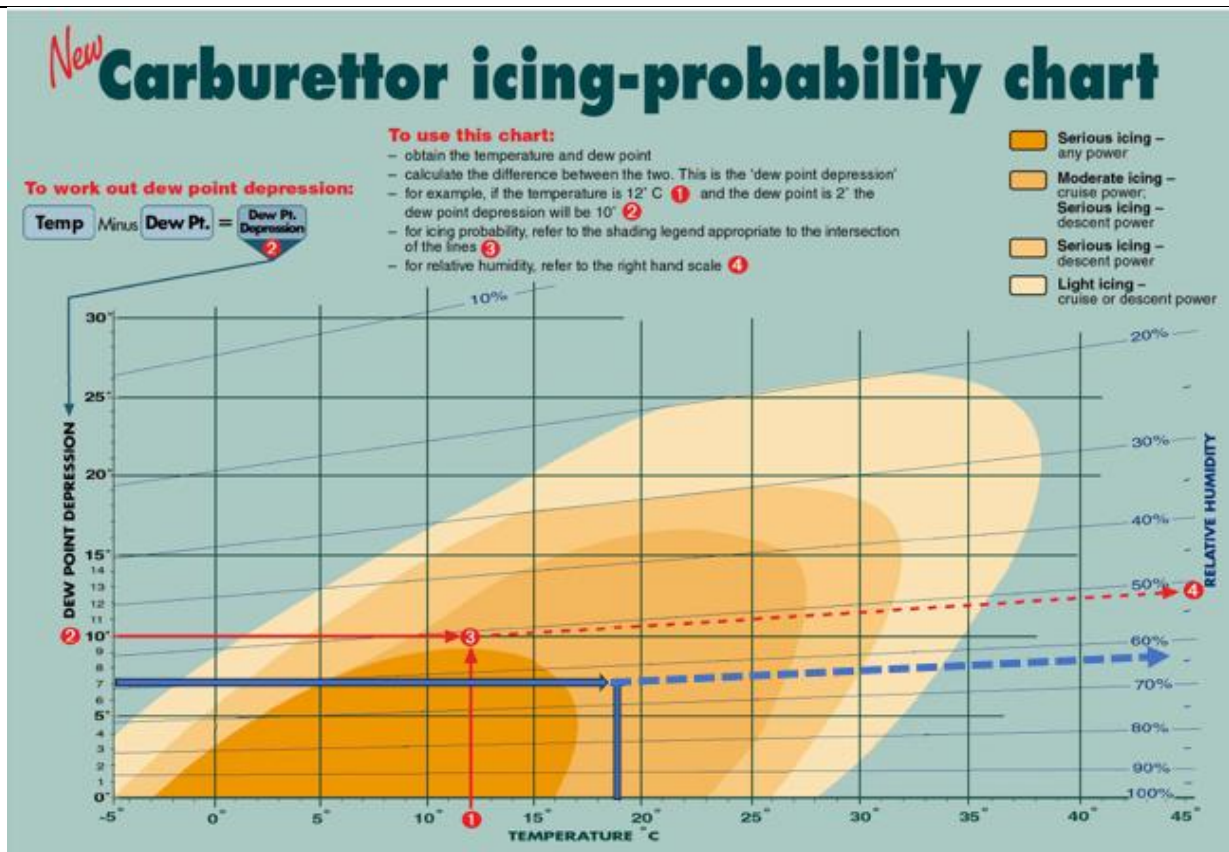
**Figure 3:** Carburetor probability Icing Chart calculation.

The provided atmospheric conditions indicated a significant chance of carburetor icing probability with a relative humidity at approximately 65%, and moderate ice formation during cruise power setting and serious icing during descent power settings.

The aircraft was on a climb during which the engine lost power, followed by an engine stoppage during descent.

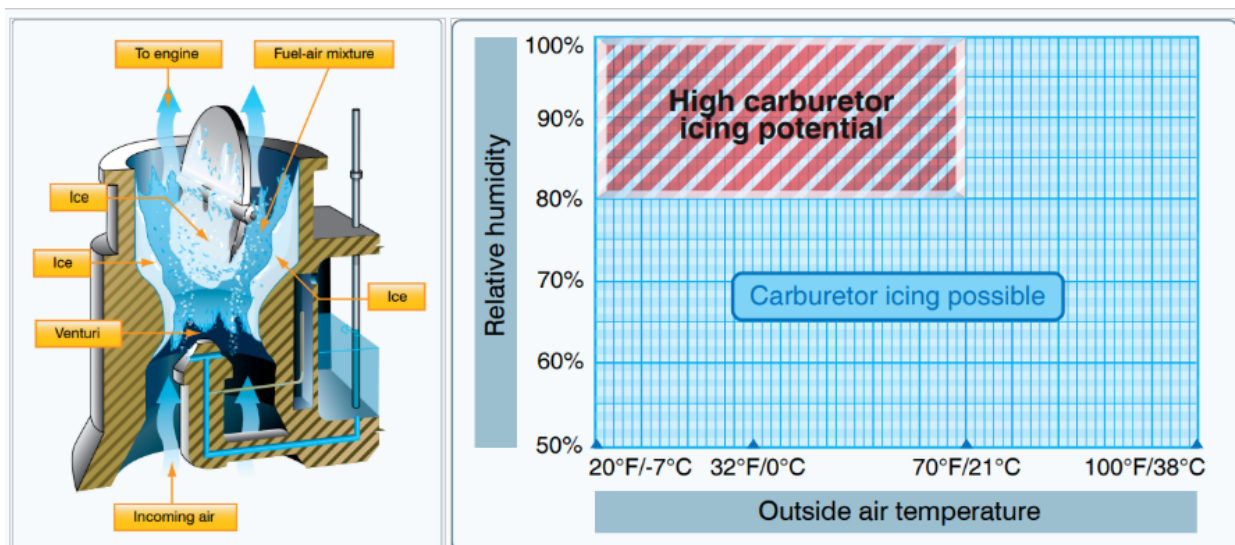
**Figure 4:** Carburetor icing effect and the related relative humidity.

According to the ICAO, induction icing (carburettor icing) may develop within a reciprocating engine carburettor when the cooling effect associated with airflow through the venturi and fuel evaporation reduces the induction air temperature sufficiently for moisture to condense and freeze. Such icing may occur in clear air and at ambient temperatures well above 0°C, provided atmospheric moisture is present. As ice accumulates within the induction system, the airflow to the engine is progressively restricted, resulting in a reduction in engine power output. Consequently, the reduction in available engine power may adversely affect aircraft performance, including a reduced rate of climb or an inability to maintain the required climb gradient.
