## AIRCRAFT SERIOUS INCIDENT REPORT AND EXECUTIVE SUMMARY

| | | | | <b>Reference:</b> | | CA18/3/2/1447 | |
| <b>Aircraft Registration</b> | <b>ZS-FGE</b> | <b>Date of Incident</b> | | 21 April 2024 | | <b>Time of Incident</b> | 1205Z |
| <b>Type of Aircraft</b> | | Boeing 737-800 | | <b>Type of Operation</b> | | Air Transport (Part 121) | |

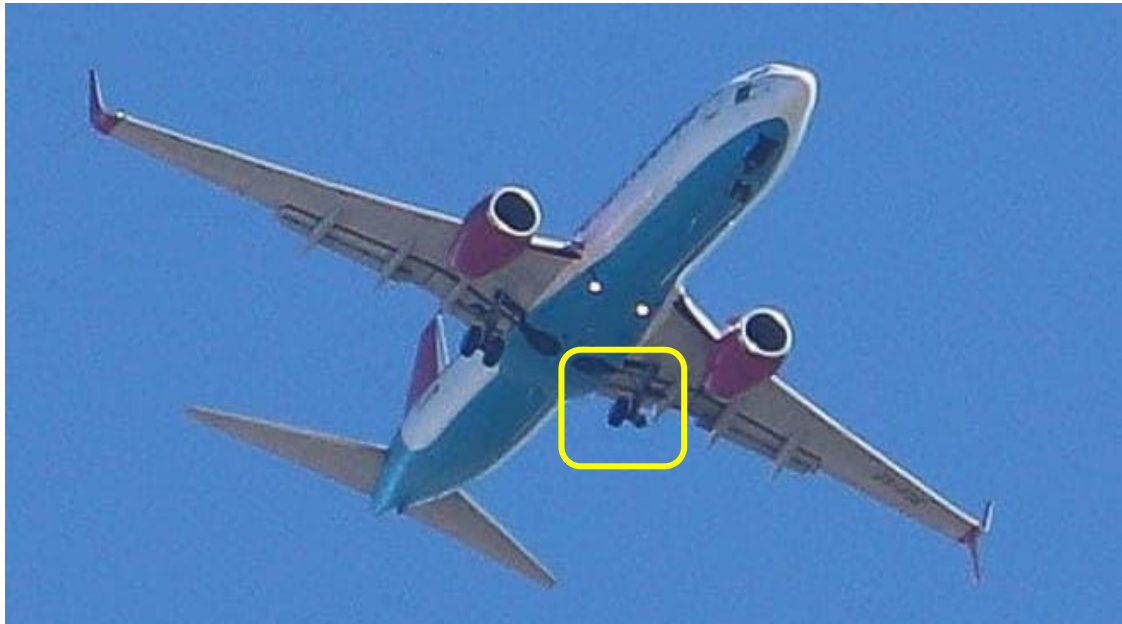
**Figure 1:** The aircraft with the missing left outer mainwheel.

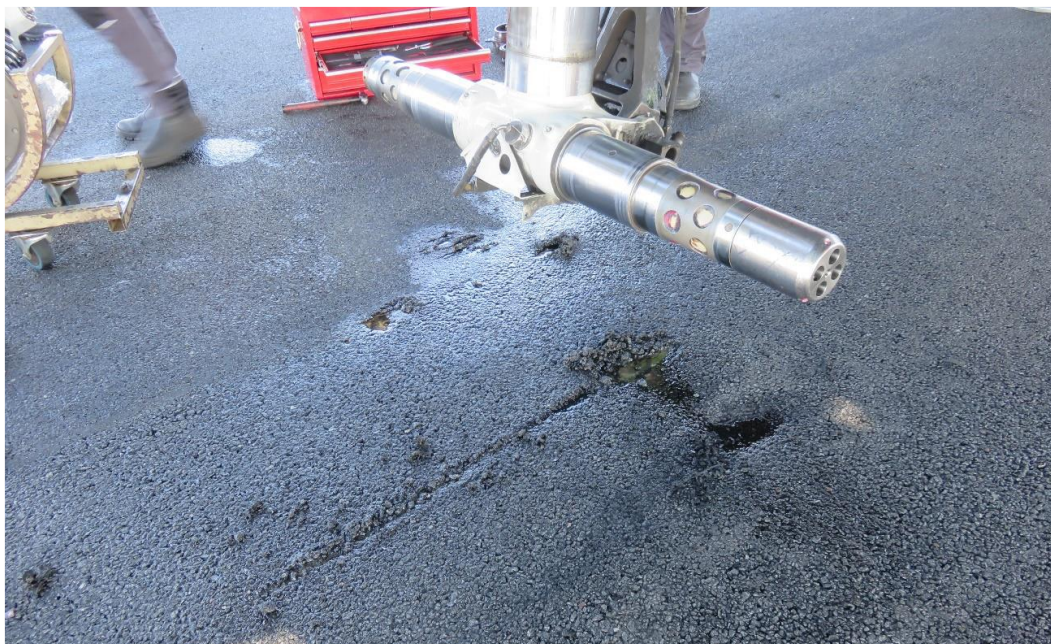
- 1.4.1 Minor damage was observed on the runway surface.

**Figure 3:** Damage caused to the runway surface where the aircraft had stopped.

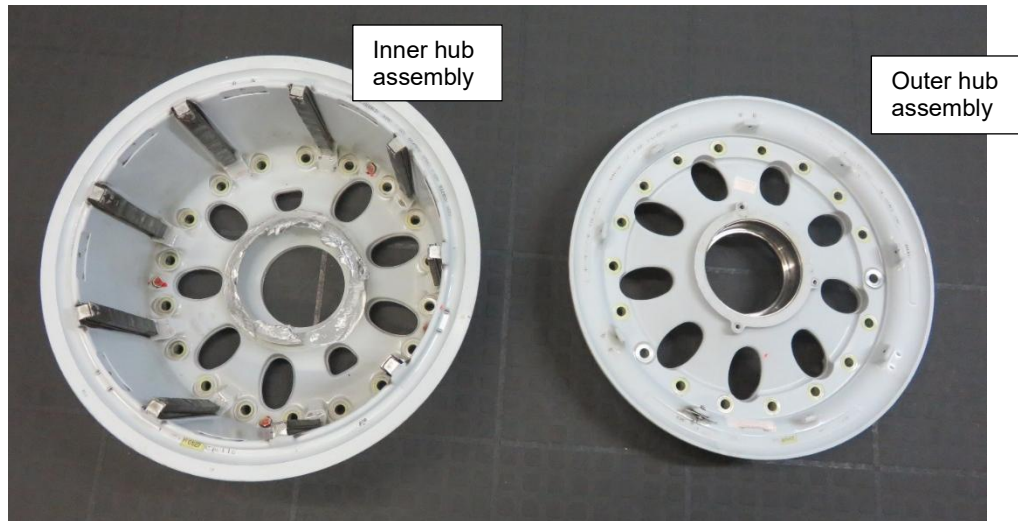
The two-wheel hubs did not leave the factory as an assembly. The wheel hub halves also had different manufacturing dates; the inner wheel hub had a serial number prefix containing the letter “H”, this type of prefix is only used when individual wheel hub halves are purchased from Honeywell.

**Figure 4:** The inner and outer hubs of the mainwheel assembly that separated from the axle.

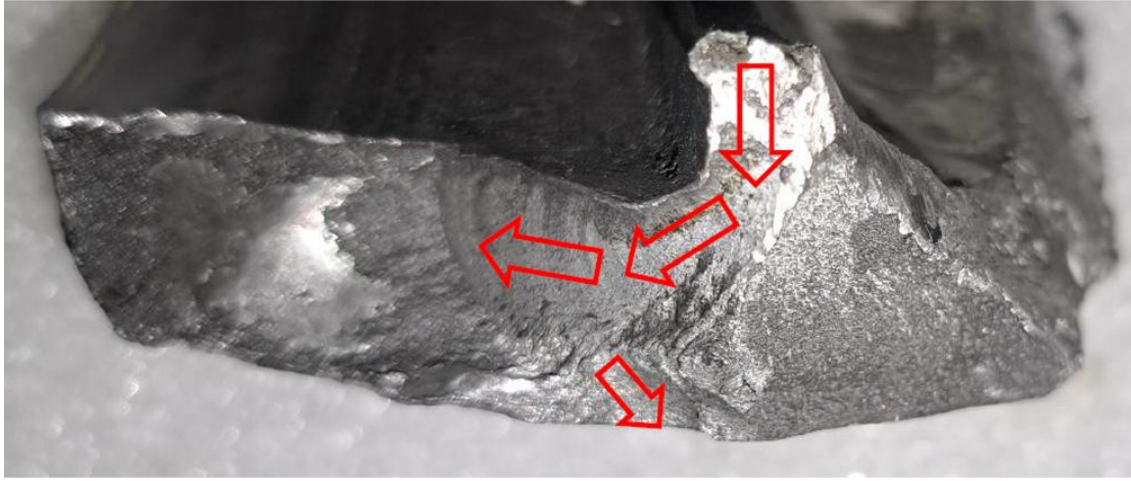
- A clear surface layer from thermal metal spray, the metallographic test results found the layer to be composed of 95% aluminium and 5% silicon.
- Clear indications of fatigue fracture with the initiation zone being coincident with the bearing bore radius and the inner surface of the bearing thrust shoulder on the hub (Figure 5).

**Figure 5:** Fatigue crack initiation site at the bearing thrust shoulder.

- 3.3.1 The failed wheel hub components indicated that the likely cause of the wheel hub failure was due to a fatigue crack that initiated at the bearing cup seat transition of the wheel inboard hub bearing bore.

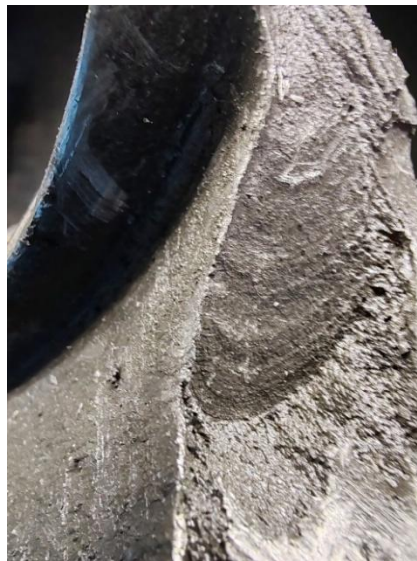
- Fatigue striations with clear progression directions (Figure 6).
- A build-up of foreign matter and mechanical (burnishing) damage at the initiation zone which suggested that the fracture surface was exposed to operational forces and environment for an undetermined period.

**Figure 6:** Fatigue striations with clear progression direction.

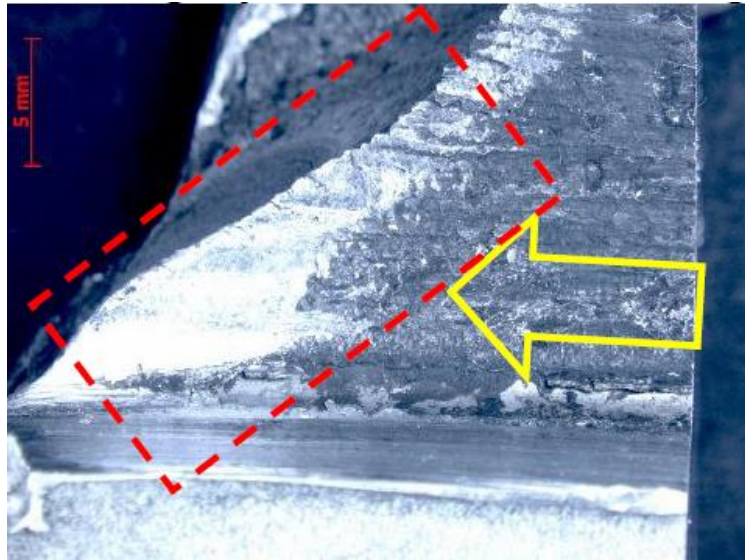
- The smearing damage noted at the edge of fracture surface suggested that the inboard bearing sleeve rotated within the bearing bore after the initiation of the fatigue fracture (Figure 7).

**Figure 7:** Smearing damage on the bearing bore.

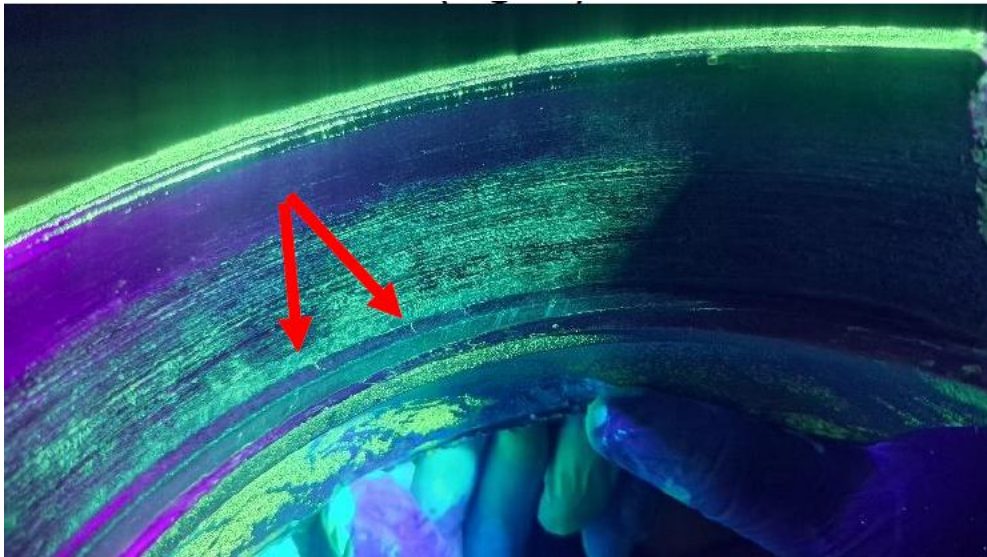
- NDT of the failed inboard hub pieces revealed possible secondary initiated fatigue fracture origins at the transition region between the bearing bore wall and the circumferential radius (Figure 8).

**Figure 8:** The NDT inspection shows possible secondary initiated fatigue fracture origins.

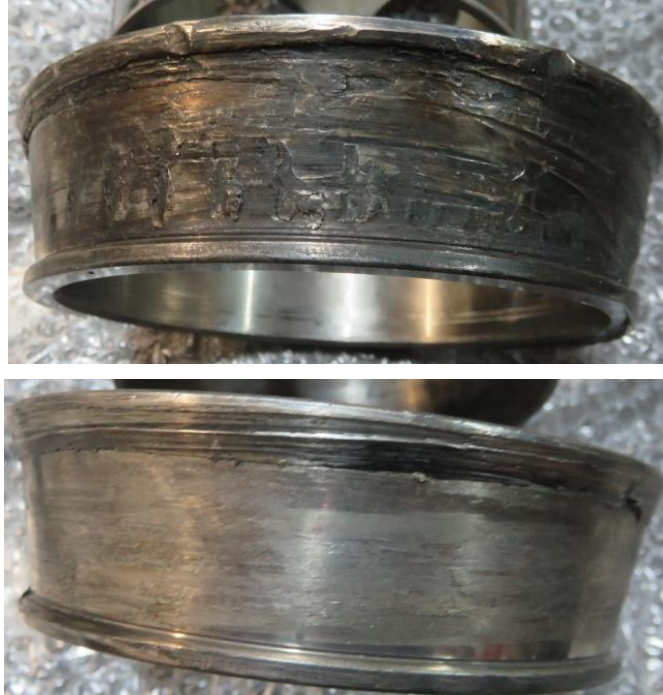
- The outboard cone was missing the roller complement and most of the cage because of the catastrophic failure. The inner race of the cone showed two clear locations of high heat discolouration as well as a section with no heat effect; these are 180° apart. The inner race showed mechanical damage in the form of roller indentations and scoring. This indicated that the cone had ceased to rotate, and that heat was only generated at the loaded zone on the bottom of the bearing race as mounted (Figures 9 and 10). The pieces of cage recovered from the outboard bearing were small and showed bridge wear and evidence of roller skewing.

**Figures 9 and 10:** The bottom half of the outboard bearing cone with high heat indications and roller indentations and scoring; and the top half of the outboard bearing cone with no high heat indications and roller indentations and only showing mechanical damage from roller scoring.

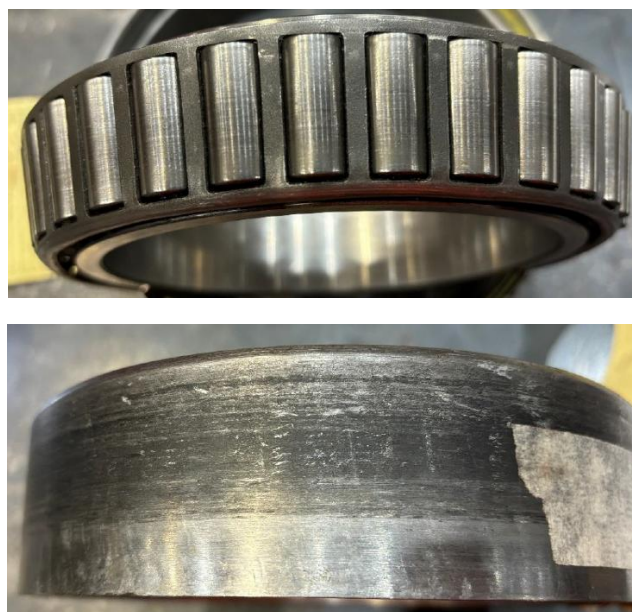
- The inboard cone was still intact and displayed only typical operating conditions such as debris-related indentations and roller scoring. No tempering colours related to excessive heat were visible. The inboard bearing cup was still mounted in a sleeve and was intact. The sleeve outside diameter exhibited minor signs of turning in the hub (Figures 11 and 12).

**Figures 11 and 12:** The inboard with the cone intact (top) and the inboard bearing sleeve with minor rotational scoring (bottom).

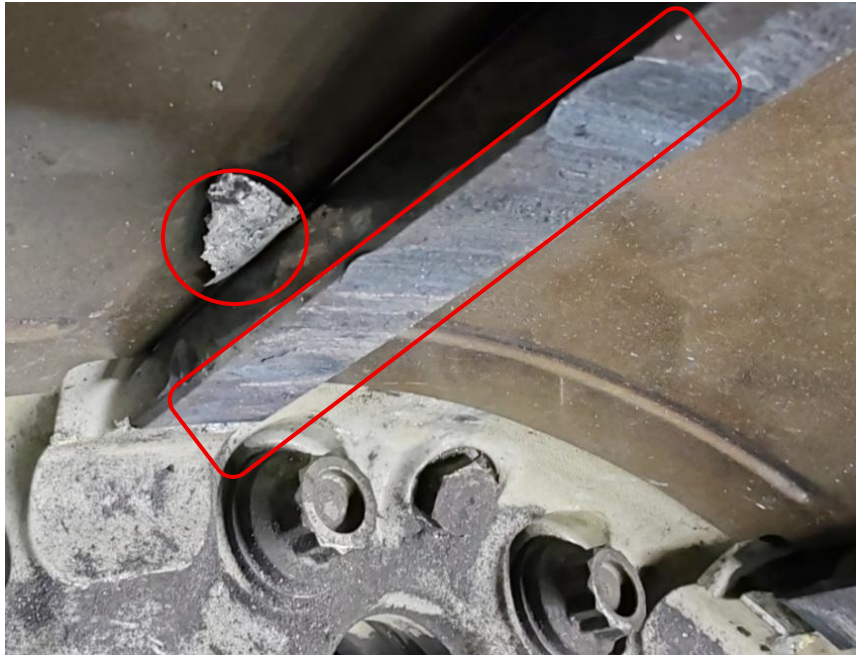
- Severe galling of the inboard wheel hub brake rotor drive keys with pieces of the failed hub jammed behind brake rotor keys (Figure 13).
- A clear zone of high heat discolouration on the outboard axle sleeve. The zone of heat discolouration was contained to the bottom half of the axle sleeve as mounted on the axle (Figures 14 and 15).

**Figure 13:** Brake rotor drive key with galling damage and a piece of the failed hub wedged behind it.

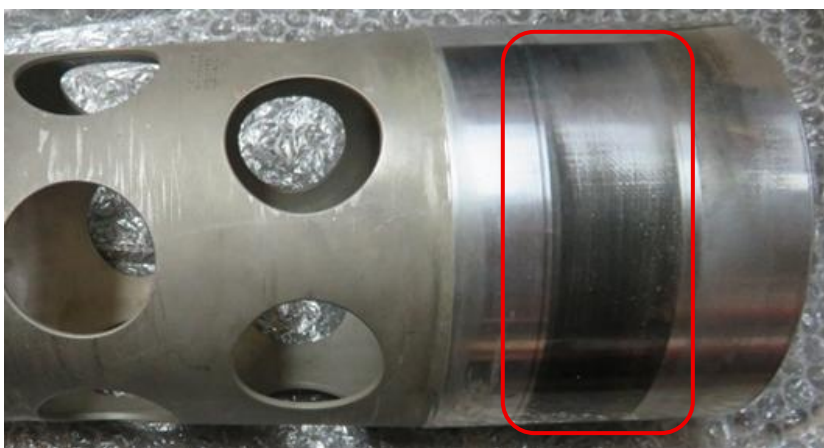
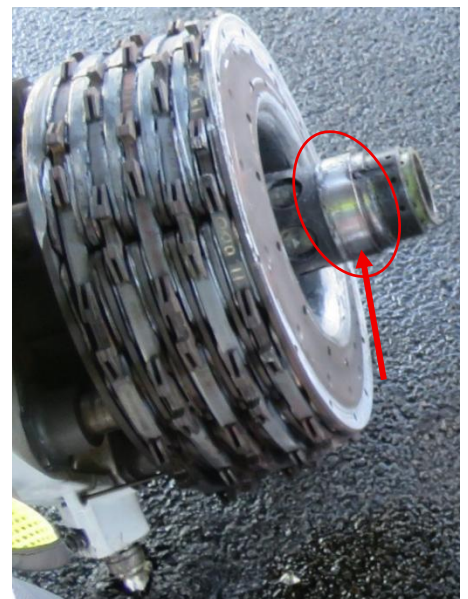
**Figures 14 and 15:** The left main landing gear outboard axle sleeve shows high heat indication localised to the bottom half of the sleeve.

- The heat discolouration zones identified on the outboard bearing cone and outboard axle sleeve were of the same nature and indicated that it was the lower half of the outboard bearing cone as mounted that suffered all the heat discolouration and roller indentation. The severe heat discolouration and roller indentation localised to the lower half of the bearing as mounted on the axle indicated that at some point during the failure sequence, the outboard bearing was carrying all the load applied to the left side outboard wheel during part of the taxi and, likely, all of the aircraft take-off rolls. The overloading and height rate of rotation of the wheel during take-off resulted in the catastrophic failure of the outboard bearing.

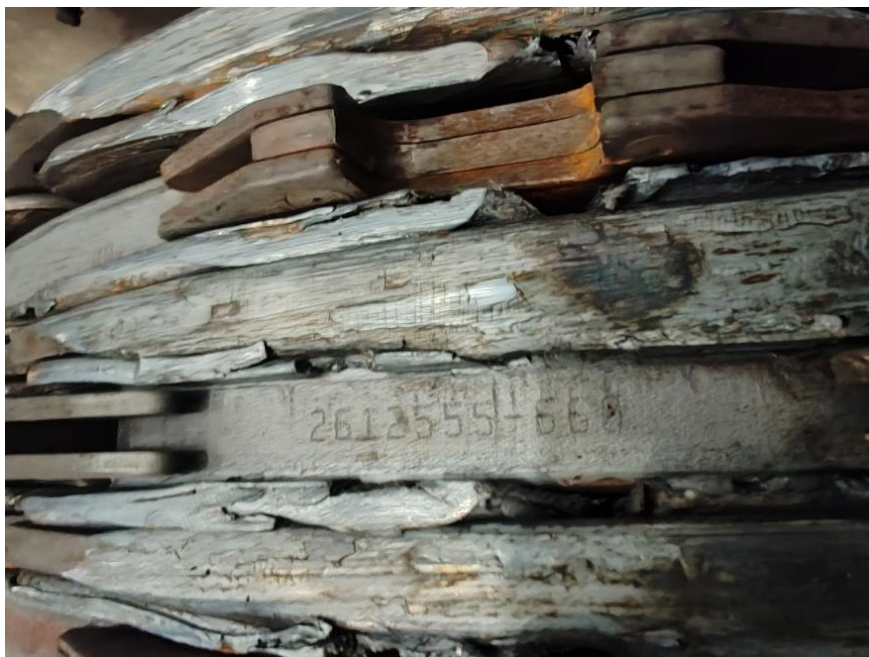
- There were large sections of galling damage and material transfer onto the brake unit stators from the liberated pieces of the failed wheel hub (Figure 16).

**Figure16:** The left main landing gear outboard brake unit shows galling damage and material transfer.

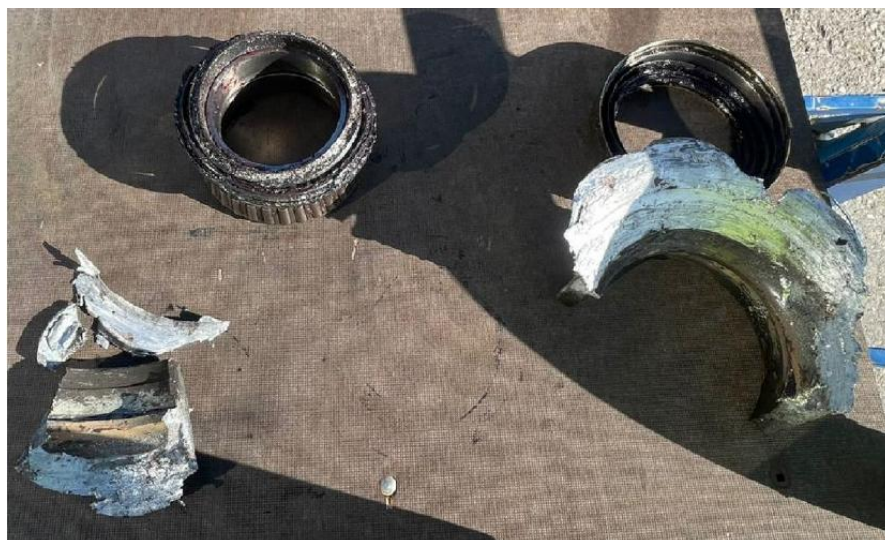
*While taxiing from the runway to the apron, the left wheel hub on the left main landing gear failed, and the aircraft came to a standstill on the taxiway. It was concluded that the incident was caused by a fracture in the hub of the inner wheel half of the left wheel on the aircraft's left main landing gear due to the propagation of a fatigue crack originating from a corrosion pit. The report also found that the instructions for the major overhaul of the wheel contained in CMM revision 10 (in force on the day of the incident) were not enough to ensure the integrity of the wheel during its service life which is thought to have been a contributing factor. The fractured wheel (P/N 2612311-1 and S/N B13557) was manufactured in 2008.*

**Figure 17:** Hub pieces from IN-019/2022 involving RyanAir aircraft.

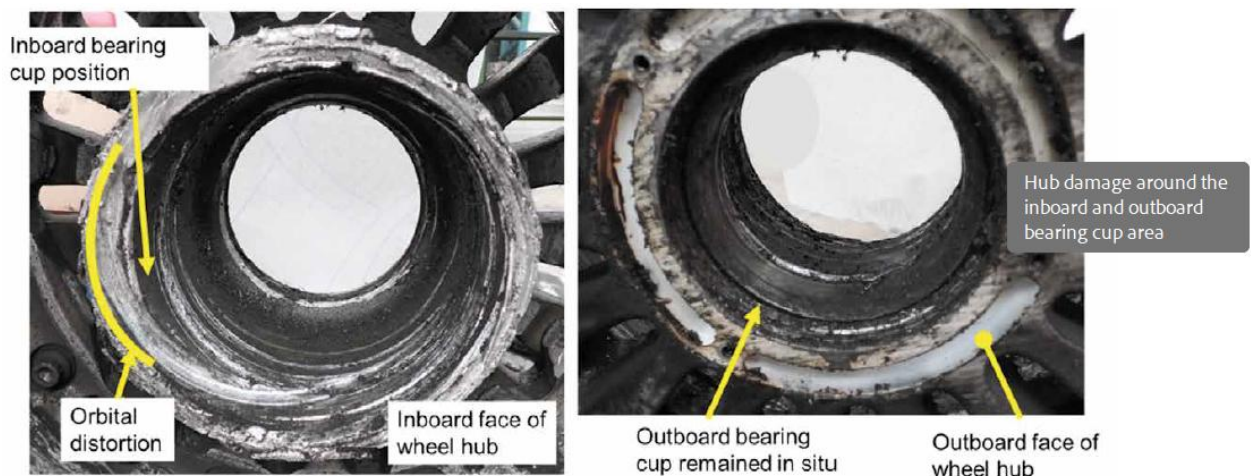
*Shortly after a normal touchdown, the right outer (No 4) mainwheel separated from its axle and was seen, by the pilots, to pass down the right side of the aircraft. The aircraft vacated the runway and was safely brought to a halt on the taxiway. The wheel separated as a result of a failure of the inboard wheel bearing which led to the failure of the outer bearing. The exact cause of the initial failure to the inboard bearing could not be determined.*

**Figure 18:** Inboard and outboard wheel hub from AAIB Bulletin: 11/2020 incident
