AIRCRAFT SERIOUS INCIDENT REPORT AND EXECUTIVE SUMMARY

Reference:	CA18/3/2/1458		
Aircraft Registration	ZS-SXJ	Date of Incident	27 October 2024		Time of Incident	0715Z	
Type of Aircraft	Airbus A330-300		Type of Operation		Commercial (Part 121)		
Pilot-in-command Licence Type	Airline Transport Pilot Licence (ATPL)		Age	53	Licence Valid	Yes	
Pilot-in-command Flying Experience		Total Flying Hours		21872.3	Hours on Type	809.6	
Last Point of Departure		Cape Town International Airport (FACT), Western Cape Province					
Next Point of Intended Landing		O.R. Tambo International Airport (FAOR), Gauteng Province					
Damage to Aircraft		None					
Location of the incident site with reference to easily defined geographical points (GPS readings if possible)							
Five (5) nm west of Loxton, Western Cape province, at Global Positioning System (GPS) co-ordinates determined to be 31°29'19.7"S 022°14'33.4"E, at an elevation of 41000 feet							
Meteorological Information		Surface Wind: 235° - 244° at 21kts; Temperature: 10.1°C; Dew Point: 2°C; QNH: 1007hPa

Synopsis

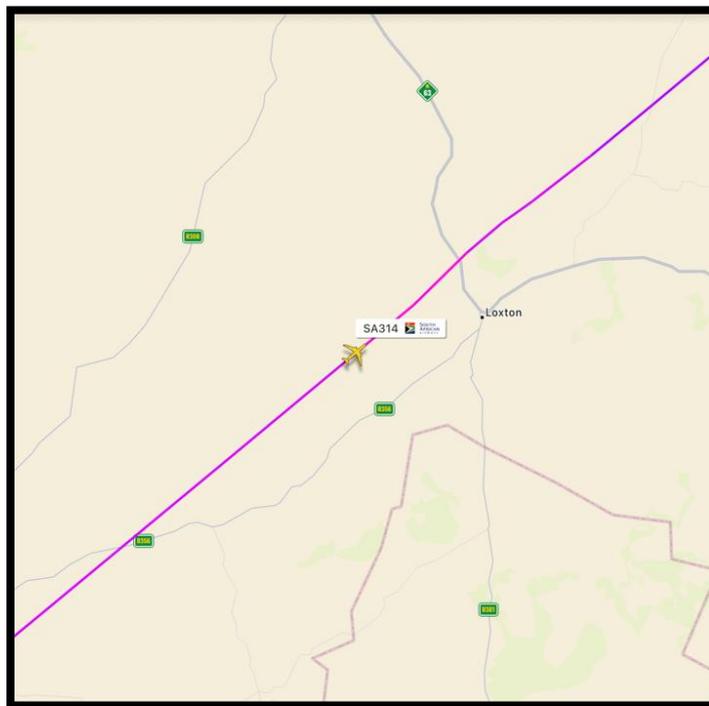
- 1.1.3. The FO immediately disconnected the autopilot (AP) and flew manual, gently pitching the aircraft down to approximately 1.5 to 2 degrees, which stopped speed acceleration. The speed trend vector then indicated a trend toward the vertical indicator/vertical protection (Vls/Vprot) range as the aircraft descended; this was a 40 to 50 kts change in the speed trend vector. The oscillation, which was followed by the rapid approach of the speed trend vector to overspeed and vertical indicators, occurred within a few seconds of each other.

Figure 1: The ZS-SXJ position during clear air turbulence. (Source: SAA)

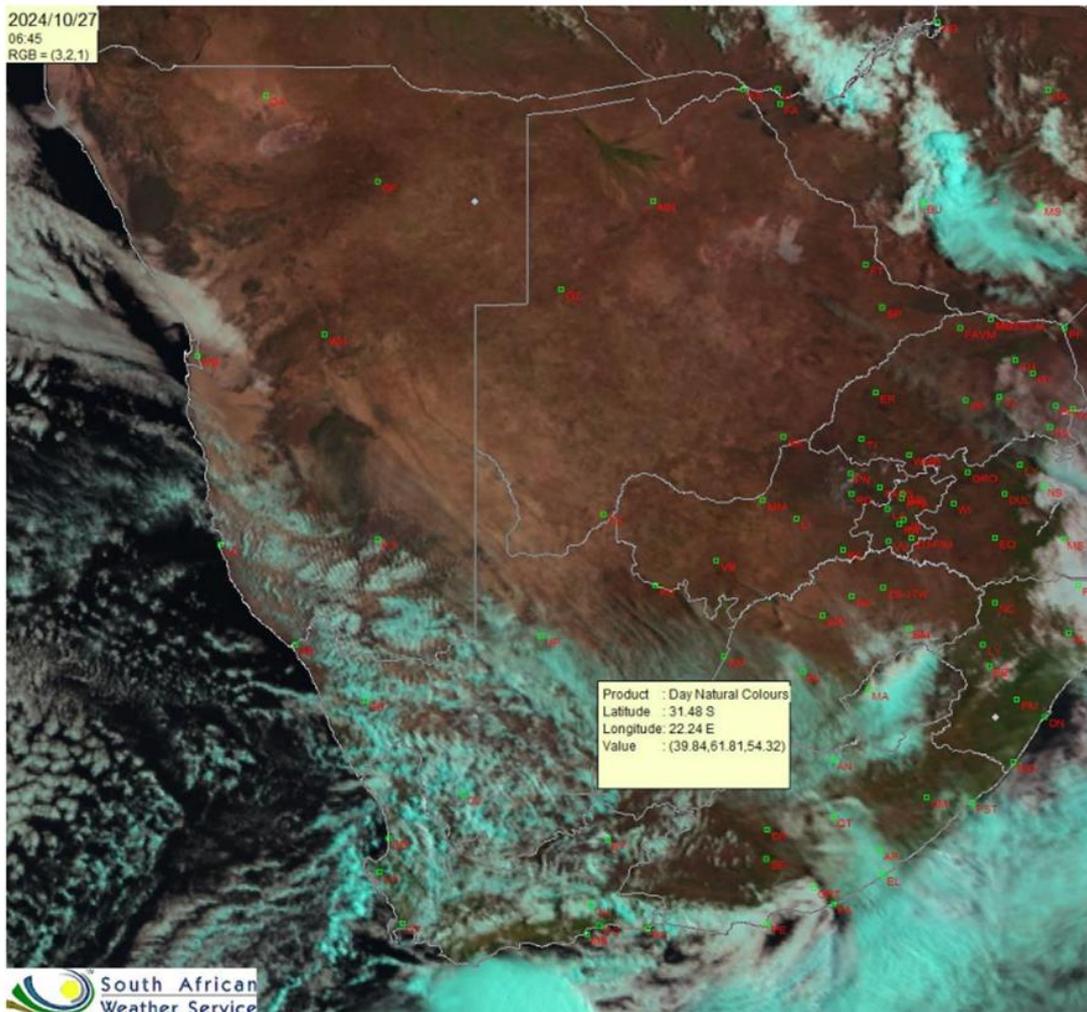
Figure 2: Day natural colours satellite image. (Source: EUMETSAT)

1.7.2. The day natural colours satellite image (below) of the MeteoSat Second Generation (MSG) taken at 0645Z indicated low clouds below the serious incident area (at 0645Z). Based on the satellite image, the low-level turbulence was evident in the cloud structure. Also, high-level turbulence was observed in the high-level clouds (see Figure 2).

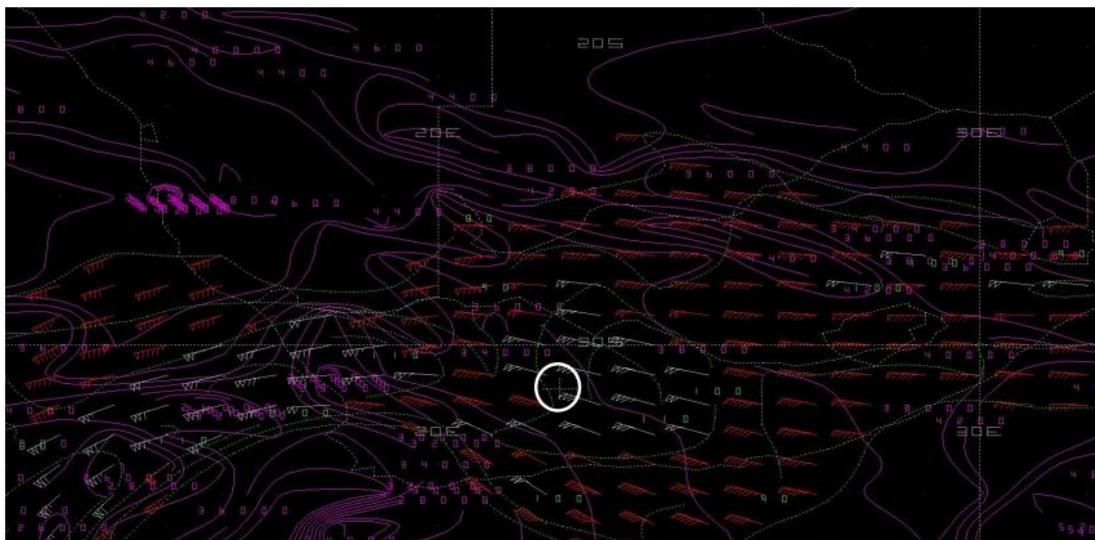
Figure 3: Forecast model output showing the area of jet stream over the serious incident area. (Source: SAWS)

1.7.3. The satellite imagery and synoptic message at 0600Z indicated the strong winds reported at the surface corresponded with the strong winds observed on the global forecast model between FL 340 and FL 450. The report also noted that at certain areas close to the serious incident area, the winds were greater than 60 kts. The winds also decreased from 100 kts at FL 360 to 80 kts at FL 410. Figure 3 indicates strong jet stream over the serious incident area.

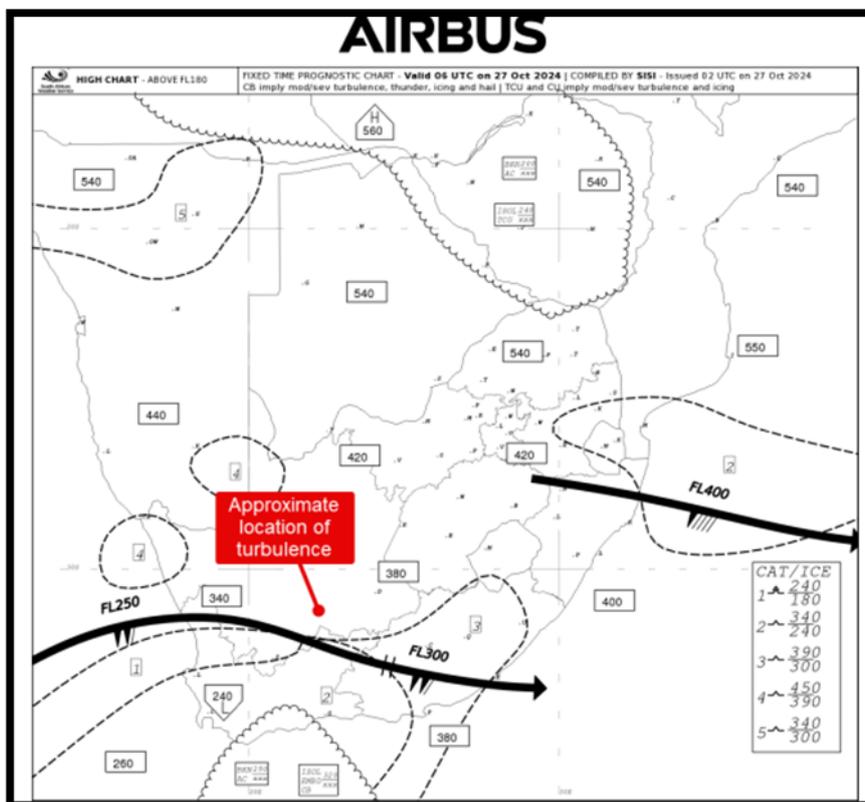
Figure 4: Weather interpretation by Airbus. (Source: Airbus)

“We can observe that the turbulence was located close to the jet stream which was below the aircraft. Such areas are known to be prone to clear air turbulence (CAT). Wind components were recomputed based on the provided QAR data. The analysis of the wind components indicated significant wind variations on the three axis (longitudinal, lateral and vertical) and was consistent with the crew report of CAT event.”

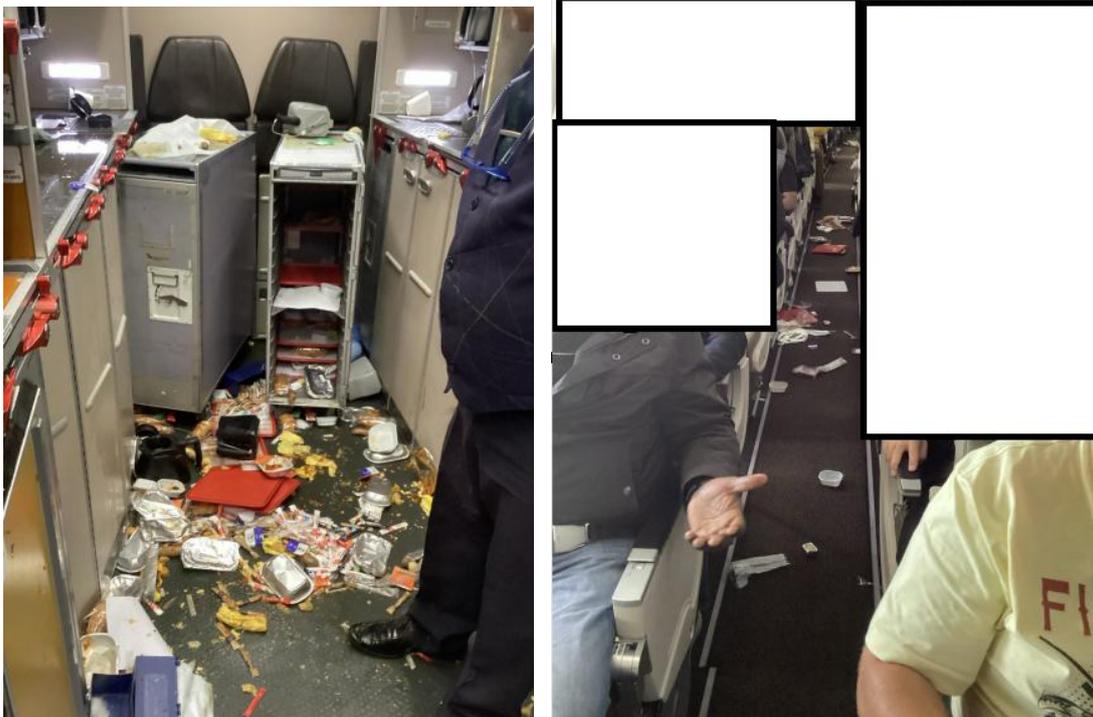
1.12.1. The aircraft encountered clear air turbulence whilst cruising at FL 410; the seat belt sign was OFF, and all passengers were seated. At the time, the cabin crew was serving breakfast. There was no turbulence warning from the cockpit crew as the weather radar did not detect it. The aircraft lost height rapidly and there was an increase in airspeed which led to the cabin crew in the aft galley sustaining injuries after losing balance. Some of the cabin crew members hit against the ceiling and other parts of the aircraft whilst others were burnt by hot beverages. Contents in the food trolleys spilled to the floor and some trolleys and other catering equipment fell to the cabin floor. Of the 10 cabin crew members, three sustained minor injuries, and one had serious injuries. During the occurrence, cabin crew members had instructed the passengers to fasten their seat belts and stow away loose items.

Figures 5 and 6: Food that had spilled to the floor (right). Most passengers had their seat belts on (left).
(Source: SAA)

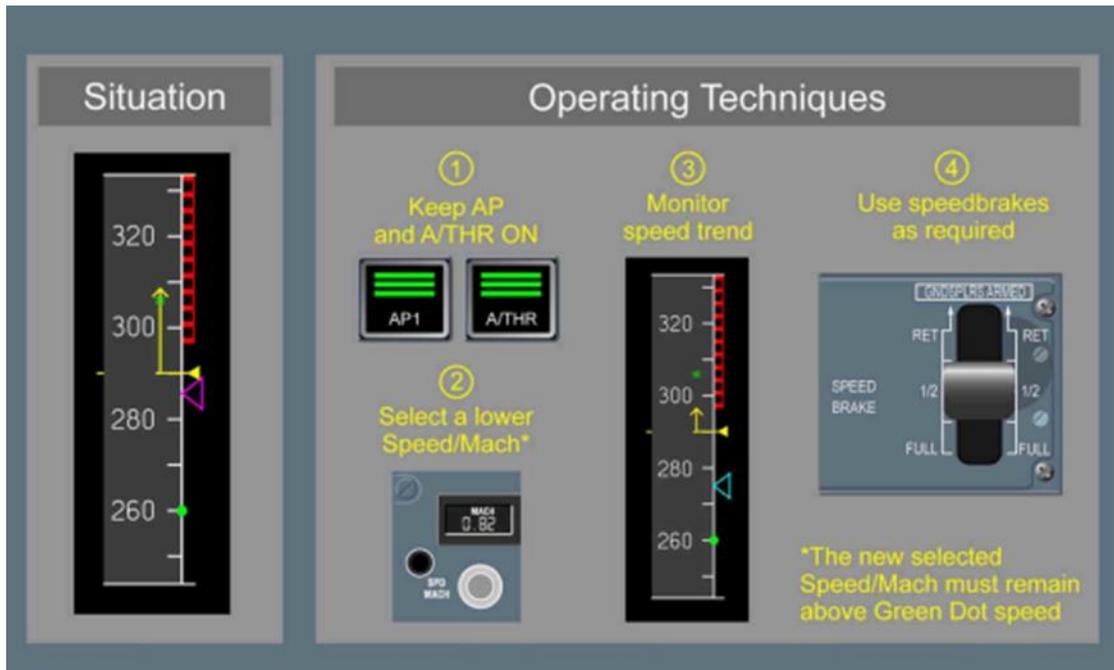
Figure 7: Instrument set up to prevent overspeed.

If the aircraft encounters significant speed variations close to VMO/MMO during the flight, the following operating techniques apply: It is recommended to keep the auto pilot (AP) and autothrust (A/THR) engaged. This enables to keep the intended flight path while thrust reduces to idle, if necessary. The flight crew selects a lower target speed to increase the margin to VMO/MMO.

However, the flight crew should not reduce the target speed below Green Dot, which is the minimum recommended speed during the flight. After the selection of the lower target speed, the flight crew monitors the speed trend arrow on the primary flight display (PFD). If the aircraft continues to accelerate, and if the speed trend arrow approaches or exceeds VMO/MMO, the flight crew uses the appropriate position of speed brakes depending on the rate of acceleration. The length of the speed trend arrow is a good indication of the rate of acceleration.

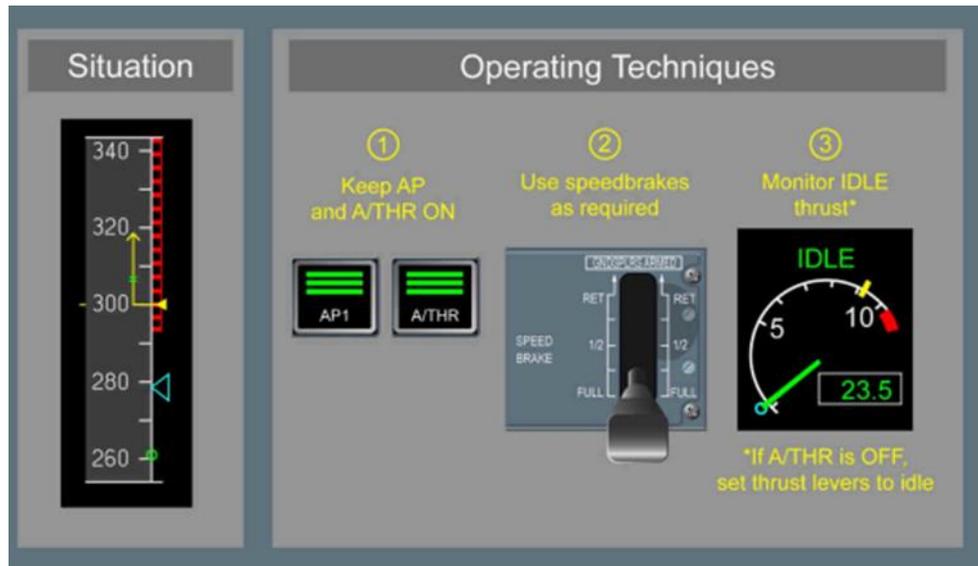
Figure 8: Instrument set up to recover from overspeed.

The flight crew must apply the overspeed recovery technique if the speed/Mach exceeds VMO/MMO. The OVERSPEED alert is triggered if the speed/Mach exceeds VMO +4 kt/MMO+M 0.006 and lasts until the speed is below VMO/MMO. The flight crew should keep the AP engaged. To minimise overspeed, the flight crew should extend the speed brakes to the most appropriate lever position depending on the overspeed situation. If the A/THR is ON, keep it engaged and check that the thrust is reducing to idle. There is no operational advantage in manually setting all thrust levers to idle for overspeed recovery. The engine thrust reduction is the same in both cases. If the A/THR is OFF, set all thrust levers to idle. In the case of severe overspeed, the AP automatically disengages and then the high-speed protection activates (except in direct law). As a result, the aircraft encounters an automatic pitch up. Note: The AP does not automatically disengage as soon as the speed reaches the green bars (that represent the threshold when the high-speed protection activates) on the PFD. The AP disengagement depends on the speed variations and the high-speed protection logic.

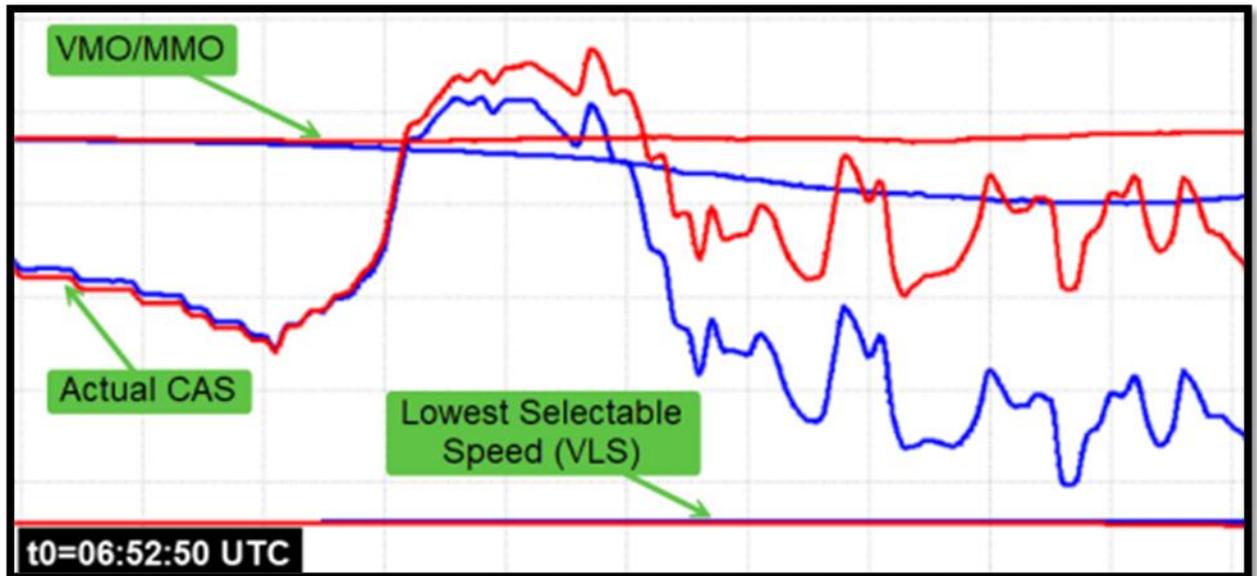
First, the event has been replayed to establish a reference simulation (blue curves below). Once this simulation was found satisfactory in terms of comparison with the event flight, a back-to-back simulation was conducted with the AP ON (red curves). The airspeed (CAS)

excursion above VMO/MMO would have been slightly increased with the AP ON (+5kts, +1.5s), but it would still have remained limited in amplitude (less than 10 kts) and duration.

Figure 9: The red line indicates the handling of the aircraft with AP ON.

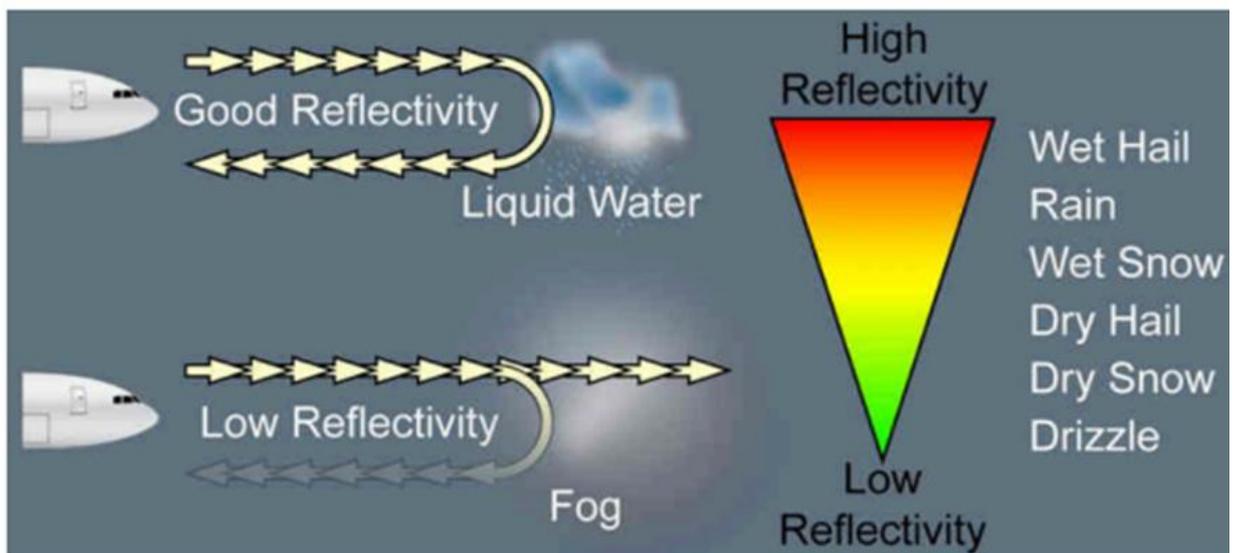
Figure 10: Aircraft weather detection.

Weather detection is based on the reflectivity of water droplets. The weather echo appears on the navigational display (ND) with a colour scale that goes from red (high reflectivity) to green (low reflectivity). The intensity of the weather echo is associated with the droplet size, composition and quantity (e.g. the reflectivity of a water particle is five times more than an ice particle of the same size). The flight crew must be aware that the weather radar does not detect weather that has small droplets (e.g. clouds or fog), or that does not have droplets (e.g. clear air turbulence).
