LIMITED OCCURRENCE INVESTIGATION REPORT – FINAL

Reference Number	CA18/3/2/1516						
Classification	Serious Incident	Date	24 November 2025		Time	1250Z	
Type of Operation	Air Transport Operations, Carriage of less than 20 passengers (Part 135)						
Location							
Place of Departure	Arathusa Safari Lodge Aerodrome (FAAR), Mpumalanga Province		Place of Intended Landing	O.R. Tambo International Airport (FAOR), Gauteng Province			
Place of Occurrence	On Runway 16 at Arathusa Safari Lodge Aerodrome, Mpumalanga Province						
GPS Co-ordinates	Latitude	24°44'11.68" S	Longitude	031°30'51.50" E	Elevation	1 256 feet	
Aircraft Information							
Registration	ZS-KMH and ZS-KMJ						
Make; Model; S/N	Cessna Aircraft Corporation, 208B Caravan (Serial Numbers: 208B-5742 [ZS-KMH] and 208B-5749 [ZS-KMJ])						
Damage to Aircraft	Substantial		Total Aircraft Hours	2 123.22			
Pilot-in-command							
Licence Type	Commercial Pilot Licence		Gender	Female		Age	26
Licence Valid	Yes	Total Hours	953.6		Total Hours on Type	651.6

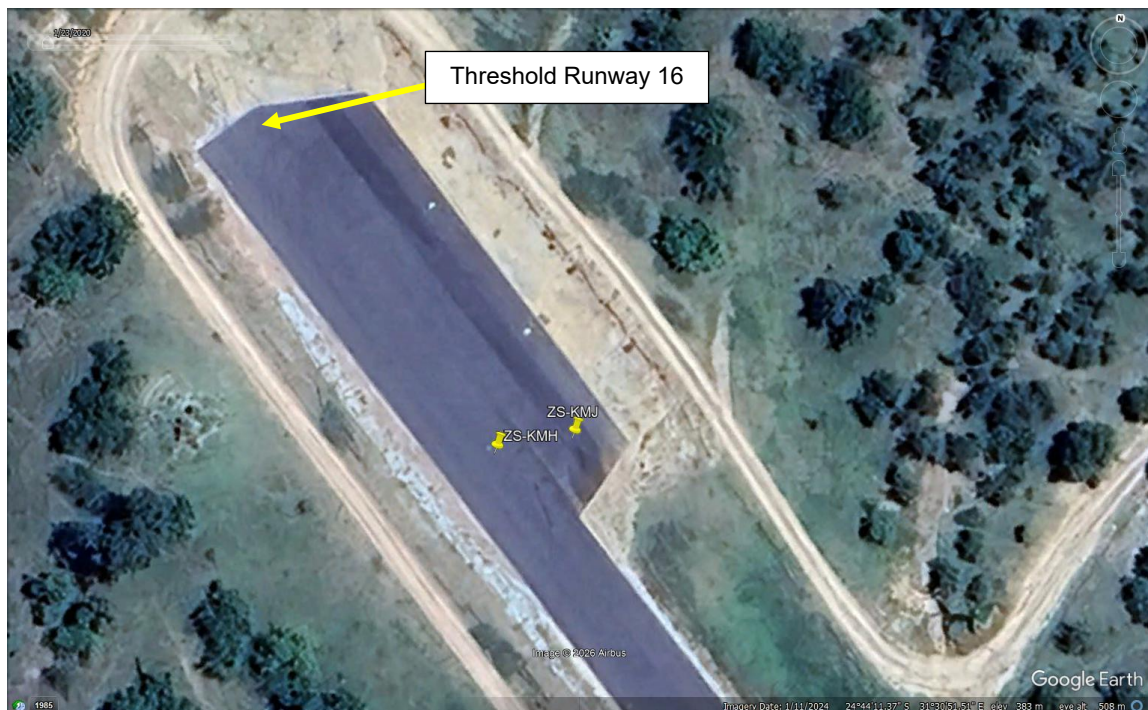
Figure 1: The position of the two aircraft when the wing impact occurred. (Source: Google Earth)

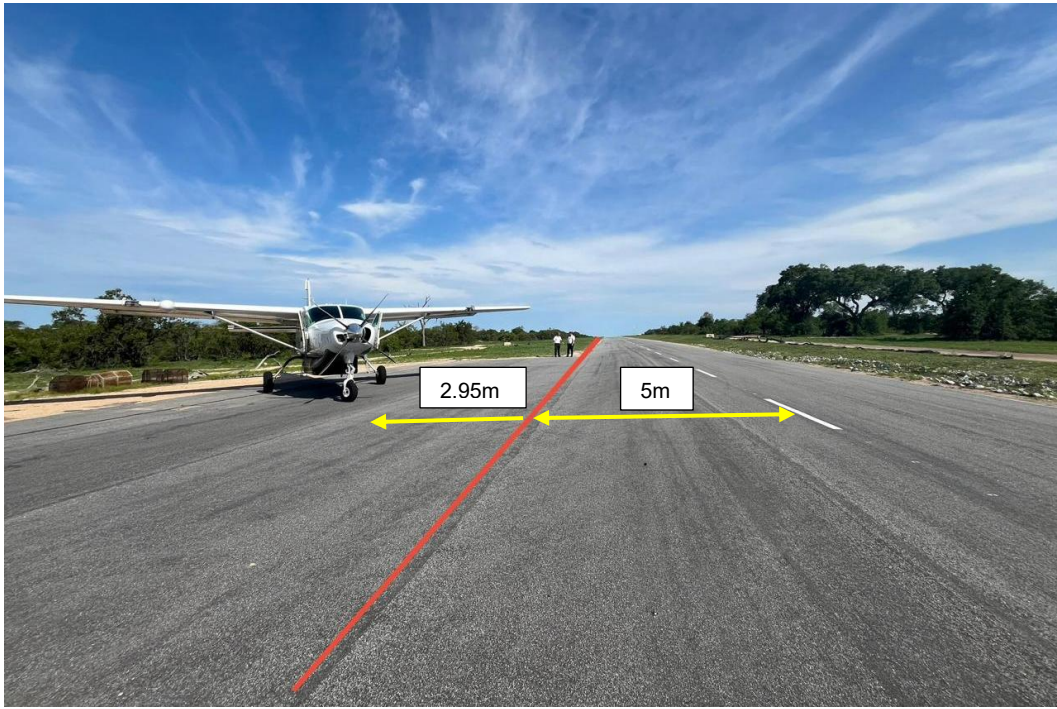
Figure 2: The ZS-KMJ aircraft as it was parked next to Runway 16 at the time. (Source: Operator)
The two arrows indicate the distance from the runway centreline to the runway edge which is 5m, and the wing exceeding the runway edge by 2.95m.

3. The ZS-KMH wings exceeded the runway edge by approximately 2.95m on either side (if the nose wheel of the aircraft was on the runway centreline during the take-off roll).

5. The ZS-KMJ crew did not park the aircraft at a 90° angle to the runway centreline (see Figure 2), this presented inadequate wing-tip clearance as the aircraft was parked at a 45° angle to the runway centreline.

1. It is recommended to the operator that if more than one aircraft is present at FAAR at any given time, both aircraft should be parked in a manner that ensures ample wing clearance is maintained to prevent a re-occurrence of this serious incident.

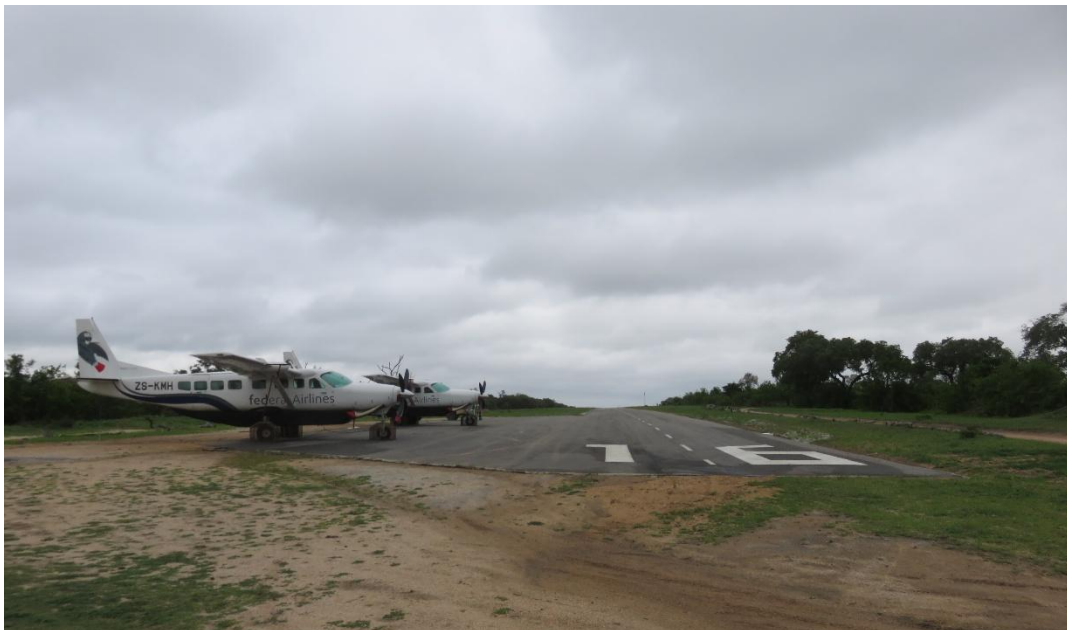
Figure 3: The threshold of Runway 16. The picture was taken after the serious incident with the two aircraft parked next to each other and tied down.

3.2 Figure 3 shows that the apron area forms part of Runway 16, with the threshold at the start of the asphalt surface.

2. It is recommended to the operator that if more than one aircraft is present at FAAR, the crew that is going to take-off first should taxi past the parked aircraft safely onto the runway area, which should exclude the apron area as being part of the runway.
3. It is recommended to the aerodrome owner and the operator of the aircraft involved (in this serious incident) that Runway 16 threshold be moved, and that it should commence past the apron area as the current layout poses a serious safety risk.
4. It is recommended to the aerodrome owner that the water drainage ditch to the right of Runway 16 be levelled off to the runway surface as it poses a risk to safe operation of aircraft at the aerodrome.

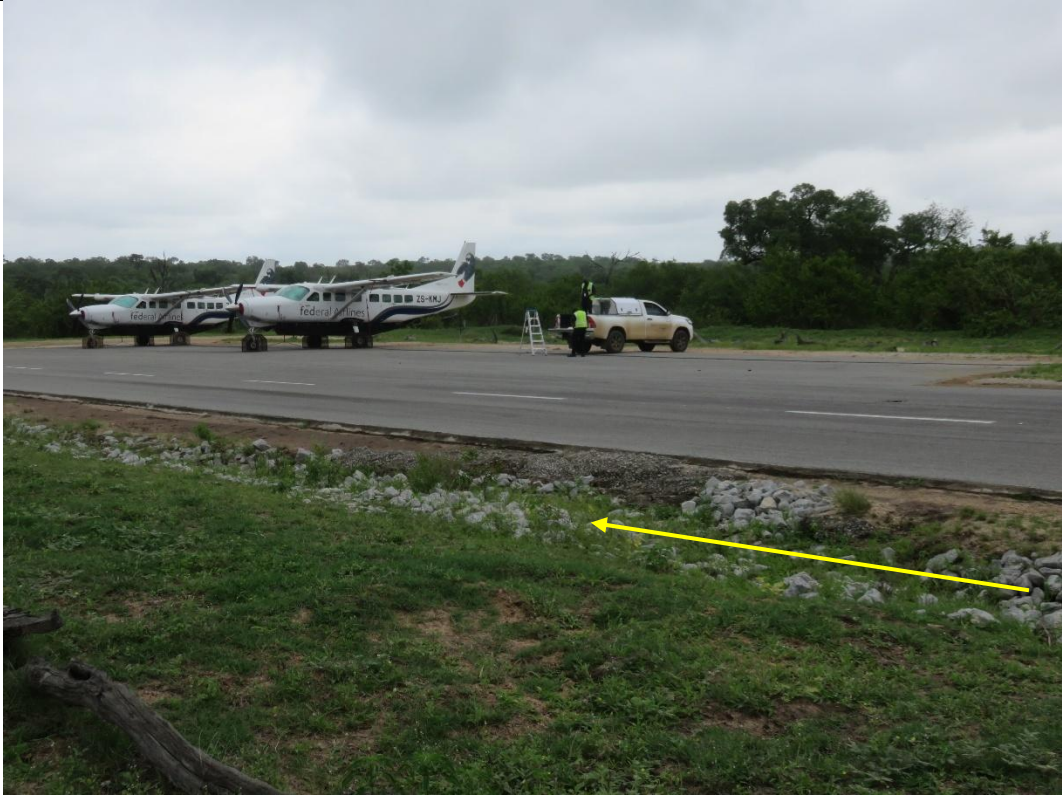
Figure 4: The water drainage ditch next to the runway edge apron area.

3.3 The initial surface area to the right of Runway 16 is not level with the rest of the runway, and it appears as if a water drainage ditch is located next to the runway along the apron area (see Figure 4).

7. The ZS-KMH crew lacked familiarity with the aircraft's general dimensions.
8. The surface area to the right of Runway 16 has a water drainage ditch (see Figure 4) which poses a potential risk to the safe operation of aircraft in this area.

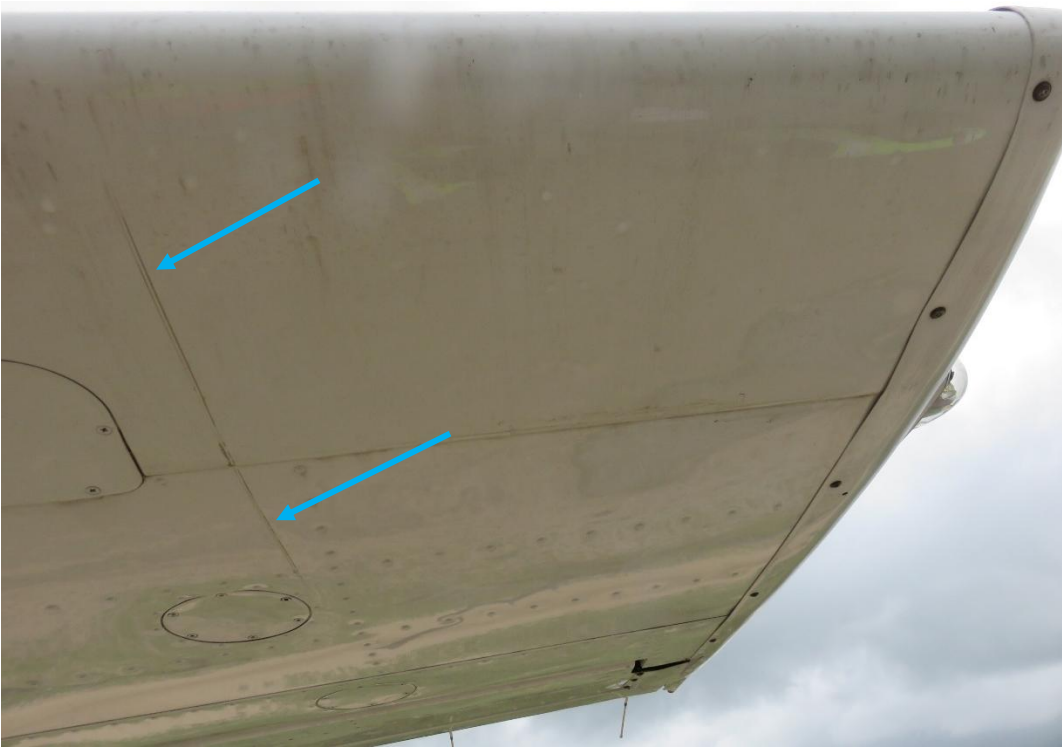
Figure 5: The contact mark that was observed on the lower wing surface of ZS-KMH.

2.6 The lower outer surface of the left wing displayed minor damage associated with aircraft-to-aircraft contact.

The crew of ZS-KMH commenced their take-off roll from the threshold of Runway 16 without ensuring adequate wing-tip clearance between them and the parked ZS-KMJ aircraft. The lower left-wing surface of ZS-KMH impacted the upper left-wing surface of ZS-KMJ.

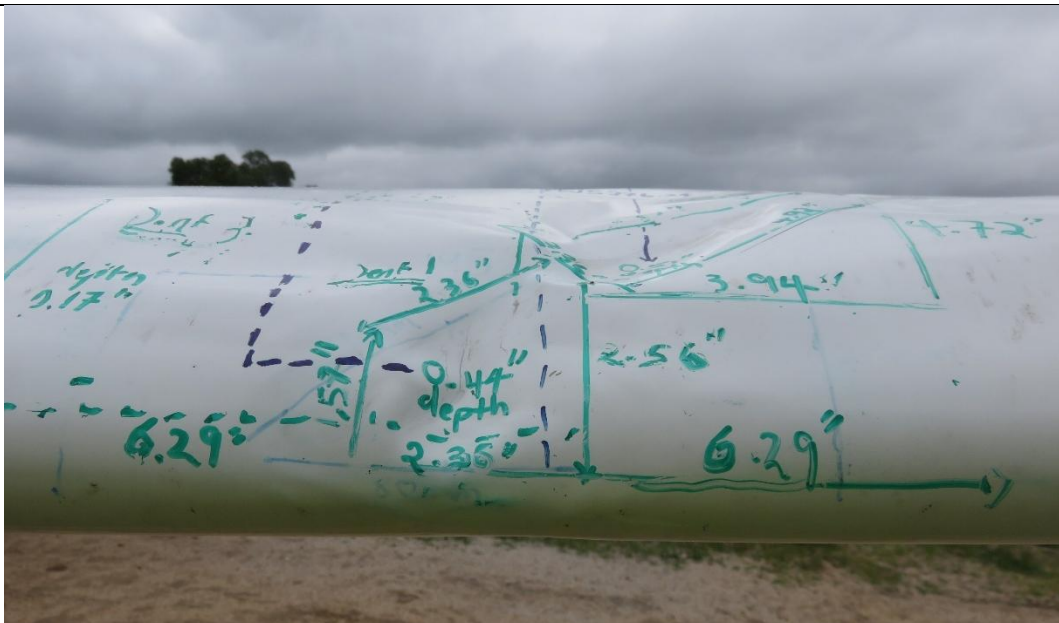
Figure 6: The leading edge of the left wing of ZS-KMJ.

2.9 The damage to the wing of the aircraft required the replacement of the sheet metal on the surfaces of the leading edge and the upper wing. The structural integrity of the wing was not compromised.

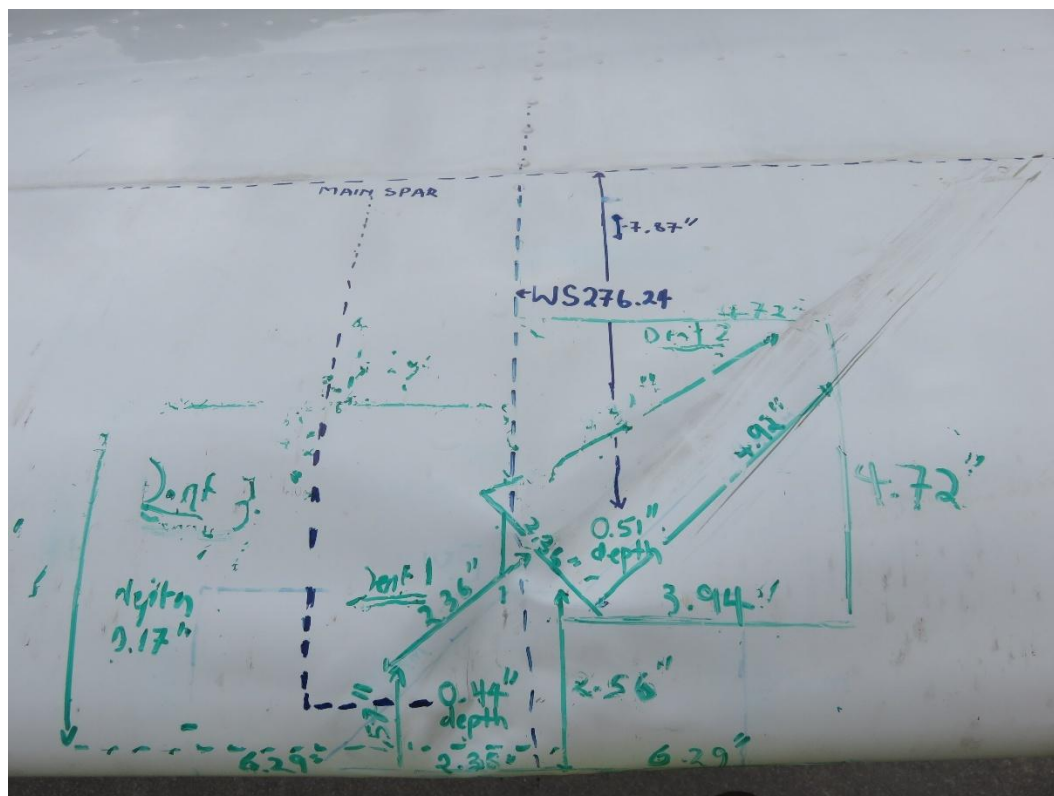
Figure 7: The damaged area on the top side of the ZS-KMJ wing.

2.8 The left-wing upper surface of the aircraft sustained damage when the left wing of ZS-KMH struck it as it was moving forward on Runway 16 for take-off.

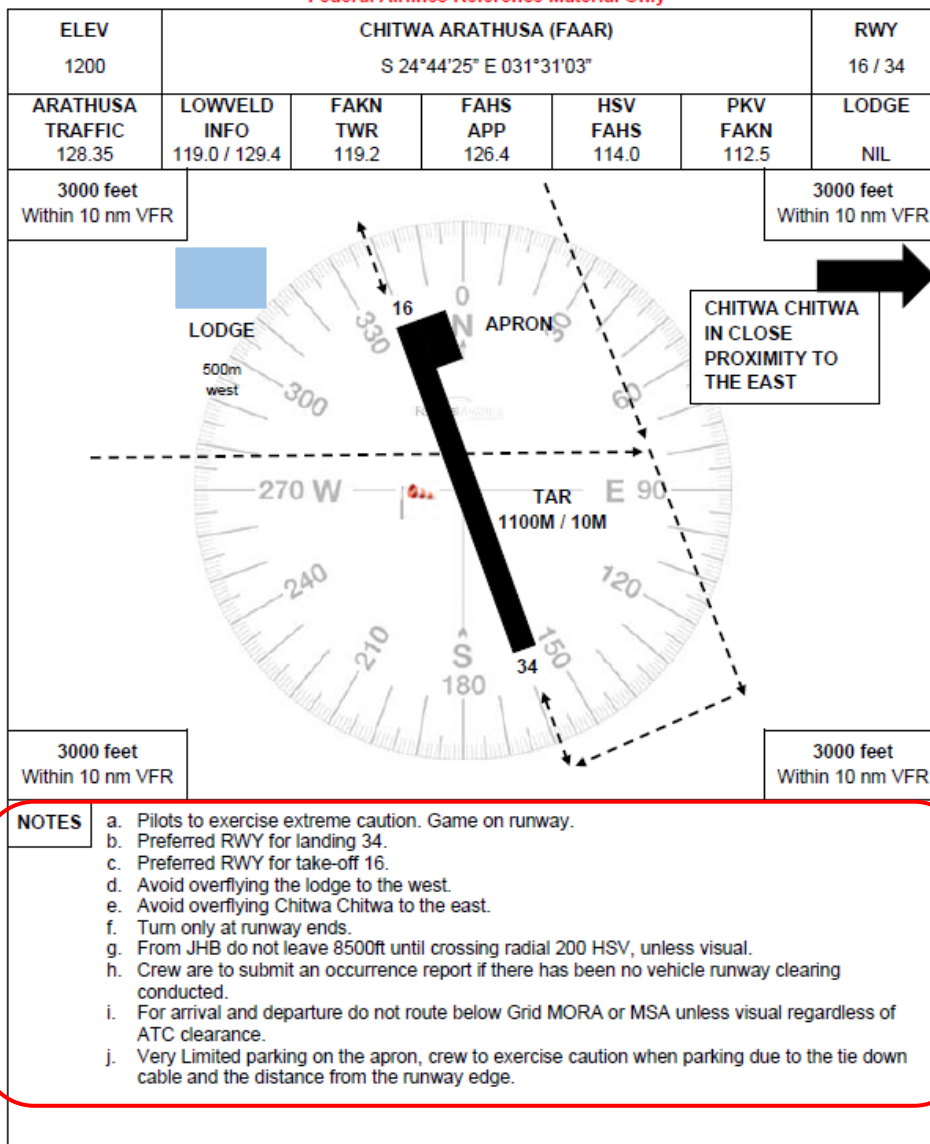
3.4 The aerodrome layout chart (see Figure 8) forms part of the trip kit that the operator makes available to crew for all the lodges and aerodromes to which they need to fly. With reference to the NOTES section on the chart, there is no mention of what is required when more than one aircraft operates from this aerodrome at any given time.

Figure 9: The aerodrome layout chart as issued by the operator.
