LIMITED OCCURRENCE INVESTIGATION REPORT – FINAL

Reference Number	CA18/3/2/1523						
Classification	Serious Incident		Date	25 January 2026		Time	1715Z
Type of Operation	Private (Part 91)						
Location							
Place of Departure	Greater KuduLand Safaris Airstrip, Limpopo Province		Place of Intended Landing		Kruger Mpumalanga International Airport (FAKN), Mpumalanga Province		
Place of Occurrence	On Runway 05 at Kruger Mpumalanga International Airport, Mpumalanga Province						
GPS Co-ordinates	Latitude	25° 22' 35.39" S	Longitude	31° 06' 12.00" E	Elevation	2 822 feet	
Aircraft Information							
Registration	ZS-OTP						
Make; Model; S/N	Beechcraft Super King Air; B200 (Serial Number: BB-683)						
Damage to Aircraft	Minor			Total Aircraft Hours	14 159.2		
Pilot-in-command							
Licence Type	Commercial Pilot Licence (CPL)		Gender	Male		Age	67
Licence Valid	Yes	Total Hours	7 880.4		Total Hours on Type	780.4	
Total Hours 30 Days	31.4		Total Flying on Type Past 90 Days			18

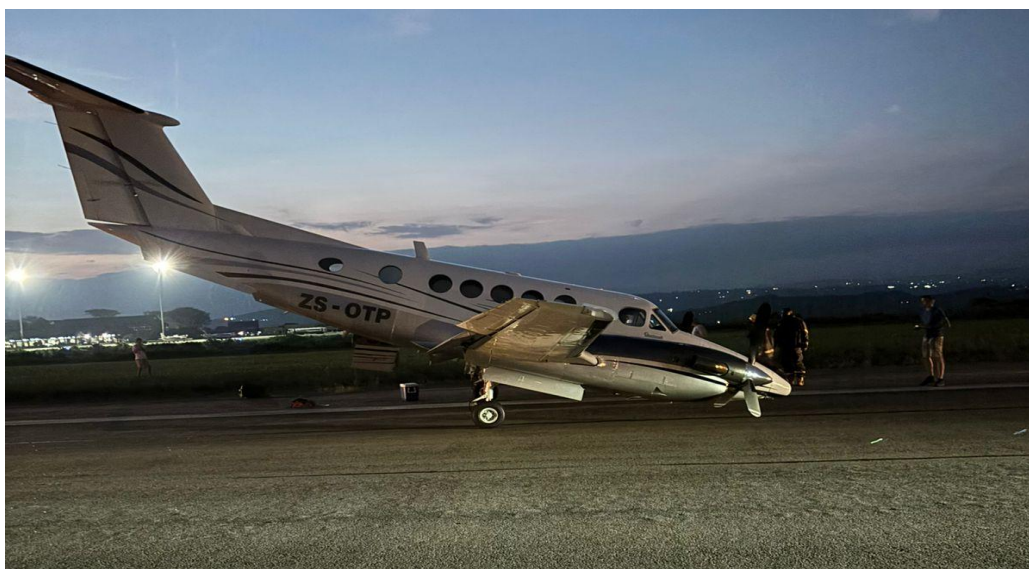
Touch down with the main landing gear was smooth; the pilot held off the aircraft's nose landing gear for as long as practicable. When the partially extended nose landing gear contacted the runway surface, the nose gear strut collapsed. The aircraft veered sharply to the left before it came to a full stop. The aircraft sustained minor damage; no person was injured.

Figure 1: The aircraft on the runway post-serious incident. (Source: Operator)

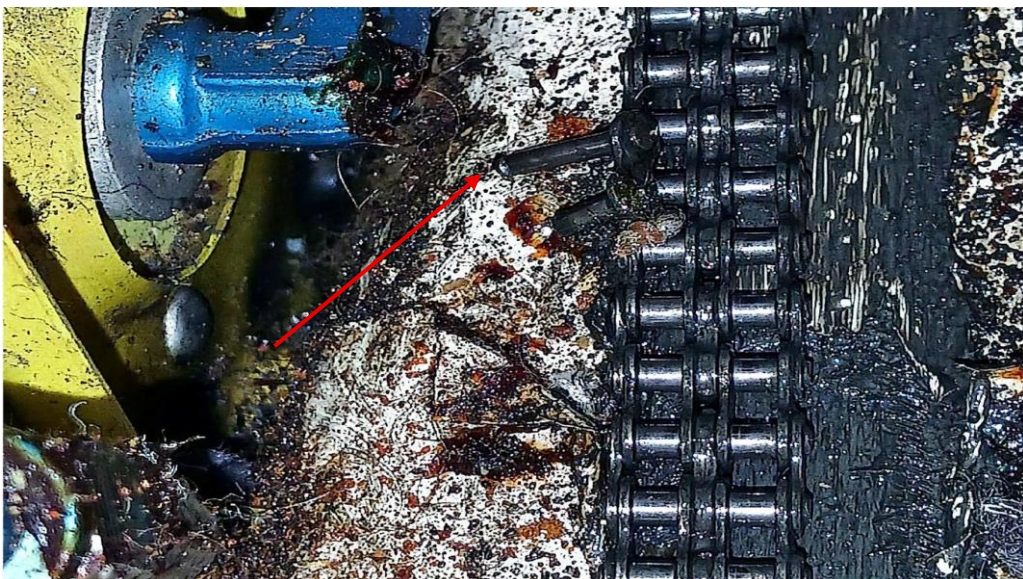
The floor panels in the main cabin were removed to establish the cause of the nose gear failure. It was noticed that the inner main nose drive train chain had snapped. It was further noticed that one of the links in the duplex chain on the extension cycle had also snapped with the link still laying under the floor panel. Various nose gear components were damaged during landing phase because of the partially extended nose gear.

After the removal of the cabin floor panels to access the gearbox, it was evident that the nose gear chain had separated. The pins, plates and spring clip which made up the link had detached, but the parts were recovered inside the aircraft. The chain was visually inspected in accordance with the manufacturer's Aircraft Maintenance Manual (AMM) and the general condition was within limits. A detailed inspection of the separated parts showed that one of the pins had fractured mid-point and half of the fractured pins were not recovered. The connecting plates were still in their original shape. It was also found that the chain had detached from one the sprockets and tensioners.

Figure 2: Damage to the duplex chain and the detached link on the floor panel (red arrow).
(Source: Aerotech)

- 2.6. The AMO found that the nose gear duplex drive chain had never been changed. The manufacturer indicated that the life span of the chain is an on-condition item that can be replaced or changed if it is deemed to be below satisfactory condition.

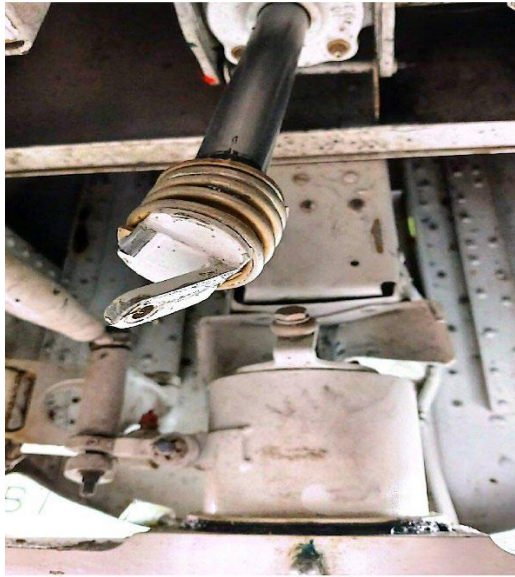
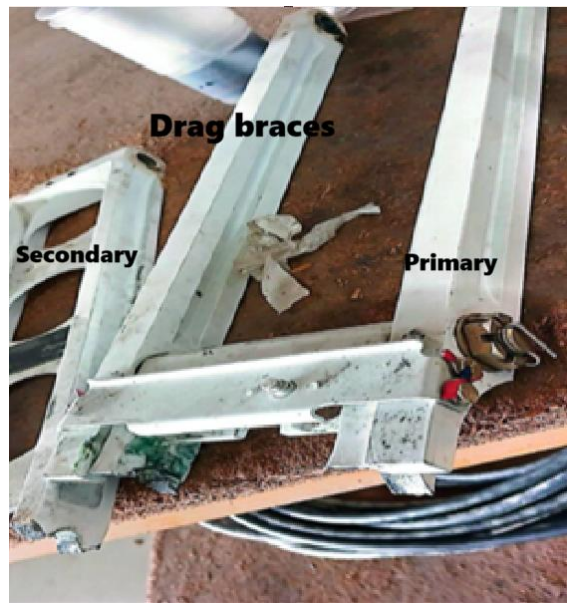
Figures 3 and 4: Damage to the nose gear actuator (left picture) and drag braces (right picture).
(Source: Aerotech)
