## LIMITED OCCURRENCE INVESTIGATION REPORT – FINAL

<b>Reference Number</b>		CA18/3/2/1524					
<b>Classification</b>		<table border="1" style="width: 100%; border-collapse: collapse;"> <tr> <td style="width: 30%;">Serious Incident</td> <td style="width: 20%;"><b>Date</b></td> <td style="width: 30%;">27 January 2026</td> <td style="width: 10%;"><b>Time</b></td> <td style="width: 10%;">1100Z</td> </tr> </table>	Serious Incident	<b>Date</b>	27 January 2026	<b>Time</b>	1100Z
Serious Incident	<b>Date</b>	27 January 2026	<b>Time</b>	1100Z			
<b>Type of Operation</b>		Training (Part 141)					
<b>Location</b>							
<b>Place of Departure</b>		Potchefstroom Aerodrome (FAPS), North West Province		<b>Place of Intended Landing</b>		Potchefstroom Aerodrome (FAPS), North West Province	
<b>Place of Occurrence</b>		On Runway 21 at Potchefstroom Aerodrome, North West Province					
<b>GPS Co-ordinates</b>	<b>Latitude</b>	26°40'16.78" S	<b>Longitude</b>	027°04'55.17" E	<b>Elevation</b>	4 520 ft	
<b>Aircraft Information</b>							
<b>Registration</b>	ZU-FNS and ZS-GFP						
<b>Make; Model; S/N (ZU-FNS)</b>		Jabiru J430 (Serial Number: 791)					
<b>Make; Model; S/N (ZS-GFP)</b>		Schempp-Hirth Flugzeug

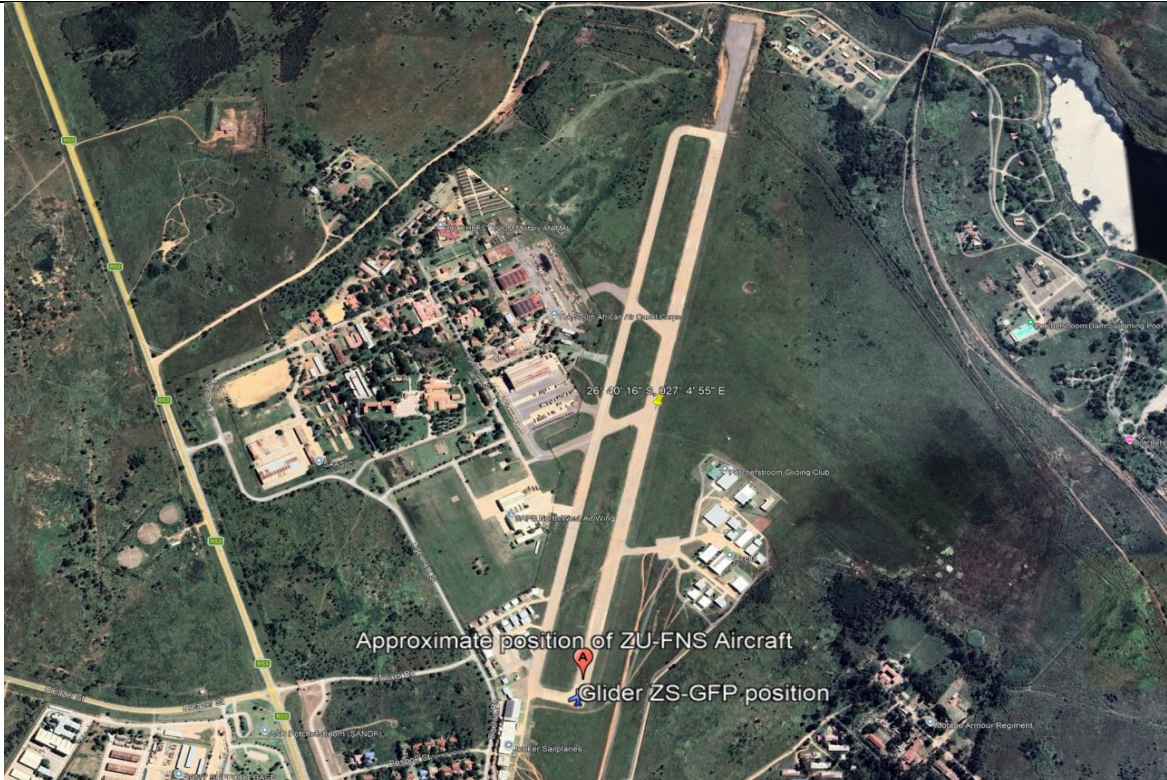
**Figure 1:** An aerial view of FAPS and the positions of the ZU-FNS and ZS-GFS. (Source: Google Earth Map)

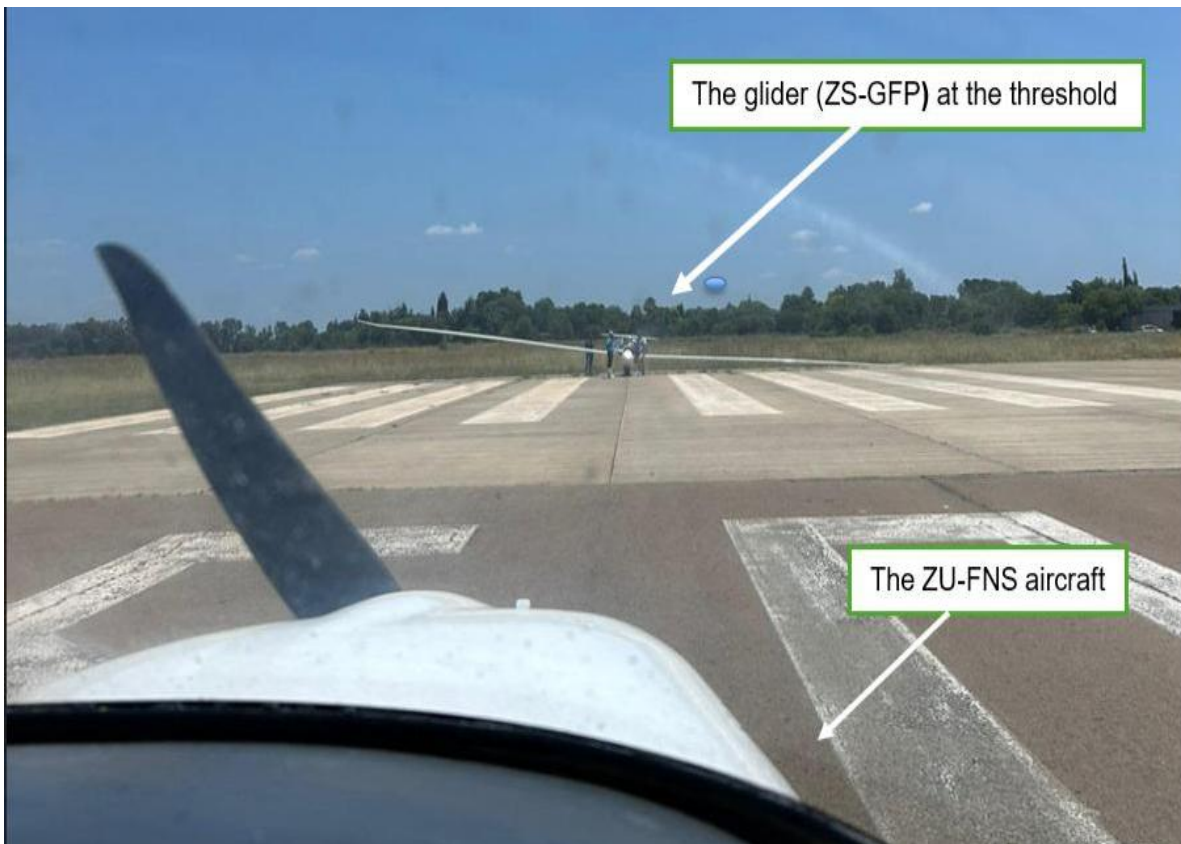
Later, the tow aircraft established contact whilst on a holding position short of RWY 03 and advised that they were following their standard procedure and that they expected to launch the glider for take-off in approximately 15 minutes. The ZU-FNS crew continued to fly a non-standard left-hand side circuit pattern and, subsequently, decided to land on RWY 21 with sufficient length available as the glider was not willing to vacate the runway. The ZU-FNS landed safely and continued to taxi towards the threshold of RWY 03 to take a picture of the glider before vacating the runway (see Figure 2).

**Figure 2:** A picture of the glider taken by the CFI following a full-stop landing near RWY 03 threshold. (Source: CPI)

18. The glider remained stationary on the active runway for an extended period before launch, unnecessarily occupying critical space and increasing risk to other aircraft.

21. The glider remained on the runway until the tow aircraft arrived and launch it, highlighting non-compliance with right-of-way rules, local gliding procedures, and safe runway practices; this resulted in runway incursion and increased collision risk.

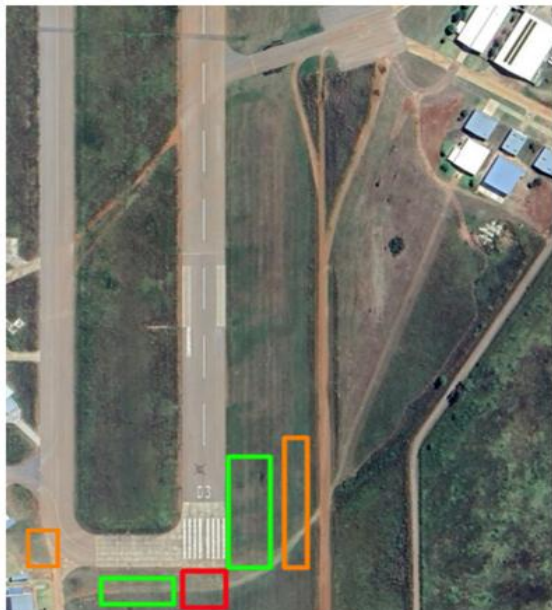
**Gridding Procedures.  
Runway 03.**

Runway 03 will mostly be in use for launching up until a tailwind of about 12-15 knots. (for rope break options)

**Before** entering the Runway make sure that there is no aircraft on the final approach or base leg segment.

**LOOKOUT! Radio call must be made to enter the runway !**

**Expedite** all movements on the runway. Park gliders in the **green** area's and leave tow out gear and vehicles in the **orange** area.

**KEEP RED CLEAR AT ALL TIMES**

**Figure 3:** FAPS demarcation for glider operation positioning. (Source: Operator)
