**LIMITED OCCURRENCE INVESTIGATION REPORT – FINAL**

<b>Reference Number</b>	CA18/3/2/1527						
<b>Classification</b>	Serious Incident		<b>Date</b>	2 February 2026		<b>Time</b>	0650Z
<b>Type of Operation</b>	Training (Part 141)						
<b>Location</b>							
Place of Departure	Ultimate Heliport, Midrand, Gauteng Province		Place of Intended Landing	Ultimate Heliport, Midrand, Gauteng Province			
Place of Occurrence	Main taxiway at Grand Central Aerodrome (FAGC), Midrand, Gauteng Province						
GPS Co-ordinates	Latitude	28° 59' 21.86" S	Longitude	28° 08' 22.55" E	Elevation	5335 ft	
<b>Aircraft Information</b>							
Registration	ZS-RBL						
Make; Model; S/N	Bell; B407 (Serial Number: 53548)						
Damage to Aircraft	Minor		Total Aircraft Hours	3 133.7			
<b>Pilot-in-command</b>							
Licence Type	Commercial Pilot Licence (CPL)		Gender	Male		Age	57
Licence Valid	Yes	Total Hours	6 210		Total Hours on Type	1 400	
Total Hours 30 Days	27.9		Total Flying on Type Past 90 Days	270

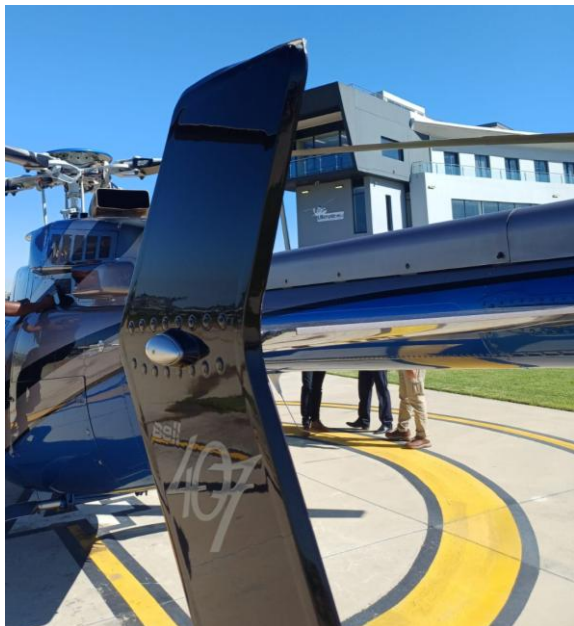
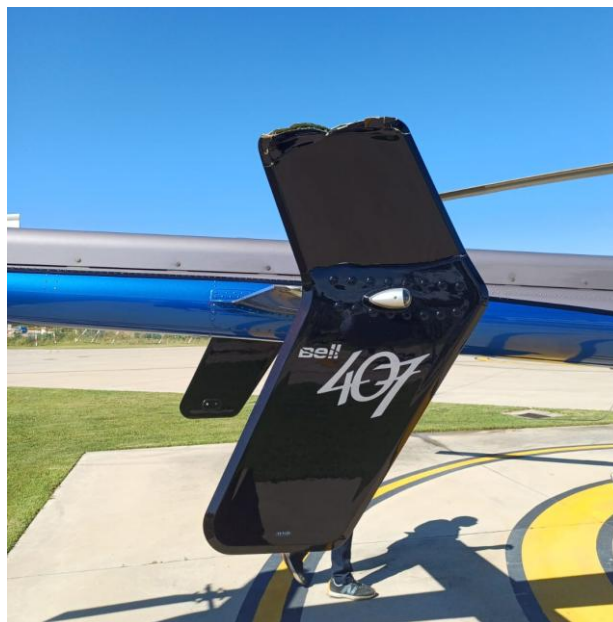
The helicopter landed safely at Ultimate Heliport apron. During the post-flight inspection, the pair observed that the top part of the two vertical stabilisers and one main rotor blade were damaged. Evidence indicated that one of the main rotor blades might have struck the top part of the vertical stabilisers during the hard landing at FAGC's main taxiway area.

**Figures 1 and 2:** Damage to the top section of the two vertical stabilisers. (Source: Operator)

10. The helicopter Certificate of Registration (C of R) was issued to the current owner on 28 October 2018.
<b>Probable Cause(s)</b>
The engine spooled up slowly during recovery after an autorotation exercise which resulted in a hard landing during which the main rotor blade struck and damaged the top part of the two vertical stabilisers.
<b>Contributing Factor(s)</b>
None.
<b>Safety Action(s)</b>
None.
<b>Safety Message and/or Safety Recommendation/s</b>
None.
<b>About this Report</b>
<i>The decision to conduct a limited investigation is based on factors including whether the cause is known and the evidence supporting the cause is clear, the level of safety benefit likely to be obtained from an investigation and that will determine the scope of an investigation. For this occurrence, a limited investigation has been conducted, and the Accident and Incident Investigations Division (AIID) has relied on the information submitted by the affected person/s and organisation/s to compile this limited report. The report has been compiled using information supplied in the initial notification, as well as from follow-up desk top enquiries to bring awareness of potential safety issues to the industry in respect of this occurrence, as well as possible safety action/s that the industry might want to consider in preventing a recurrence of a similar occurrence.</i>

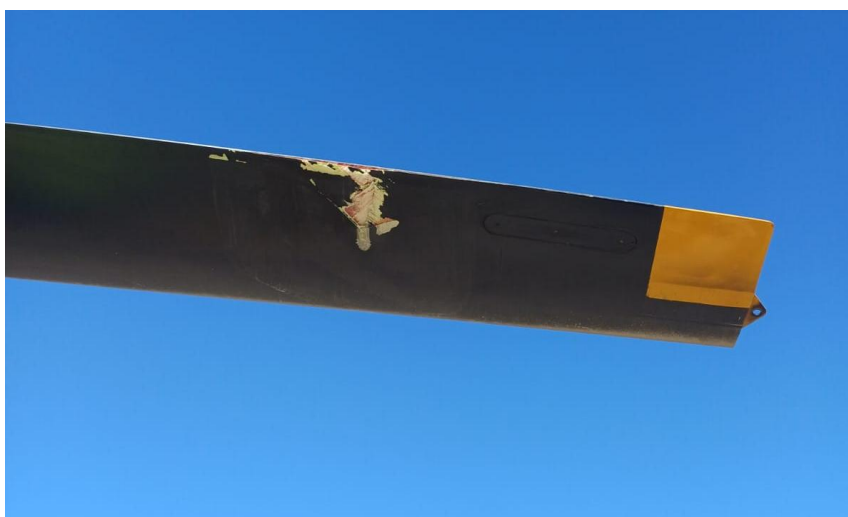
**Figure 3:** The main rotor blade that struck the top part of the vertical stabiliser. (Source: Operator)
