LIMITED OCCURRENCE INVESTIGATION REPORT

Reference Number		CA18/3/2/1528						
Classification		<table border="1" style="width: 100%; border-collapse: collapse;"> <tr> <td style="width: 25%;">Serious Incident</td> <td style="width: 25%;">Date</td> <td style="width: 25%;">7 February 2026</td> <td style="width: 25%;">Time</td> <td style="width: 20%;">1530Z</td> </tr> </table>	Serious Incident	Date	7 February 2026	Time	1530Z	
Serious Incident	Date	7 February 2026	Time	1530Z				
Type of Operation		Private (Part 94)						
Location								
Place of Departure		Orient Airfield (FAOI), Gauteng Province		Place of Intended Landing		Orient Airfield (FAOI), Gauteng Province		
Place of Occurrence		Orient Airfield (FAOI), Gauteng Province						
GPS Co-ordinates		<table border="1" style="width: 100%; border-collapse: collapse;"> <tr> <td style="width: 25%;">Latitude</td> <td style="width: 25%;">26° 02' 16.51" S</td> <td style="width: 25%;">Longitude</td> <td style="width: 25%;">27° 35' 42.55" E</td> <td style="width: 20%;">Elevation</td> <td style="width: 20%;">5 100ft</td> </tr> </table>	Latitude	26° 02' 16.51" S	Longitude	27° 35' 42.55" E	Elevation	5 100ft

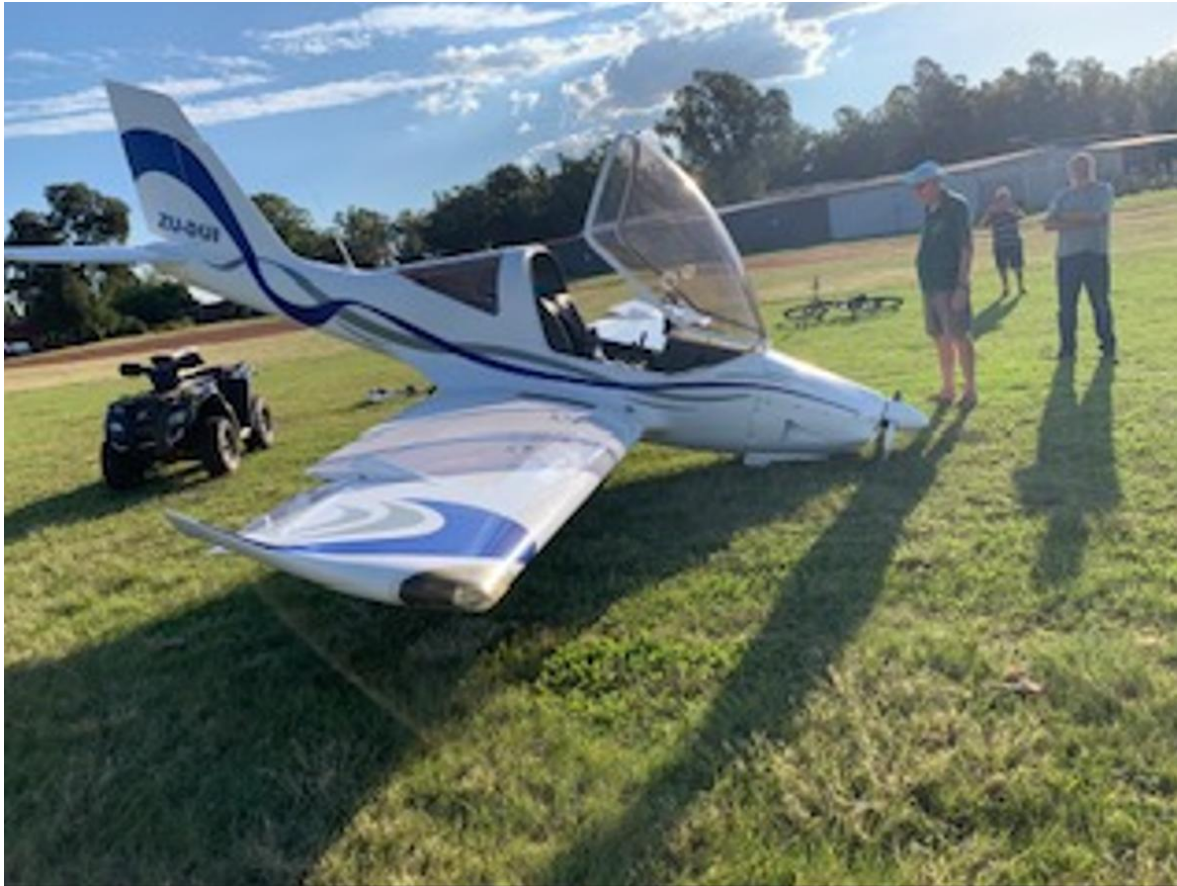
Figure 1: The aircraft at the serious incident site. (Source: Pilot)

9. The aircraft's nose landing gear collapsed as soon as it touched the ground during landing.
10. The aircraft landed at a speed of 65 kts, which was consistent with the recommended speed in the Pilot's Operating Handbook [POH]; however, the flaps were set at 10° less than the recommended setting.

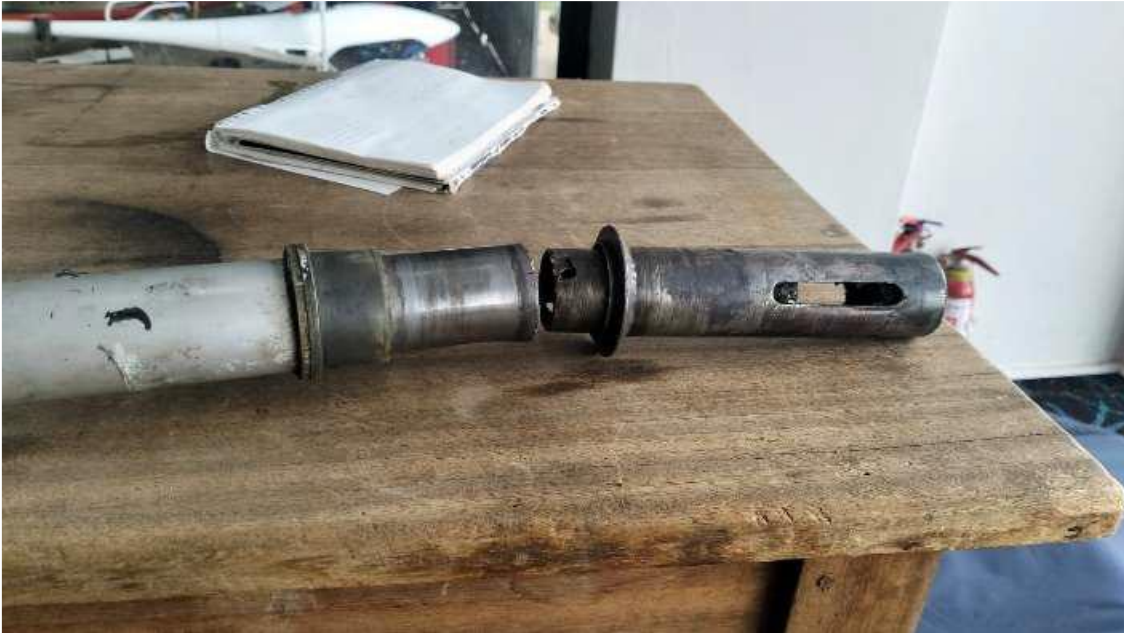
Post-serious incident examination of the aircraft by an approved person (AP) revealed that the nose gear shear bolt fractured, which led to loss of structural integrity. The nose landing gear assembly detached as a direct consequence of the shear bolt failure. There was no evidence of pre-existing defects in materials. The failure was consistent with progressive fatigue or overload stress caused by repeated operation on rough surfaces.

Figure 2: The failed shear bolt.

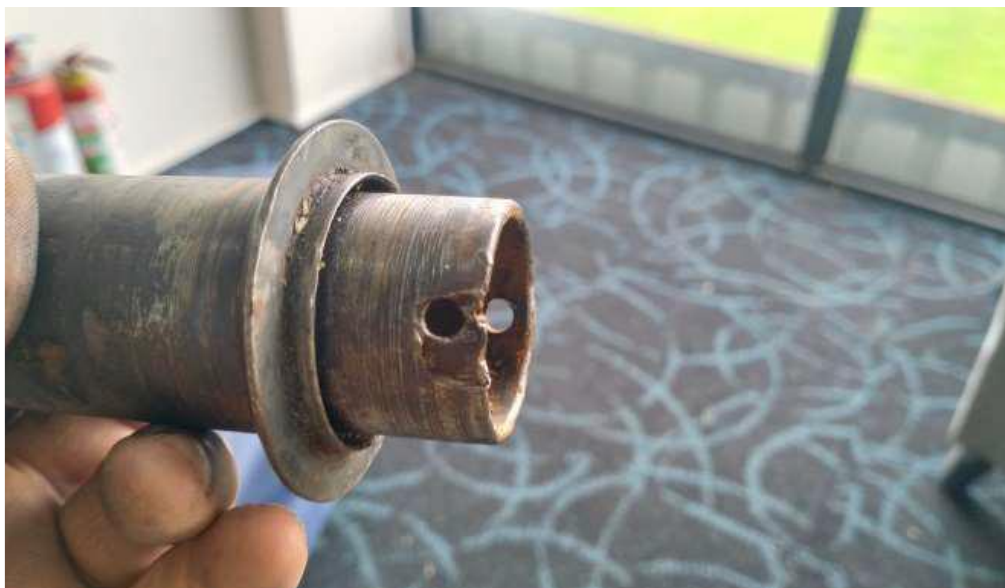
Figure 3: The close-up picture of the failed shear bolt.
