LIMITED OCCURRENCE INVESTIGATION REPORT – FINAL

Reference Number	CA18/3/2/1530							
Classification	Serious Incident		Date	10 February 2026		Time	0600Z	
Type of Operation	Training (Part 141)							
Location								
Place of Departure	Secunda Airfield (FASC), Mpumalanga Province		Place of Intended Landing	Wonderboom Airport (FAWB), Gauteng Province				
Place of Occurrence	On Runway 35 at Rand Airport (FAGM), Gauteng Province							
GPS Co-ordinates	Latitude	26° 14' 33.31" S	Longitude	28° 9' 4.54" E	Elevation	5 477ft		
Aircraft Information								
Registration	ZS-IIZ							
Make; Model; S/N	Cessna; 177RG (Serial Number: 177RG-0134)							
Damage to Aircraft	Minor			Total Aircraft Hours	3 543.7			
Pilot-in-command								
Licence Type	Private Pilot Licence (PPL)		Gender	Male		Age	22	
Licence Valid	Yes	Total Hours	133.3		Total Hours on Type	48.4		
Total Hours 30 Days	9.6		Total Flying on Type Past 90 Days	48.4				
People On-board	1 + 1		Injuries	0		Fatalities	0

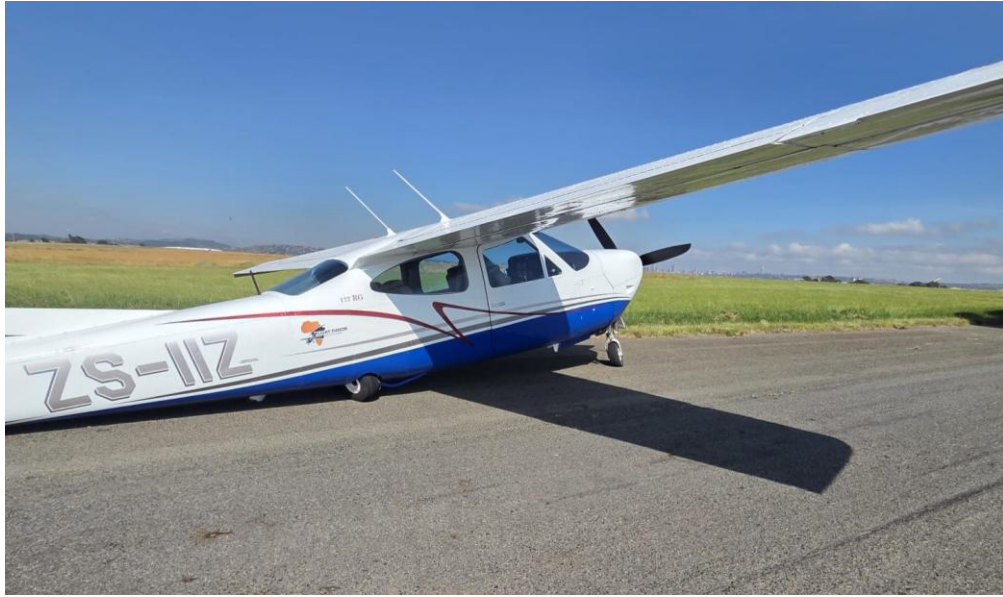
The aircraft was configured for landing and, after touchdown, the main landing gear collapsed and folded into the wheel wells whilst the nose landing gear remained extended. The aircraft remained upright and came to a stop on the runway. The ATC activated the crash alarm and the Aircraft Rescue and Firefighting (ARFF) personnel swiftly responded to the serious incident scene. The active runway was closed for approximately an hour during which the aircraft was recovered to the hangar; the runway was reopened soon after. The aircraft sustained minor damage. No injuries were sustained by the occupants who were in the aircraft.

Figure 2: The aircraft on the runway after the serious incident. (Source: ARFF)

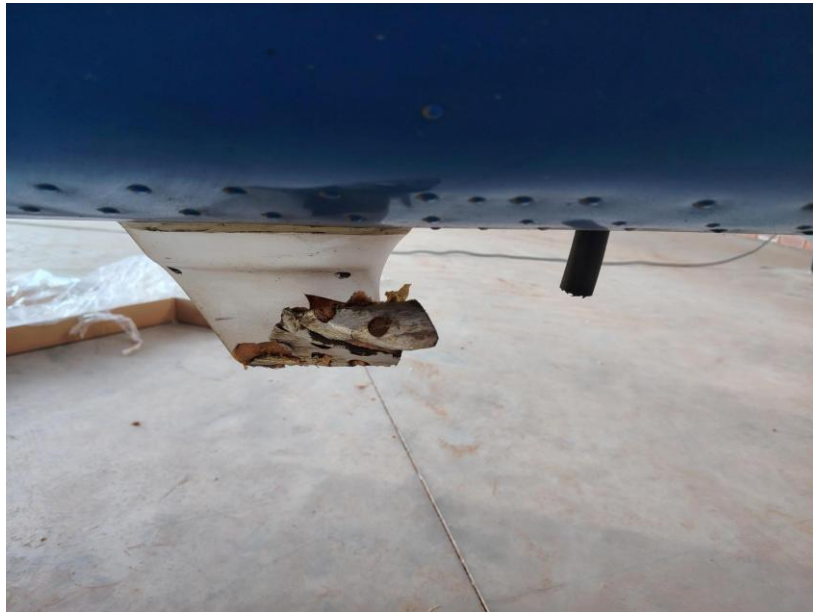
Figure 3: The damaged antenna in the rear fuselage area.

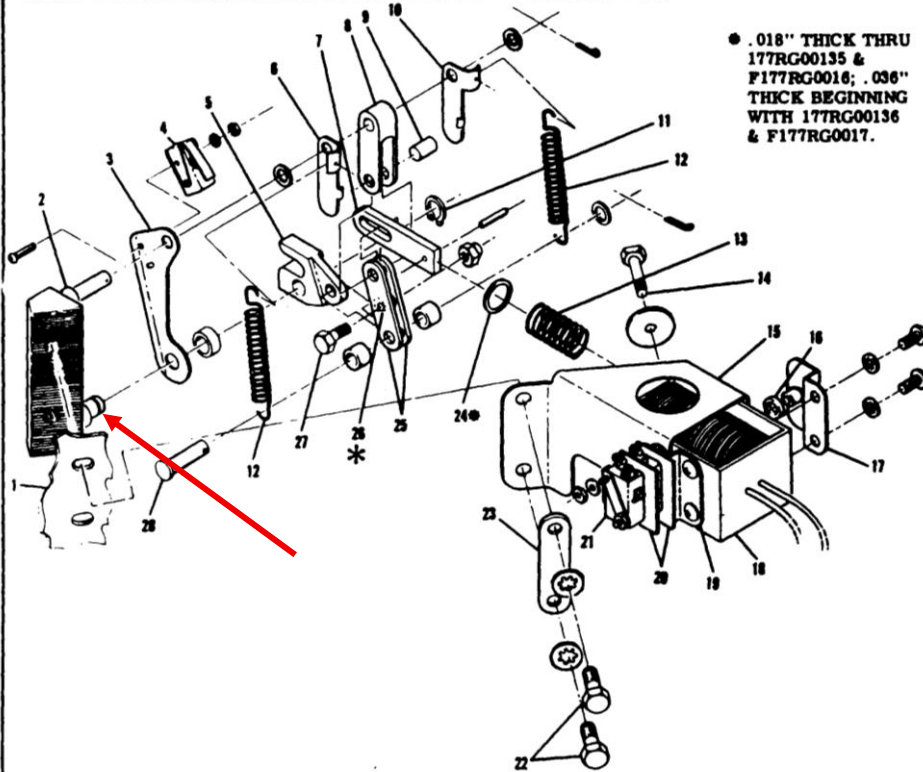
Figure 5: Main landing gear down-lock assembly (red arrow) showing the pin that sheared off.
 (Source: Cessna RG Service Manual)

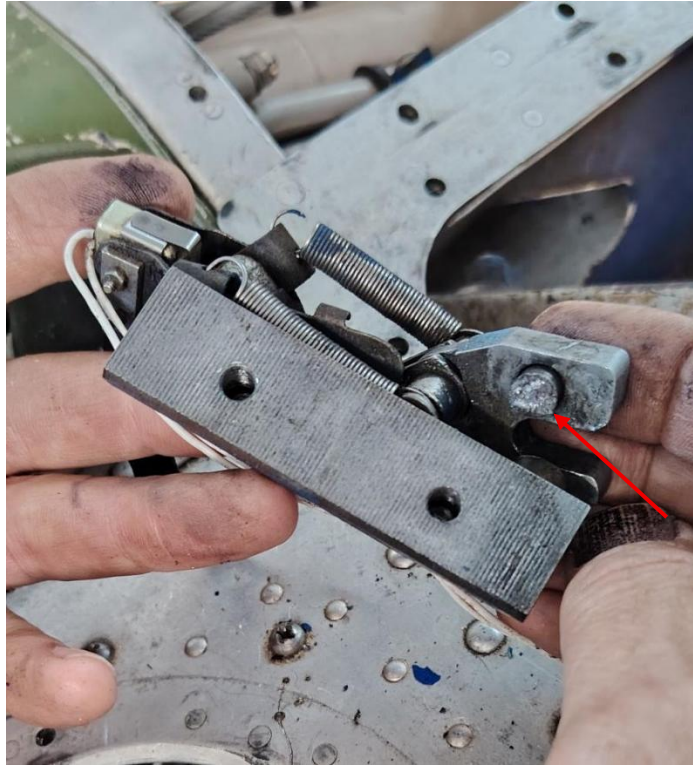
The aircraft was placed on jacks for further investigation. The engineers at the aircraft maintenance organisation (AMO) conducted inspection of the landing gear system; the landing gear retraction and extension worked properly. The landing gear's unsafe warning horn was tested, and it was found to be operating normally. The main landing gear microswitch operated correctly with no fault found. The green light in the cockpit illuminated, which showed that the landing gear was down and locked. The aircraft had adequate MIL-H-5606 hydraulic fluid in the reservoir and none of the circuit breakers (CB) popped. The landing gear hydraulic lines were inspected, and no obvious signs of hydraulic leaks were observed; all fasteners were in place and properly secured. The emergency landing gear extension procedure was conducted, and all three landing gears extended and locked into position with the green light illuminating. Further inspection found that the pin in the down-lock support assembly had sheared off, and there was a small buckle on the left main gear tunnel, indicating signs of a hard landing.

Figure 4: The landing gear down-lock support assembly pin that sheared off.

Hard landing on Runway 35 which caused the pin on the down-lock support assembly to shear off; consequently, the main landing gear collapsed.

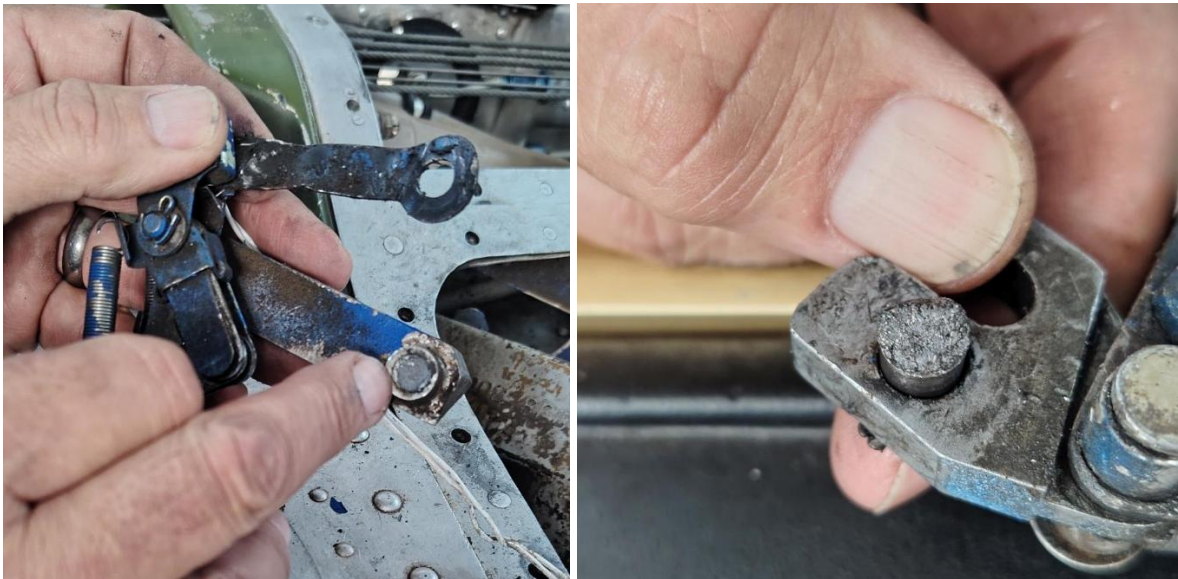
Figures 5 and 6: A closer view of the sheared down-lock support assembly pin.
