LIMITED OCCURRENCE INVESTIGATION REPORT – FINAL

Reference Number	CA18/3/2/1531						
Classification	Serious Incident	Date	8 February 2026		Time	0630Z	
Type of Operation	Private (Part 94)						
Location							
Place of Departure	Panorama Airfield, Gauteng Province		Place of Intended Landing	Parys Airfield (FAPY), Free State Province			
Place of Occurrence	Runway 20 at Panorama Airfield, Gauteng Province						
GPS Co-ordinates	Latitude	26°19'54.24" S	Longitude	28°4'2.37" E	Elevation	4 998ft	
Aircraft Information							
Registration	ZS-GYW						
Make; Model; S/N	Pipistrel; Virus 912 (Serial Number: 006V912-1299)						
Damage to Aircraft	Minor		Total Aircraft Hours	954.03			
Pilot-in-command							
Licence Type	Private Pilot Licence (PPL)		Gender	Male		Age	70
Licence Valid	Yes	Total Hours	747		Total Hours on Type	340	
Total Hours 30 Days	0		Total Flying on Type Past 90 Days	0			
People On-board	1 + 1	Injuries	0	Fatalities	0	Other (on ground)	0
What Happened

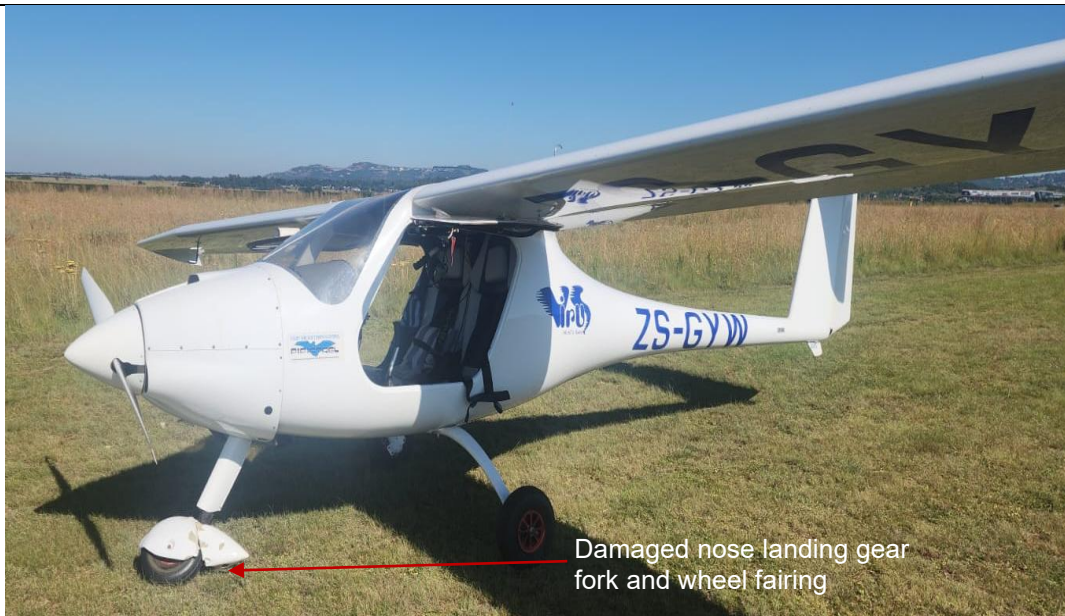
first. The right main landing gear strut broke but remained attached to the fuselage. Moreover, the nose gear fork twisted, damaging the fairing. Both the pilot and the passenger evacuated the aircraft uninjured.

Figure 2: The aircraft with a damaged nose landing gear fork and wheel fairing. (Source: Pilot)

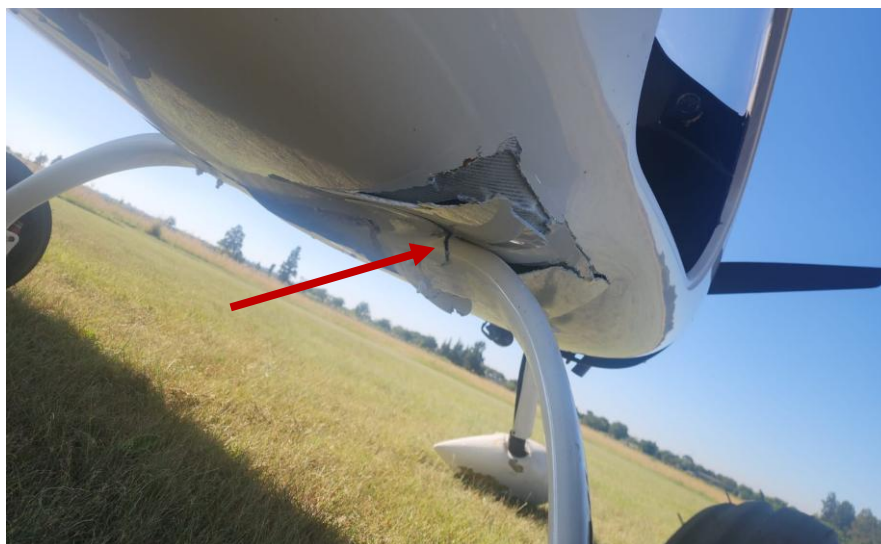
Figure 3: The right main landing gear and the area where the breakage occurred (red arrow). (Source: Pilot)
