**AIRCRAFT SERIOUS INCIDENT REPORT AND EXECUTIVE SUMMARY**

| | | | | <b>Reference:</b> | | CA18/3/2/1532 | |
| <b>Aircraft Registration</b> | ZS-CHL | <b>Date of Incident</b> | 12 February 2026 | | <b>Time of Incident</b> | 0650Z | |
| <b>Type of Aircraft</b> | Beechcraft Baron 58 | | <b>Type of Operation</b> | | Type Private (Part 91) | | |

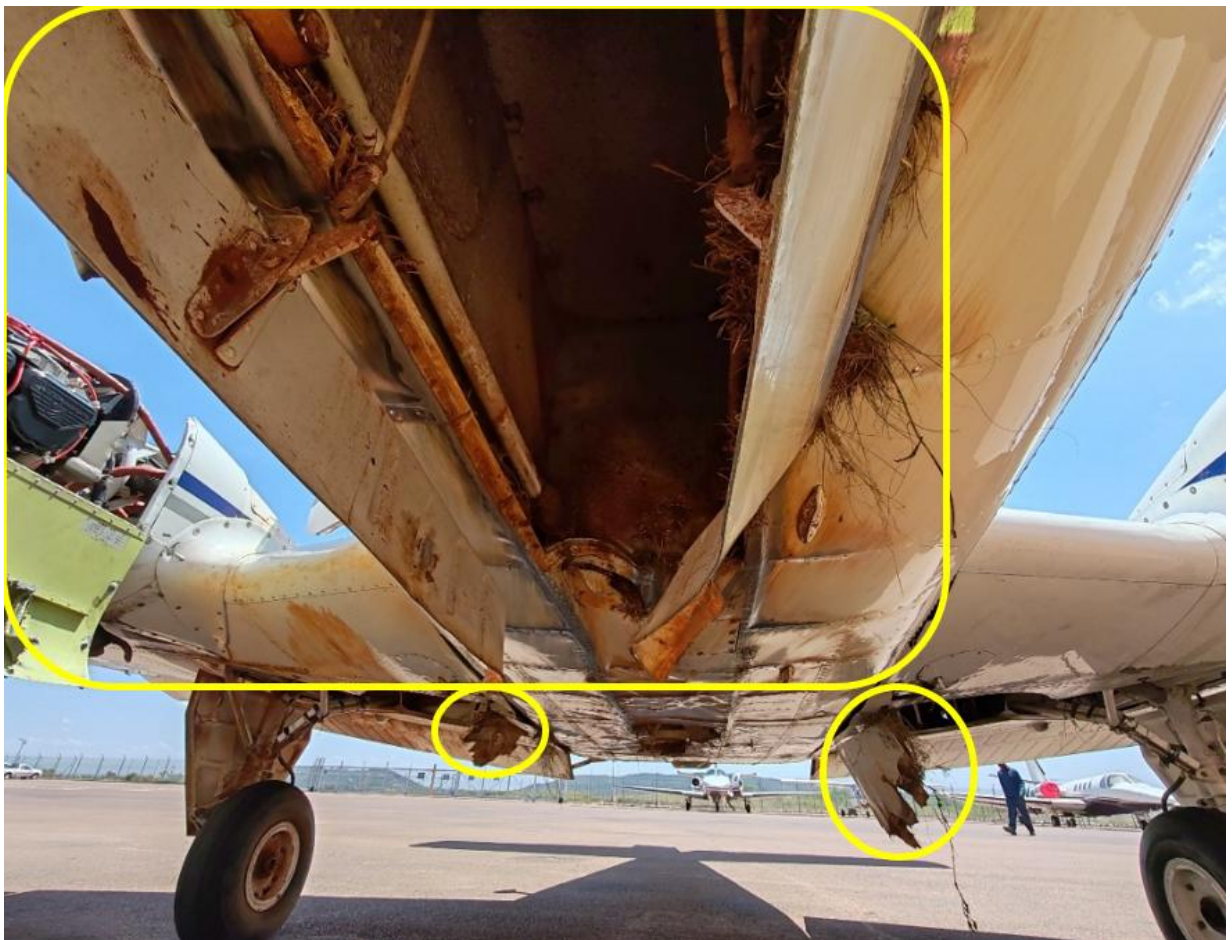
1.3.1. The aircraft sustained substantial damage to the landing gear system components, landing gear doors, left and right engine propellers and underbelly skin.

**Figure 1:** The damaged landing gear doors and belly of the ZS-CHL aircraft.

- 1.12.2.1 Damage to the main landing gear inboard doors and nose landing gear doors indicated that the landing gear doors were selected to open position when the landing gears collapsed (see Figure 1).

2.2.2.4. Damage to the main landing gear doors indicated that the doors were open when the landing gears collapsed. The open landing gear doors indicated that the manual extension procedure had not been completed in full.

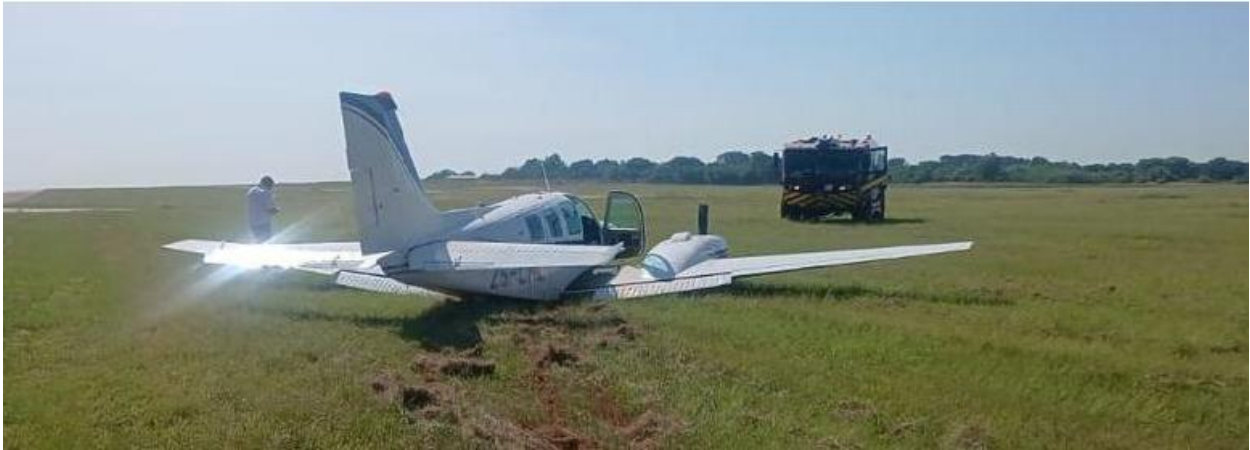
- 1.12.1. The pilot performed a normal landing on RWY 11 at FAWB. During the landing roll, the right main landing gear collapsed, which caused the aircraft to veer off to the right. Shortly thereafter, the left main landing gear and nose landing gear collapsed, and the aircraft came to rest on its belly next to the runway.

**Figure 3:** The aircraft resting on its belly after the serious incident. (Source: AMO)

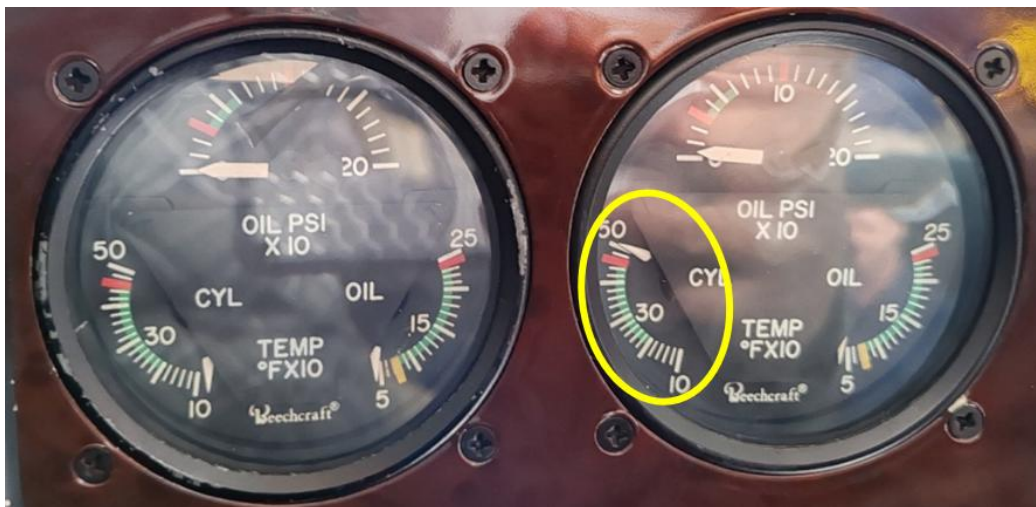
1.16.2. When the aircraft's power was switched on, the cylinder temperature gauge moved to full deflection. Troubleshooting of the gauge and probe revealed that the temperature probe had failed.

**Figure 4:** The engine's right-side cylinder head temperature gauge at full deflection with the engine off.

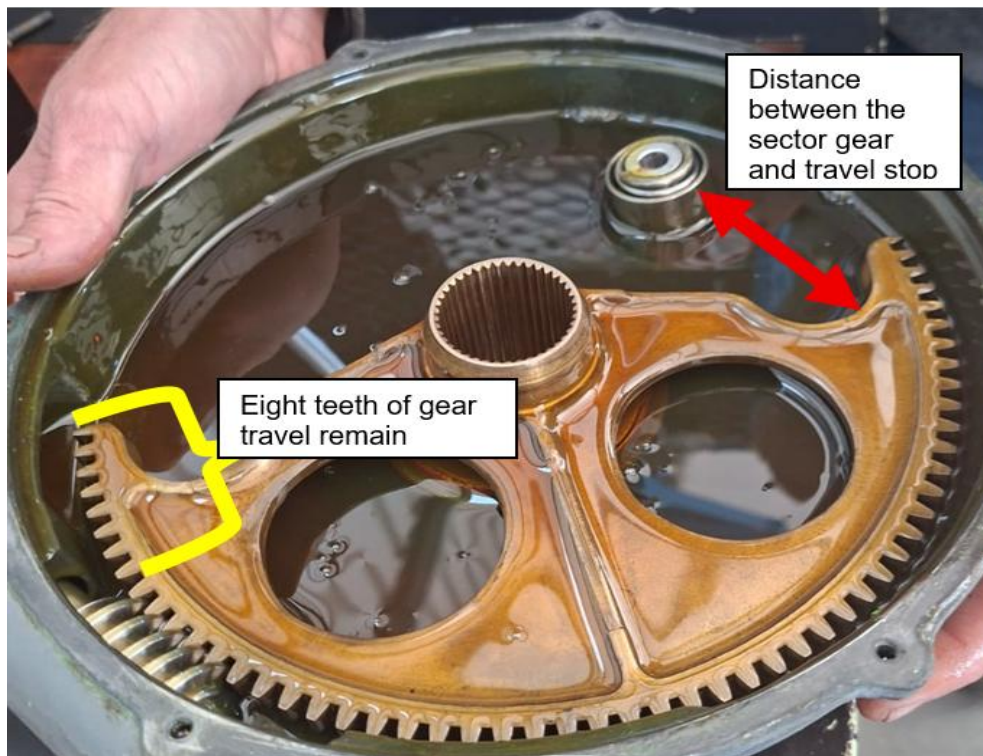
1.16.3. The landing gear gearbox, used to extend and retract the gear manually, was opened and examined. The manual extension crank handle and worm gear operated normally. The gearbox contained sufficient contaminant-free oil. However, the sector gear had not reached its full travel limit; eight teeth of travel remained, equating to approximately eight rotations of the crank handle. This is an indication that the manual extension procedure was not completed in full.

**Figure 5:** Inspection of the landing gear gearbox of the ZS-CHL aircraft.

2.2.2.3. Assessment of the landing gear gearbox revealed that the sector gear did not reach the internal travel stop. This indicated that the manual extension procedure was not carried out to completion and prevented the landing gear from locking into position.
