## LIMITED OCCURRENCE INVESTIGATION REPORT – FINAL

<b>Reference Number</b>	CA18/3/2/1533						
<b>Classification</b>	Serious Incident	<b>Date</b>	13 February 2026		<b>Time</b>	1025Z	
<b>Type of Operation</b>	Training (Part 141)						
<b>Location</b>							
Place of Departure	Wonderboom Airport (FAWB), Gauteng Province		Place of Intended Landing	Wonderboom Airport (FAWB), Gauteng Province			
Place of Occurrence	Runway 24 at Wonderboom Airport (FAWB)						
GPS Co-ordinates	Latitude	25° 25' 39.29" S	Longitude	028° 13' 14.62" E	Elevation	4 081 ft	
<b>Aircraft Information</b>							
Registration	ZS-EOZ						
Make; Model; S/N	Piper; PA-28-140 Cherokee (Serial Number: 28-22041)						
Damage to Aircraft	Substantial		Total Aircraft Hours	11 937.4			
<b>Pilot-in-command</b>							
Licence Type	Commercial Pilot Licence (CPL)		Gender	Male		Age	27
Licence Valid	Yes	Total Hours	1 230.2		Total Hours on Type	1 053.3	
Total Hours 30 Days	21.1		Total Flying on Type Past 90 Days	63.2

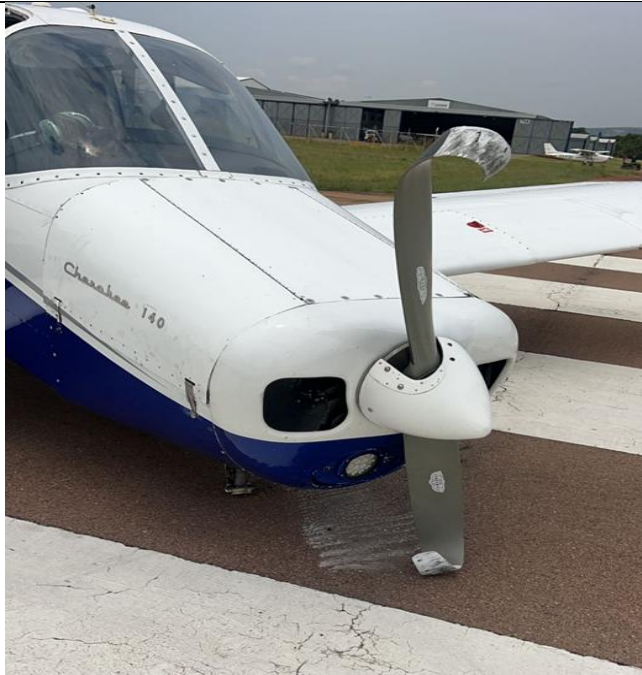
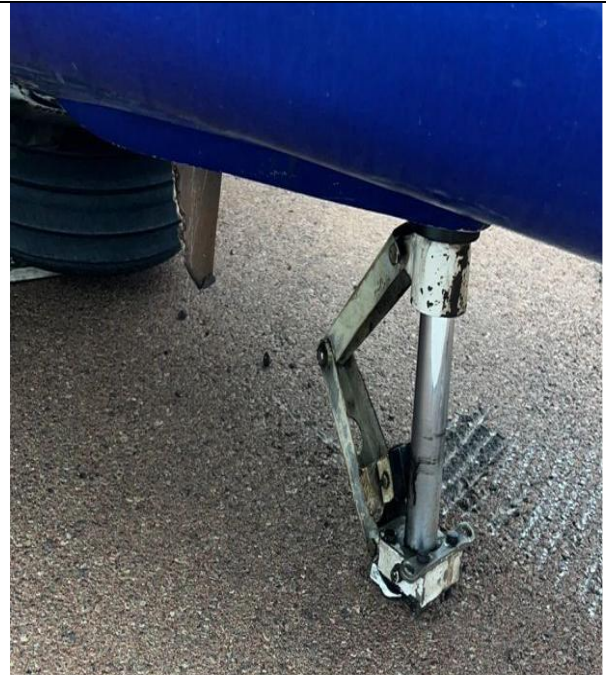
The two pilots were not injured. The aircraft sustained damage to the nose landing gear strut and the propeller blades.

**Figures 2 and 3:** The aircraft on the runway (left picture). The remaining upper portion of the nose gear strut (right picture). (Source: Operator)

<b>Probable Cause(s)</b>
The aircraft was unstable on final approach for Runway 24, and it touched down with the nose wheel first; consequently, the lower portion of the nose gear, including the fork, broke off and the proper struck the runway surface.
<b>Contributing Factor(s)</b>
Poor landing technique.
<b>Safety Action(s)</b>
None.
<b>Safety Message and/or Safety Recommendation/s</b>
None.
<b>About this Report</b>
<i>The decision to conduct a limited investigation is based on factors including whether the cause is known and the evidence supporting the cause is clear, the level of safety benefit likely to be obtained from an investigation and that will determine the scope of an investigation. For this occurrence, a limited investigation has been conducted, and the Accident and Incident Investigations Division (AIID) has relied on the information submitted by the affected person/s and organisation/s to compile this limited report. The report has been compiled using information supplied in the initial notification, as well as from follow-up desk top enquiries to bring awareness of potential safety issues to the industry in respect of this occurrence, as well as possible safety action/s that the industry might want to consider in preventing a recurrence of a similar occurrence.</i>
