LIMITED OCCURRENCE INVESTIGATION REPORT – FINAL

Reference Number	CA18/3/2/1534						
Classification	Serious Incident		Date	19 February 2026		Time	1140Z
Type of Operation	Private (Part 91)						
Location							
Place of Departure	Plot 131, Uitzicht van der Hoff Road, Pretoria West, Gauteng Province		Place of Intended Landing	Gemsbok Lodge, Klerksdrop, North West Province			
Place of Occurrence	Approximately 5nm south-west of Wonderboom Airport (FAWB) at Plot 131, Uitzicht van der Hoff Road, Pretoria West, Gauteng Province						
GPS Co-ordinates	Latitude	25°43'37.36"S	Longitude	28°10'02.30"E	Elevation	4 192.9ft	
Aircraft Information							
Registration	ZS-FDV						
Make; Model; S/N	R44 Raven II (Serial Number: 11630)						
Damage to Aircraft	Substantial		Total Aircraft Hours	2 042.2			
Pilot-in-command							
Licence Type	Commercial Pilot Licence (CPL)		Gender	Male		Age	48
Licence Valid	Yes		Total Hours	1895.6		Total Hours on Type	1 751
Total Hours 30 Days	19		Total Flying on Type Past 90 Days	64

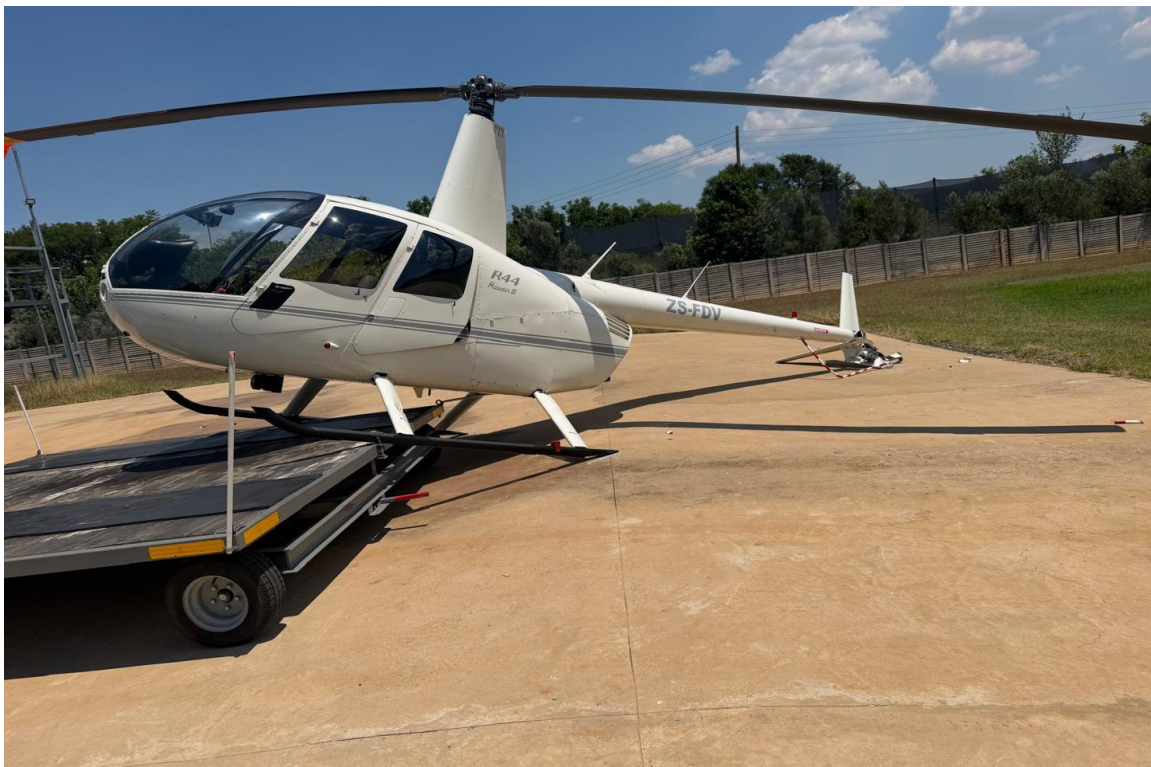
People On-board	1+2		Injuries	0		Fatalities	0
						Other (on ground)	0
What Happened							
<p>On Thursday, 19 February 2026, a pilot and two passengers on-board a Robinson R44 Raven II helicopter with registration ZS-FDV took off on a private flight from Plot 131 at Uitzicht van der Hoff Road in Pretoria West, Gauteng province, with the intention to land at Gemsbok Lodge in Klerksdrop, North West province. The flight was conducted under visual meteorological conditions (VMC) by day and under the provisions of Part 91 of the Civil Aviation Regulations (CAR) 2011, as amended.</p> <p>The pilot reported that no anomalies were observed during the pre-flight inspection. At approximately 1140Z, the helicopter lifted off from a stationary mobile trailer platform (dolly), after which the pilot noticed low engine power and low rotor revolutions per minutes (rpm) on the instrument panel. The pilot promptly opted to abort take-off. Whilst attempting to land back on the trailer platform, the helicopter inadvertently touched down on the two perpendicular sides (see Figure 2) of the platform (dolly) near the right rear corner whereafter, it tilted backwards and further slipped. Subsequently, the tail boom struck the ground. The helicopter sustained substantial damage to the tail boom and tail rotor blades. None of the occupants sustained any injury.</p>

Figure 2: The resting position of the helicopter after the serious incident. (Source: The pilot)

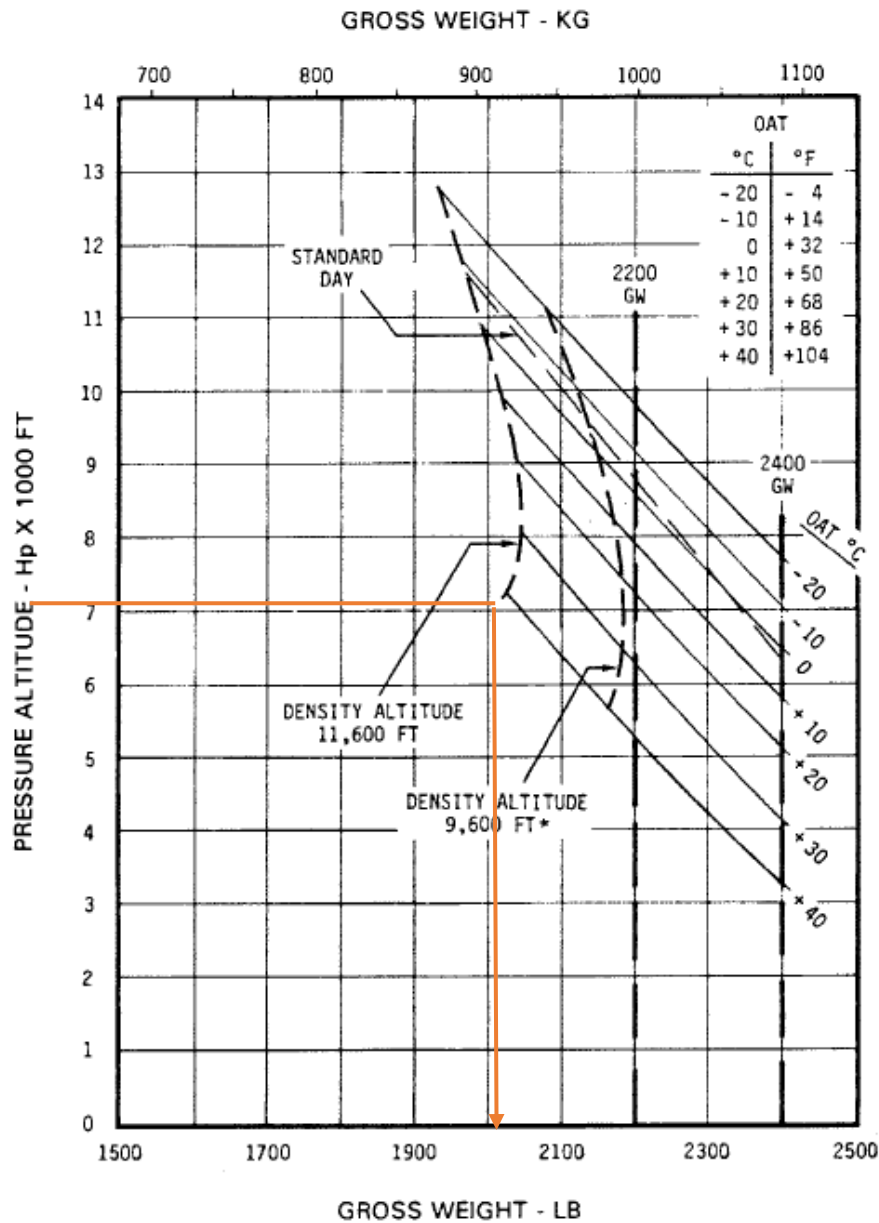
IN GROUND EFFECT AT 2 FOOT SKID HEIGHT
FULL THROTTLE
101-102% RPM
ZERO WIND

Figure 4: The ideal weight of the aircraft for the density altitude at the time of lift-off. (Source: POH)

The environmental condition prevailing on the day limited the helicopter to a take-off weight of 2 150lb (pounds) due to density altitude calculations; however, the helicopter had a gross weight of 2 342lb which was 192lb more than the required calculation, suggesting that the power required was more than the power available.
