LIMITED OCCURRENCE INVESTIGATION REPORT – FINAL

Reference Number	CA18/3/2/1535						
Classification	Serious Incident		Date	17 February 2026		Time	0740Z
Type of Operation	Private (Part 94)						
Location							
Place of Departure	Johan Pienaar Airport (FAKU), Northern Cape Province		Place of Intended Landing		Rhenosterfontein Farm Airstrip, North West Province		
Place of Occurrence	On the gravel runway at Rhenosterfontein Farm Airstrip, North West Province						
GPS Co-ordinates	Latitude	27° 11' 26.0" S	Longitude	24° 18' 11.0" E	Elevation	4 603ft	
Aircraft Information							
Registration	ZU-EGC						
Make; Model; S/N	Jabiru J430 (Serial number: 280)						
Damage to Aircraft	Substantial			Total Aircraft Hours	1 078.2		
Pilot-in-command							
Licence Type	Private Pilot Licence (PPL)		Gender	Male		Age	44
Licence Valid	Yes	Total Hours	187.4		Total Hours on Type	187.4	
Total Hours 30 Days	3.7		Total Flying on Type Past 90 Days		20.9		
People On-board	1 + 0	Injuries	0	Fatalities	0	Other (on ground)	0

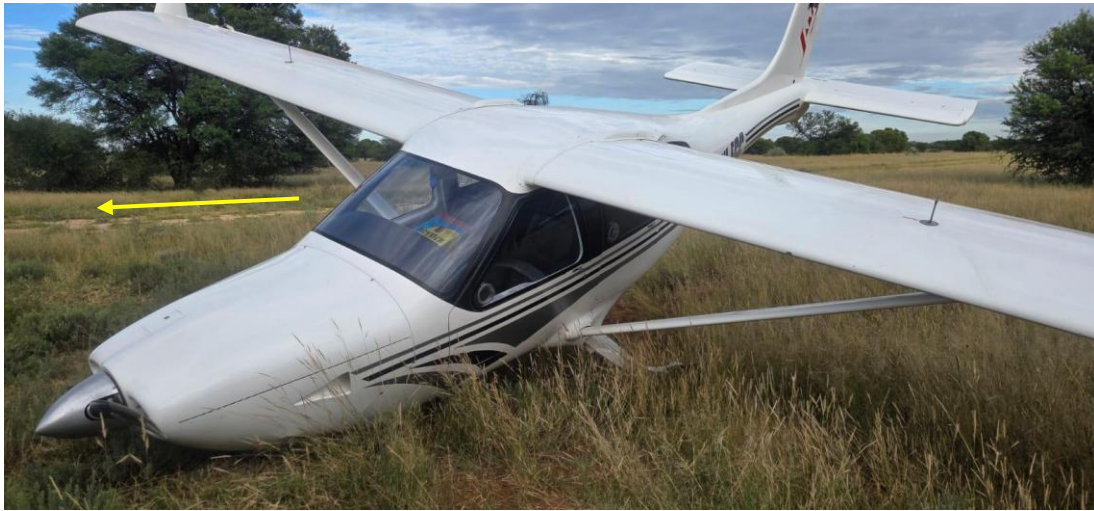
Figure 1: The direction of landing (yellow arrow) and the final position of the aircraft. (Source: Pilot)

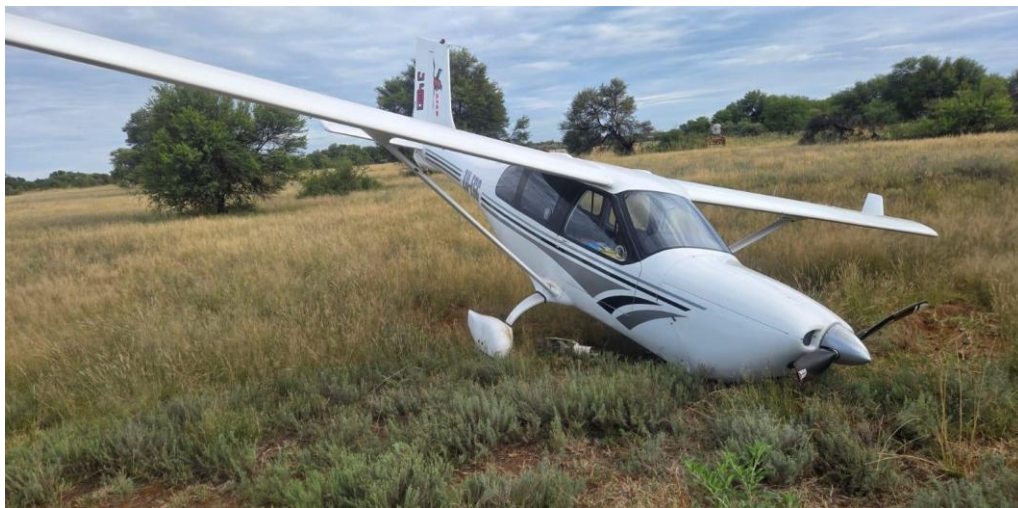
Figure 2: The aircraft post-serious incident. (Source: Pilot)

It is possible that the aircraft was unstable on final approach which resulted in a hard landing and the collapse of the left main landing gear.

- i. Poor landing technique.

ii. Failure to execute a go-around.
Safety Action(s)
None.
Safety Message and/or Safety Recommendation/s
None.
About this Report
<p><i>The decision to conduct a limited investigation is based on factors including whether the cause is known and the evidence supporting the cause is clear, the level of safety benefit likely to be obtained from an investigation and that will determine the scope of an investigation. For this occurrence, a limited investigation has been conducted, and the Accident and Incident Investigations Division (AIID) has relied on the information submitted by the affected person/s and organisation/s to compile this limited report. The report has been compiled using information supplied in the initial notification, as well as from follow-up desk top enquiries to bring awareness of potential safety issues to the industry in respect of this occurrence, as well as possible safety action/s that the industry might want to consider in preventing a recurrence of a similar occurrence.</i></p> <p><i>All times given in this report are Co-ordinated Universal Time (UTC) and will be denoted by (Z). South African Standard Time is UTC plus 2 hours.</i></p>
