LIMITED OCCURRENCE INVESTIGATION REPORT – FINAL

Reference Number	CA18/3/2/1536						
Classification	Serious Incident		Date	21 February 2026		Time	1000Z
Type of Operation	Private (Part 94)						
Location							
Place of Departure	Alzu Rondefontein Airfield, Mpumalanga Province		Place of Intended Landing	Zevenfontein Farm Airstrip, Mpumalanga Province			
Place of Occurrence	Zevenfontein Farm Airstrip, Mpumalanga Province						
GPS Co-ordinates	Latitude	25°48'00.4" S	Longitude	29°43'23.6" E	Elevation	5 426.5 ft	
Aircraft Information							
Registration	ZU-IKU						
Make; Model; S/N	Van's; RV10 (Serial Number: 41730)						
Damage to Aircraft	Substantial		Total Aircraft Hours	768			
Pilot-in-command							
Licence Type	Private Pilot Licence		Gender	Male		Age	59
Licence Valid	Yes	Total Hours	611.1		Total Hours on Type	500	
Total Hours 30 Days	10		Total Flying on Type Past 90 Days	23.2			
People On-board	1 + 0	Injuries	0	Fatalities	0	Other (on ground)	0
What Happened

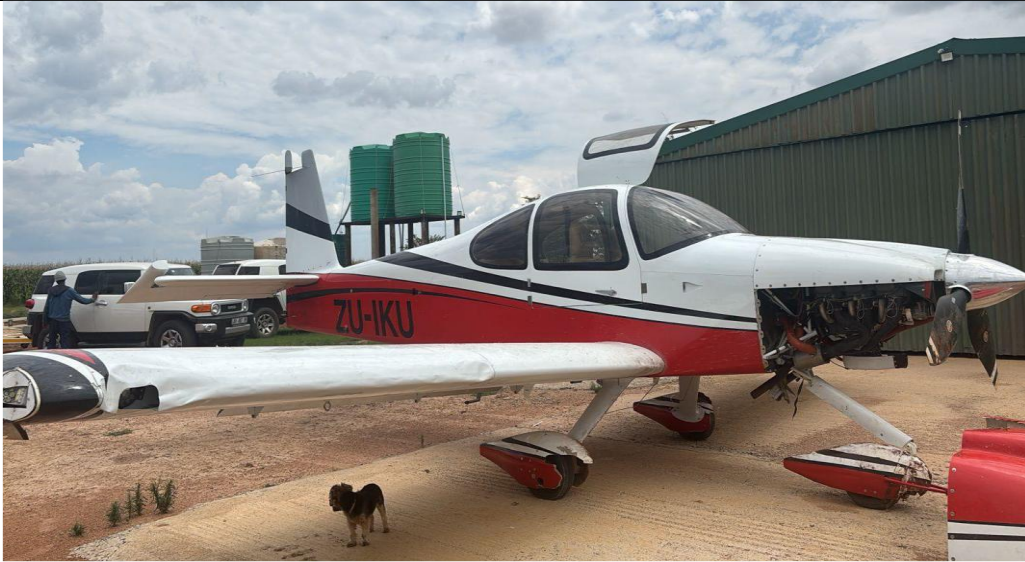
During the landing roll, the aircraft was exposed to a light crosswind component from the right; subsequently, the pilot lost directional control and the aircraft veered off to the left, departing the runway. The right-wing tip impacted the maize crops that were adjacent to the runway. This induced a further yaw to the left during which the nose landing gear strut collapsed; however, the propeller remained clear of the ground. The aircraft sustained substantial damage to both wing tips, the right-wing leading-edge, the nose gear strut and the main landing gear wheel fairings. The pilot was not injured.

Figure 2: The aircraft after recovery from the serious incident site. (Source: The pilot)

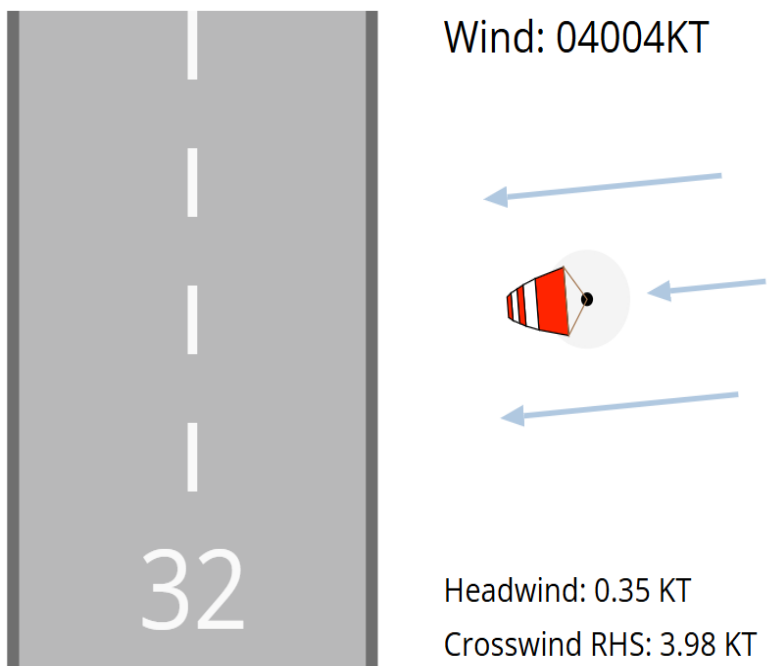
Crosswind Calculation (Source: SAWS)

Select By:	Runway Head	▼
Runway Name:	03	▼
Runway Heading:	315	°
Wind Direction:	40	°
Wind Speed:	4	kts ▼

Headwind Component:	0,35	kts
Crosswind from Right:	3,98	kts

Based on Van's RV-10 POH, the aircraft was certified to safely handle direct crosswinds of up to 28.7 mph (25 knots). The crosswind component was approximately 3.98 knots at the time of landing. The calculated crosswind component was within the aircraft's prescribed operational safety limits.
