## LIMITED OCCURRENCE INVESTIGATION REPORT – FINAL

<b>Reference Number</b>	CA18/3/2/1537						
<b>Classification</b>	Serious Incident		<b>Date</b>	20 February 2026		<b>Time</b>	0830Z
<b>Type of Operation</b>	Private (Part 94)						
<b>Location</b>							
Place of Departure	Witbank Aerodrome (FAWI), Mpumalanga Province		Place of Intended Landing	Deneysville Airfield, Free State Province			
Place of Occurrence	Grass airstrip on a private farm, 30km south of Heidelberg, Gauteng Province						
GPS Co-ordinates	Latitude	26°49'46.5" S	Longitude	28°22'37.9" E	Elevation	5 131 ft	
<b>Aircraft Information</b>							
Registration	ZU-ESS						
Make; Model; S/N	Jabiru J430 (Serial Number: 506)						
Damage to Aircraft	Minor		Total Aircraft Hours	1 421.1			
<b>Pilot-in-command</b>							
Licence Type	Private Pilot Licence (PPL)		Gender	Male		Age	57
Licence Valid	Yes	Total Hours	137.6		Total Hours on Type	92.6	
Total Hours 30 Days	0.5		Total Flying on Type Past 90 Days		1.8

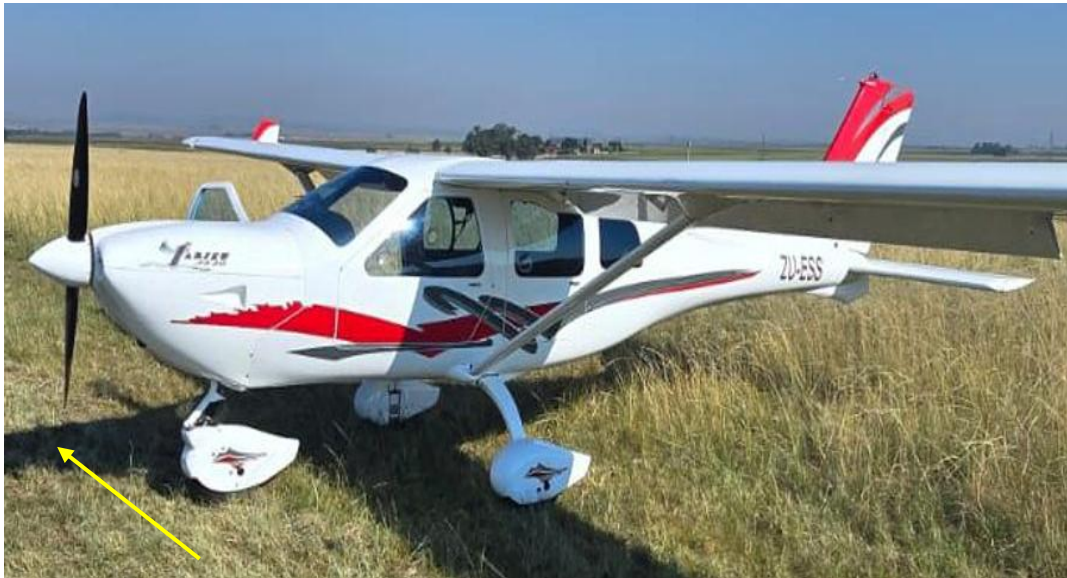
At this point, the pilot felt the engine vibrating, however, the engine parameters were reading normal. He identified a grass airstrip on a farm ahead of his flight path. At this time, the aircraft was still too high, which prompted him to execute a go-around. He selected 30 degrees flaps whilst approaching at a speed of 60 kts. During landing, the aircraft impacted the runway surface hard (touched down hard) with the main landing gears and bounced. After the bounce, the engine vibration increased. The aircraft touched down again and, during the landing roll, the engine stopped. The aircraft came to a stop on the right side of the runway. The pilot switched off the ignition and disembarked from the aircraft. He then rotated the propeller by hand during which he noticed that the crankshaft rotated freely with no compression. The aircraft sustained minor damage to the propeller blades. The pilot and the passenger were not injured.

**Figure 2:** The aircraft next to the runway and the direction of landing (yellow arrow). (Source: Pilot)

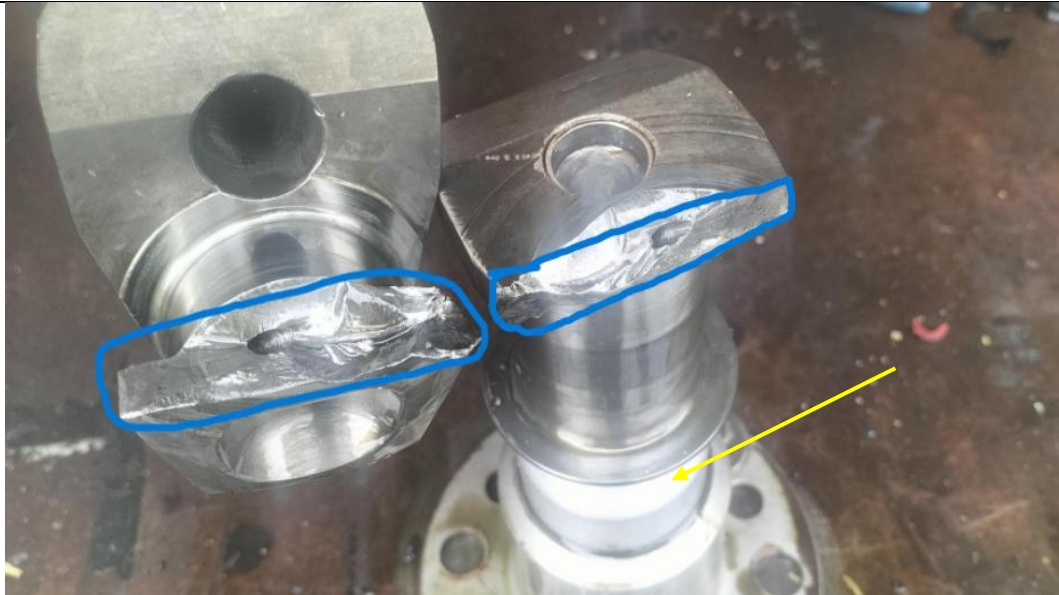
1. Scoring marks were found on the journals and metal shavings inside the crankcase.
2. The crankshaft with serial number 36424F-33A-104 had broken off between the Number 2 main journal and the Number 1 big end journal.
3. The crankshaft journals were measured, and the main journals were precisely 0.010 inches under the standard size of 0.050 inches stipulated in the engine overhaul manual JEM 001-20.
4. The main bearing shells fitted to the crankshaft were 0.010-inches under size, an indication of a mismatch between the bearing shells which resulted in excessive crankshaft end float or end play; consequently, this damaged the front side faces of the connecting rods.

**Figure 3:** The broken crankshaft and scoring marks on the journal (yellow line).

7. The engine teardown inspection revealed that the crankshaft with serial number 36424F-33A-104 had broken off between the Number 2 main journal and the Number 1 big end

<p>journal. The inspection also revealed incorrect bearing shells that were fitted to the crankshaft which resulted in excessive crankshaft end float.</p>
<p><b>Probable Cause</b></p>
<p>Unstable approach during a precautionary landing which resulted in the aircraft bouncing and the propeller striking the soft ground.</p>
<p><b>Contributing Factor</b></p>
<p>Poor landing technique.</p>
<p><b>Safety Action</b></p>
<p>None.</p>
<p><b>Safety Message and/or Safety Recommendation</b></p>
<p>None.</p>
<p><b>About this Report</b></p>
<p><i>The decision to conduct a limited investigation is based on factors including whether the cause is known and the evidence supporting the cause is clear, the level of safety benefit likely to be obtained from an investigation and that will determine the scope of an investigation. For this occurrence, a limited investigation has been conducted, and the Accident and Incident Investigations Division (AIID) has relied on the information submitted by the affected person/s and organisation/s to compile this limited report. The report has been compiled using information supplied in the initial notification, as well as from follow-up desk top enquiries to bring awareness of potential safety issues to the industry in respect of this occurrence, as well as possible safety action/s that the industry might want to consider in preventing a recurrence of a similar occurrence.</i></p> <p><i>All times given in this report are Co-ordinated Universal Time (UTC) and will be denoted by (Z). South African Standard Time is UTC plus 2 hours.</i></p>
