LIMITED OCCURRENCE INVESTIGATION REPORT – FINAL

Reference Number	CA18/3/2/1540						
Classification	<table border="1" style="width: 100%; border-collapse: collapse;"> <tr> <td style="width: 25%;">Serious Incident</td> <td style="width: 15%;">Date</td> <td style="width: 35%;">13 March 2026</td> <td style="width: 15%;">Time</td> <td style="width: 10%;">0750Z</td> </tr> </table>	Serious Incident	Date	13 March 2026	Time	0750Z	
Serious Incident	Date	13 March 2026	Time	0750Z			
Type of Operation	Private (Part 94)						
Location							
Place of Departure	Morningstar Airfield, Western Cape Province		Place of Intended Landing	Doringbaai Airstrip, Northern Cape Province			
Place of Occurrence	At the end of Runway 18 at Doringbaai Airstrip (FASB), Northern Cape Province						
GPS Co-ordinates	Latitude	31°48'37.14" S	Longitude	18°14'23.86" E	Elevation	92ft	
Aircraft Information							
Registration	ZU-CIT						
Make; Model; S/N	Shadow Lite, Jabiru SP 470 (Serial Number: 435)						
Damage to Aircraft	Substantial			Total Aircraft Hours	676.4		
Pilot-in-command							
Licence Type	Private Pilot Licence (PPL)		Gender	Female		Age	52
Licence Valid	Yes	Total Hours	107.8		Total Hours on Type	13	
Total

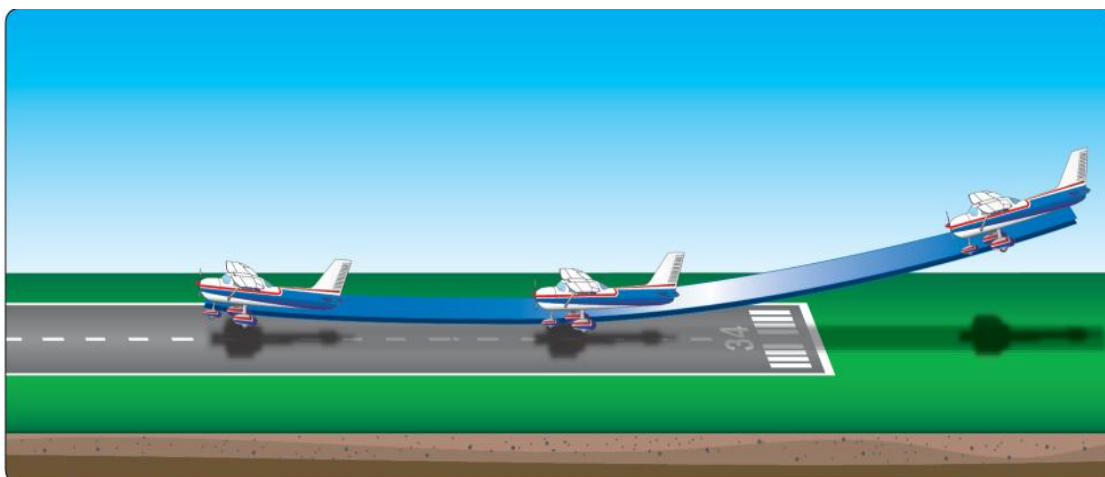
of 65kts. The aircraft floated above the runway before it touched down deep, about two-thirds of the runway.

Figure 1: Floating during landing. (Source: Airplane Flying Handbook [3] Chapter 9)

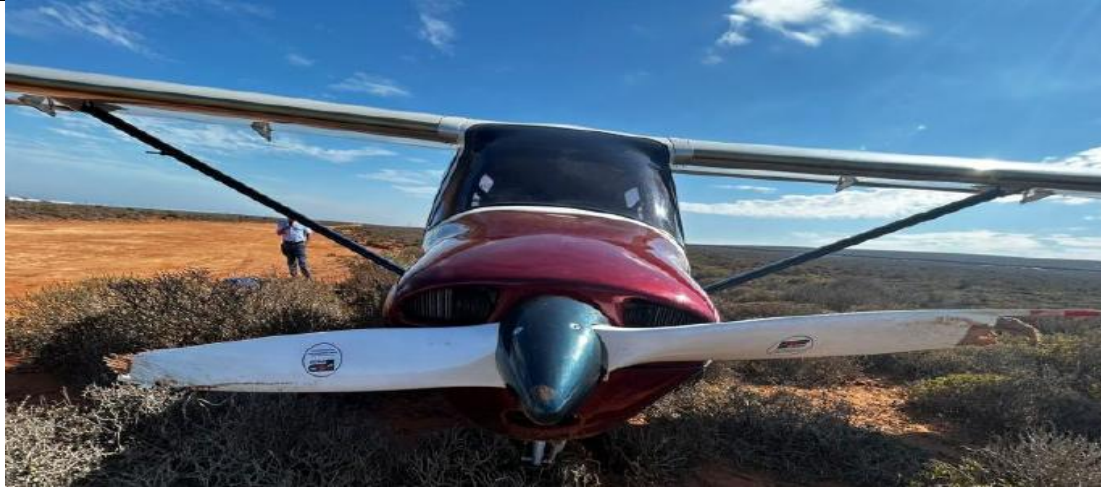
The pilot could not bring the aircraft to a stop on the remainder of the runway. Therefore, the aircraft overran the runway and careered into the bush beyond the boundary. Subsequently, the nose wheel assembly collapsed and the aircraft pitched forward, resulting in the propeller strikes on the ground. The aircraft came to rest on a bushy terrain approximately 5m beyond the end of Runway 18, settling to a level attitude. The aircraft was substantially damaged; the pilot was not injured.

Figure 3: The aircraft at the serious incident site. (Source: Pilot)

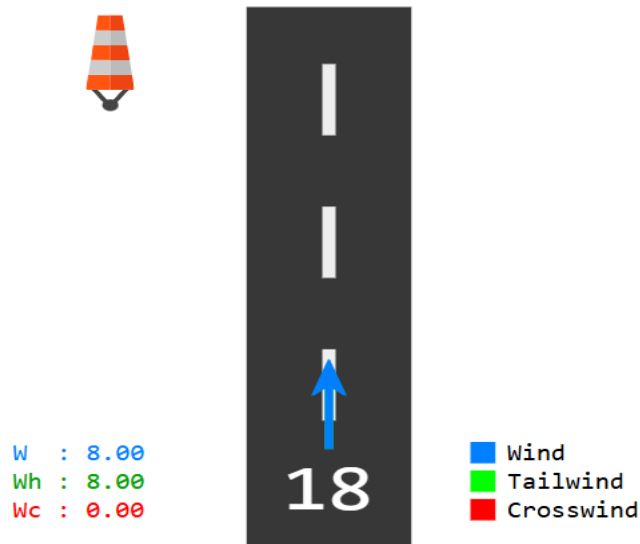
Figure 4: The calculated tailwind component is 08kts. (Source: <https://e6bx.com>)

The tailwind component at the time of landing was recorded as 8kts. This increased the aircraft's groundspeed during approach and landing phases which resulted in an increased landing distance compared to an environment in which there was calm wind or headwind.
