**LIMITED OCCURRENCE INVESTIGATION REPORT – FINAL**

| <b>Reference Number</b> | CA18/3/2/1543 | | | | | | |
| <b>Classification</b> | Serious Incident | | <b>Date</b> | 11 April 2026 | | <b>Time</b> | 0835Z |
| <b>Registration</b> | ZU-JOL | | | | | | |

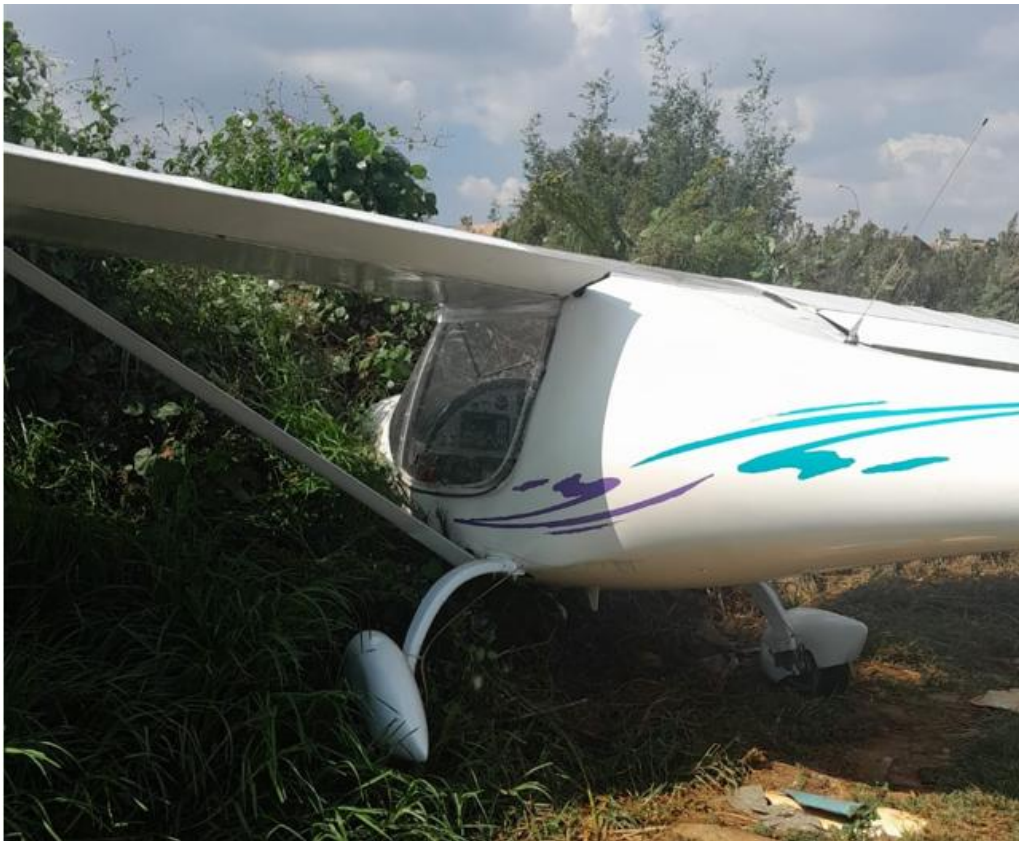
**Figure 2:** The aircraft after the serious incident site. (Source: Pilot)

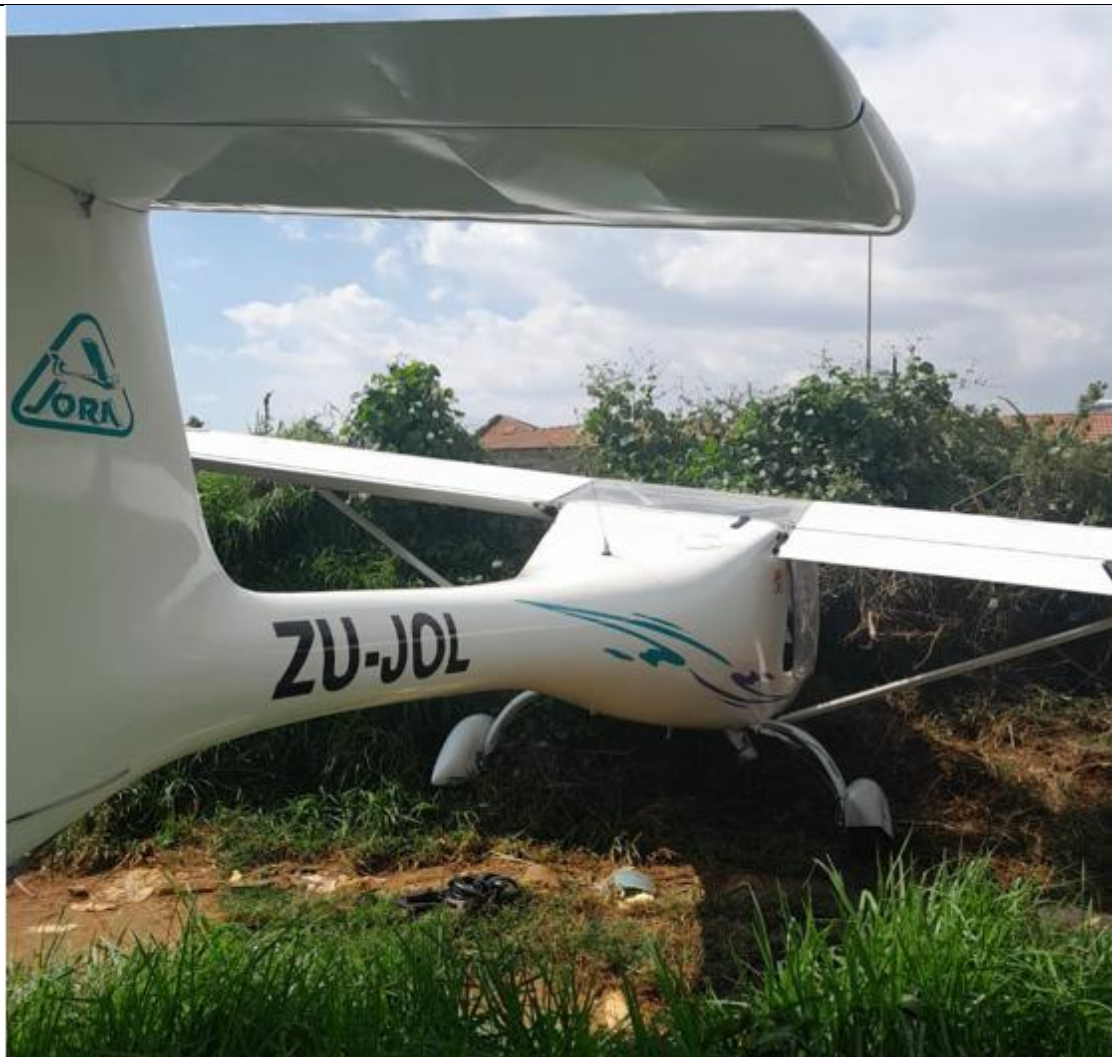
**Figure 3:** The rear view of the aircraft at the serious incident site. (Source: Pilot)

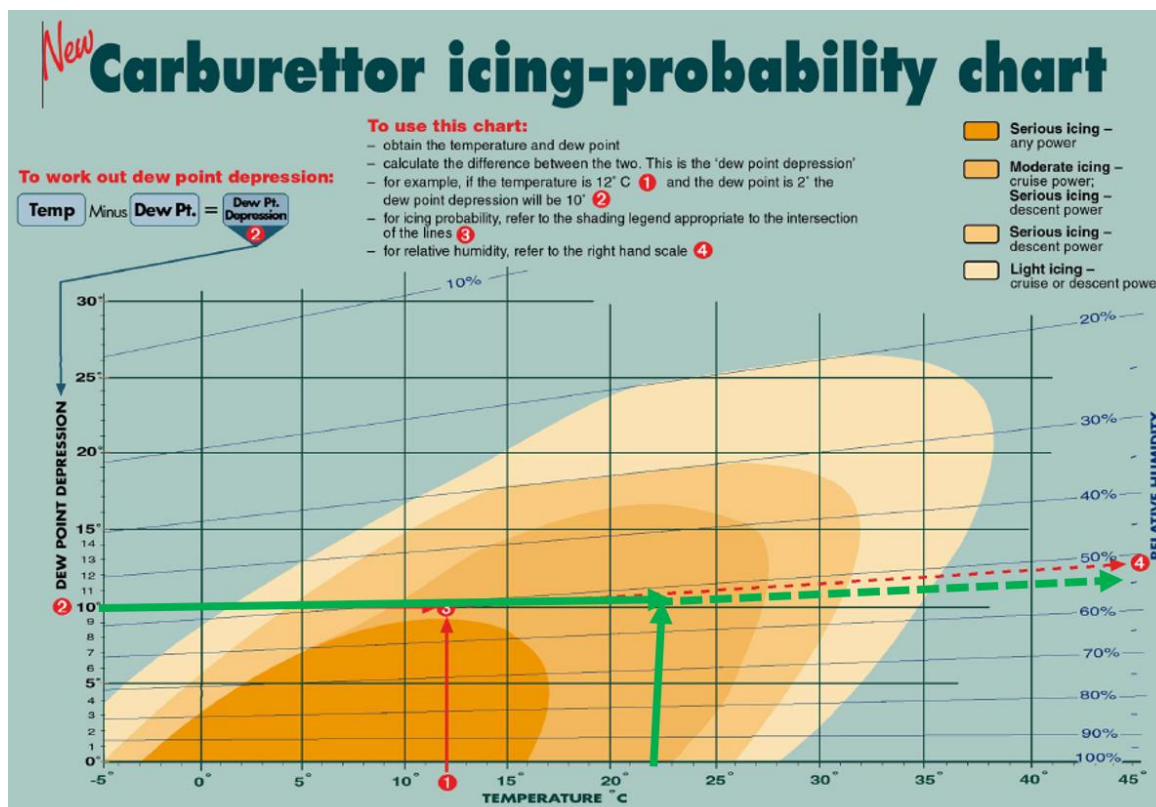
According to the carburettor icing probability chart below, the recorded conditions showed a dew point depression of 10°C with an ambient temperature of 23°C and a dew point of 13°C. An estimated relative humidity of about 55% was recorded. A likelihood of carburettor icing was considered a serious probability at descent power settings. Additionally, the aircraft was in descent phase of flight in preparation for landing at FAKR. Typically, this involved lower engine power settings which further increased the potential for ice formation.

**Figure 4:** Carburettor icing-probability chart. (Source: <https://alaskafloatratings.com/float-flying-journal/what-is-carburetor-icing/>)
