LIMITED OCCURRENCE INVESTIGATION REPORT – FINAL

Reference Number	CA18/3/2/1544						
Classification	Serious Incident		Date	12 April 2026		Time	0725Z
Type of Operation	Private (Part 94)						
Location							
Place of Departure	Morningstar Airfield, Western Cape Province		Place of Intended Landing	Diemerskraal Airfield, Western Cape Province			
Place of Occurrence	Right side of Runway 22 at Diemerskraal Airfield, Western Cape Province						
GPS Co-ordinates	Latitude	33°34'31.73"S	Longitude	18°54'59.98"E	Elevation	275 feet	
Aircraft Information							
Registration	ZU-CCG						
Make; Model; S/N	Bushbaby 450 (Serial Number: 049)						
Damage to Aircraft	Minor		Total Aircraft Hours	455.8			
Pilot-in-command							
Licence Type	National Pilot Licence (NPL)		Gender	Male		Age	53
Licence Valid	Yes	Total Hours	407.3		Total Hours on Type	276.5	
Total Hours 30 Days	22		Total Flying on Type Past 90 Days	40.2			
People On-board	1+1	Injuries	0	Fatalities	0	Other (on ground)	0

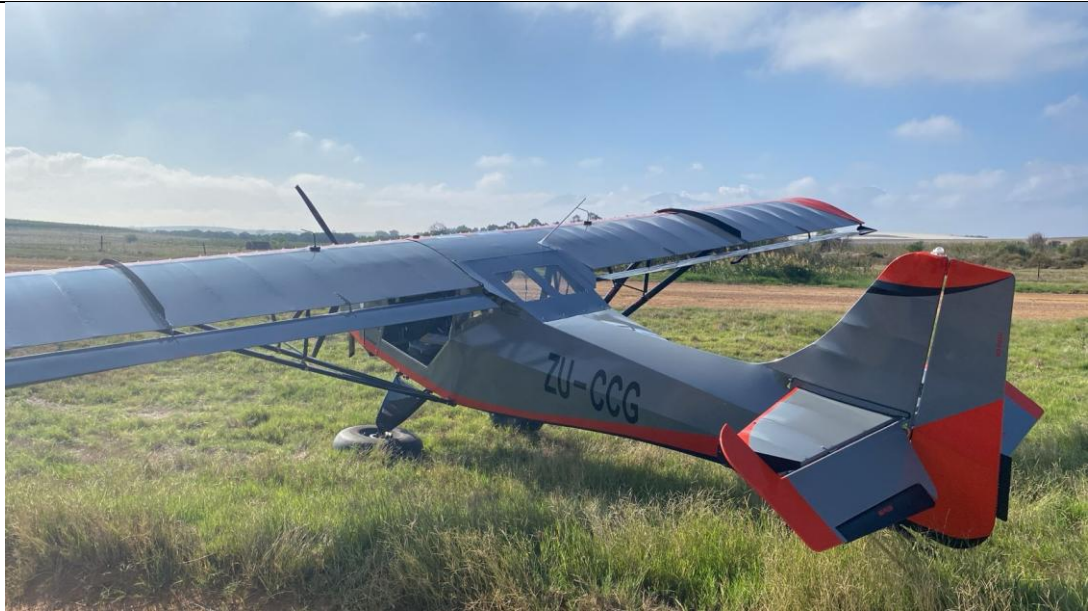
What Happened							
<p>On Sunday morning, 12 April 2026, a pilot and a passenger on-board a Bushbaby 450 aircraft (taildragger) registered ZU-CCG took off on a private flight from Morningstar Airfield to Diemerskraal Airfield, both located in the Western Cape province. The flight was conducted under visual meteorological conditions (VMC) and under the provisions of Part 94 of the Civil Aviation Regulations (CAR) 2011, as amended.</p> <p>According to the pilot, upon arrival at Diemerskraal Airfield, he performed an unmanned joining procedure and selected Runway (RWY) 22 for landing. The downwind leg and approach phases were uneventful. During touchdown at an estimated speed of about 48 miles per hour (mph) and whilst the tail was still in the air, the pilot reached down to manually retract the flaps. Shortly thereafter, the aircraft unexpectedly began to lose directional control, and it veered to the right of the runway. The pilot attempted to regain control by applying full left rudder and then the left brake; however, these efforts were unsuccessful. As the aircraft rolled onto the grass area alongside the runway, it ground-looped and came to a stop facing the runway at an angle. No person was injured during the serious incident. The aircraft sustained damage to the left main landing gear.</p>

Figure 1: Aircraft came to rest on the right side of the runway. (Source: Owner)

The pilot lost control of the aircraft during the landing roll, which resulted in damage to the undercarriage.

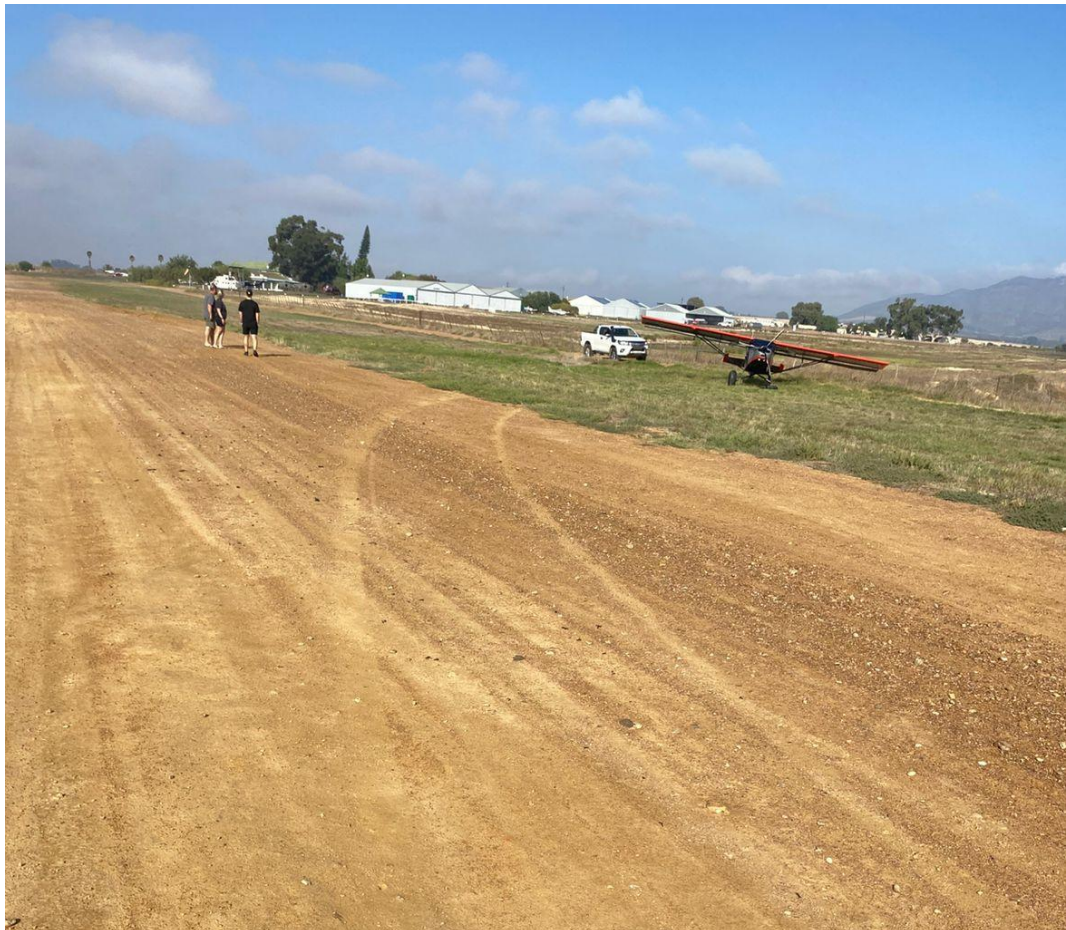
Figure 2: The skid marks on the gravel runway veering to the right. (Source: Owner)

2.4 The pilot stated that during the landing roll “while the tail section was still in the air, he reached down to manually retract the flap. Shortly thereafter, the aircraft unexpectedly began to lose directional control, and it veered to the right of the runway.

2.5 The manual retraction of flaps during the landing roll likely diverted the pilot’s attention from maintaining directional control during the critical phase of flight when the tail section was still in the air.

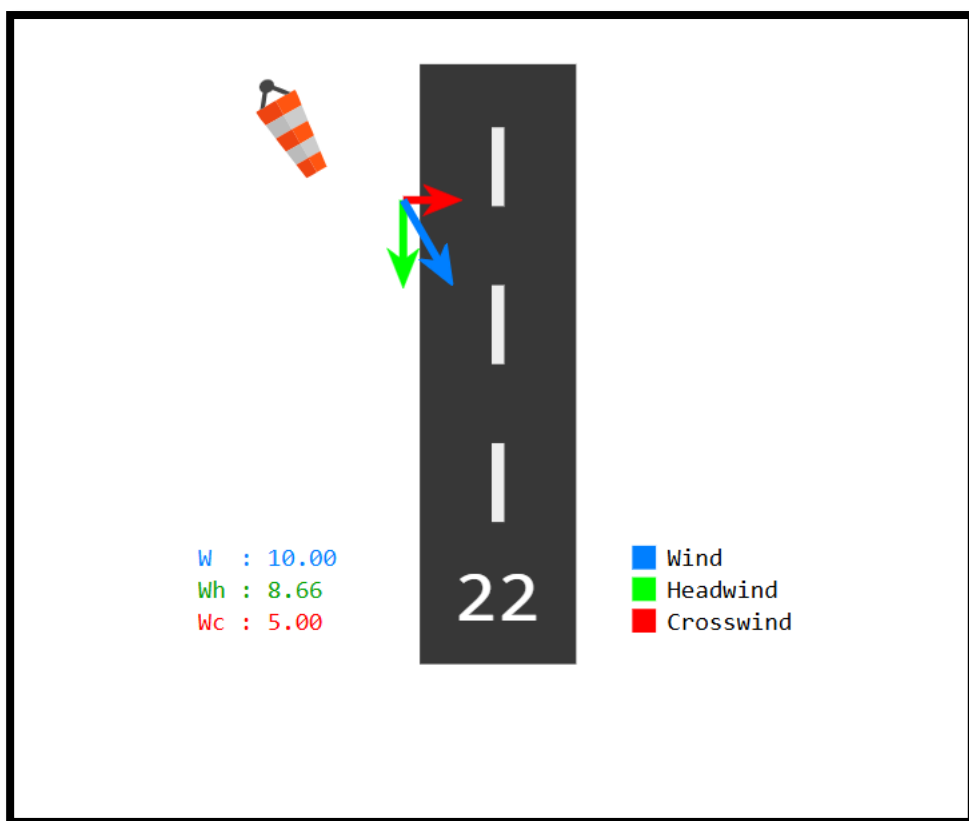
Figure 4: Crosswind calculation. (Source: Source: <https://e6bx.com/wind-components/>)
