**LIMITED OCCURRENCE INVESTIGATION REPORT – FINAL**

<b>Reference Number</b>	CA18/3/2/1545						
<b>Classification</b>	Serious Incident	<b>Date</b>	26 April 2026		<b>Time</b>	1235Z	
<b>Type of Operation</b>	Private (Part 94)						
<b>Location</b>							
Place of Departure	Orient Airfield (FAOI), Gauteng Province		Place of Intended Landing	El Mirador Airfield (FALQ), KwaZulu-Natal Province			
Place of Occurrence	On Runway 29 at Reitz Airfield (FARZ), Free State Province						
GPS Co-ordinates	Latitude	27°47'3.81" S	Longitude	28°25'40.93" E	Elevation	5 331 feet	
<b>Aircraft Information</b>							
Registration	ZS-GUE						
Make; Model; S/N	Super Dimona; HK-36TTC (Serial Number: 36-539)						
Damage to Aircraft	Minor		Total Aircraft Hours	1 490.4			
<b>Pilot-in-command</b>							
Licence Type	National Pilot Licence (NPL)		Gender	Male		Age	67
Licence Valid	Yes	Total Hours	2 354		Total Hours on Type	139	
Total Hours 30 Days	7		Total Flying on Type Past 90 Days	7

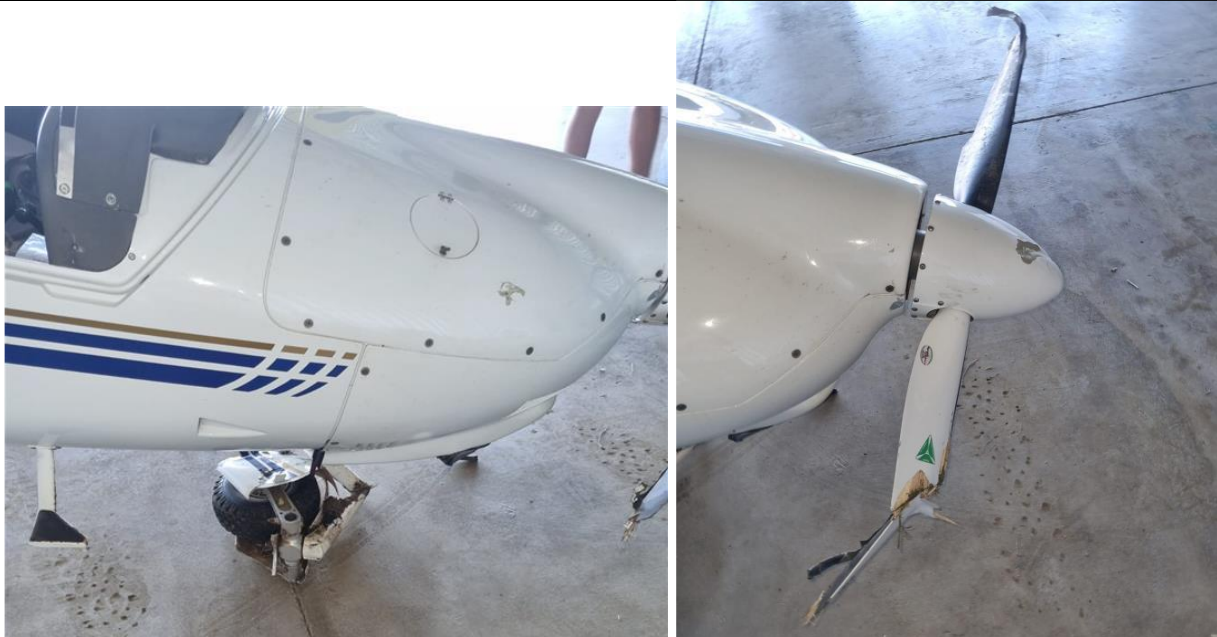
The pilot decided to continue with the flight to FALQ. At this time, there was about 70L of fuel in the tank. The pilot and the passenger embarked the aircraft. At 1230Z, the pilot taxied to the threshold of Runway 29; he opened the throttle to 5 150 revolutions per minute (rpm) and commenced with the take-off roll. During the take-off roll, the aircraft veered off to the left. He then applied the right rudder to recover the aircraft, but without success. The aircraft exited the runway during which it ground looped. The nose gear strut broke off, and the propellers struck the soft ground. The aircraft sustained minor damage. No person was injured.

**Figures 2 and 3:** The damaged nose gear strut (left picture); the damaged propeller blades (right picture).  
(Source: Pilot)

Loss of directional control during the take-off roll which resulted in the aircraft veering off to the left of the grass surface runway.

Inappropriate handling of the aircraft during the take-off roll.
