## LIMITED OCCURRENCE INVESTIGATION REPORT – FINAL

| <b>Reference Number</b> | CA18/3/2/1547 | | | | | | |
| Registration | ZU-STA | | | | | | |
| Make; Model; S/N | Sling 2 (Serial Number: 242) | | | | | | |

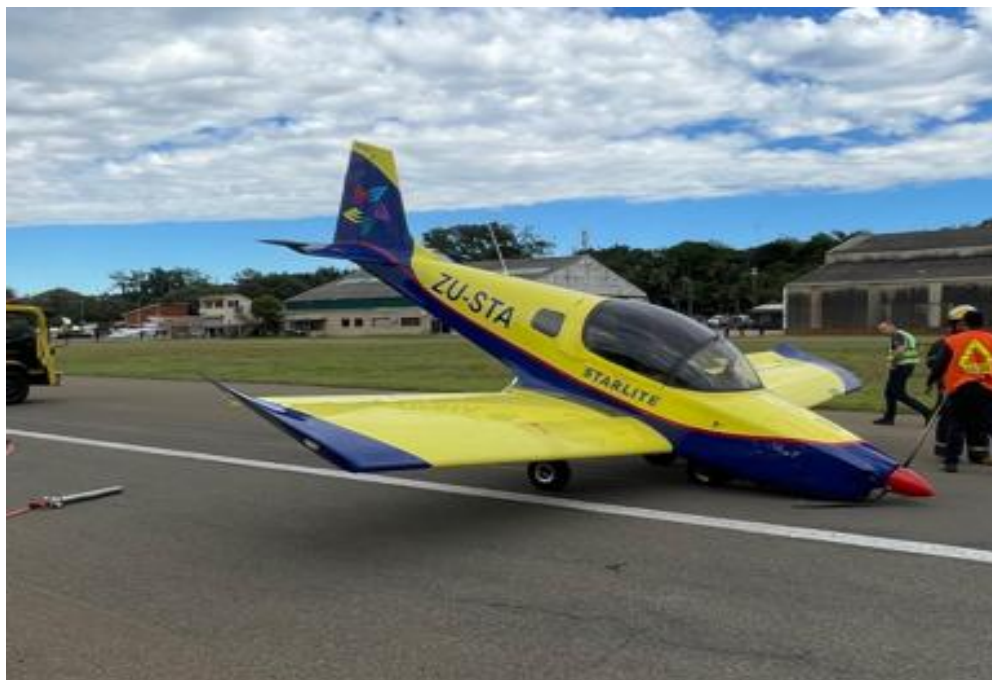
The aircraft sustained minor damage to the nose gear strut and the propeller. The SP disembarked from the aircraft uninjured.

**Figure 2:** The aircraft on the runway after the serious incident. (Source: Pilot)

| 2.6. | The flare was initiated higher than recommended, which resulted in a hard touch down and a bounce; after the second bounce the nose gear strut collapsed and the propeller struck the runway. |
| Unstable approach due to high speed and an early flare resulted in the aircraft bouncing during touch down. Consequently, the nose gear strut collapsed, and the propeller struck the runway surface. | |

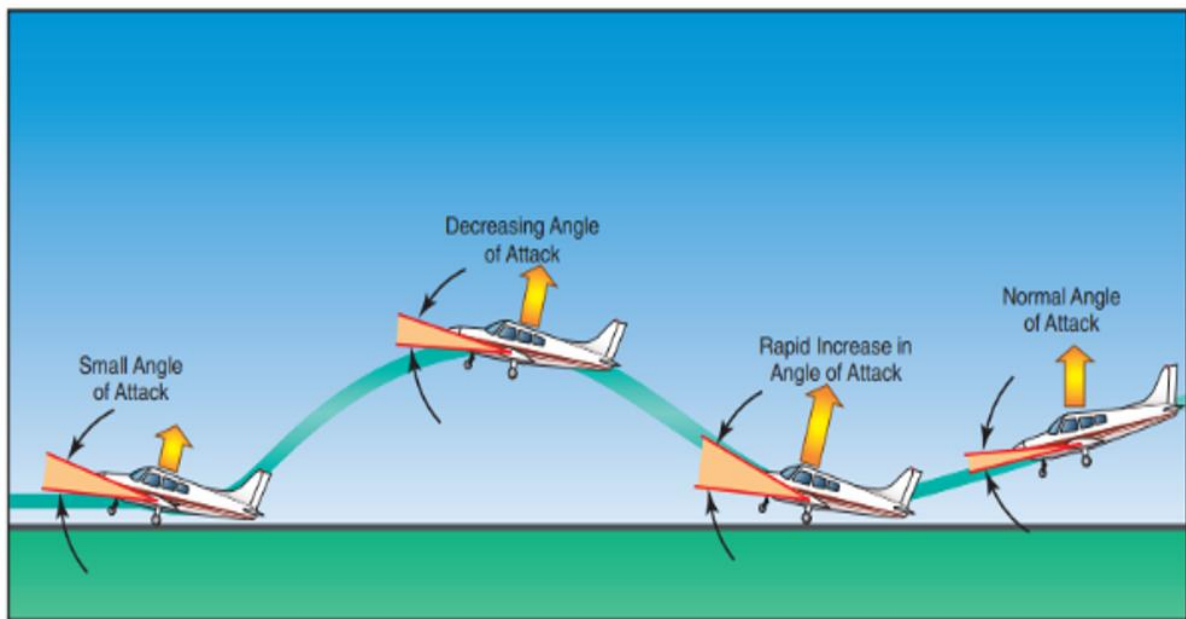
**Figure 3:** Illustration of a bounce on the runway. (Source: FAA-H-8083-25B)

*When the airplane contacts the ground with a sharp impact as the result of an improper attitude or an excessive rate of sink, it tends to bounce back into the air. Though the airplane's tires and shock struts provide some springing action, the airplane does not bounce like a rubber ball. Instead, it rebounds into the air because the wing's angle of attack was abruptly increased, producing a sudden addition of lift. [Figure 3] The abrupt change in angle of attack is the result of inertia instantly forcing the airplane's tail downward when the main wheels contact the ground sharply. The severity of the bounce depends on the airspeed at the moment of contact and the degree to which the angle of attack or pitch attitude was increased. Since a bounce occurs when the airplane makes contact with the ground before the proper touchdown attitude is attained, it is almost invariably accompanied by the application of excessive back-elevator pressure. This is usually the result of the pilot realizing too late that the airplane is not in the proper attitude and attempting to establish it just as the second touchdown occurs. The corrective action for a bounce is the same as for ballooning and similarly*
