## LIMITED OCCURRENCE INVESTIGATION REPORT – FINAL

| <b>Reference Number</b> | CA18/3/2/1552 | | | | | | |
| Registration | ZU-FZI | | | | | | |
| Make; Model; S/N | Sling 2 (Serial Number: 134) | | | | | | |

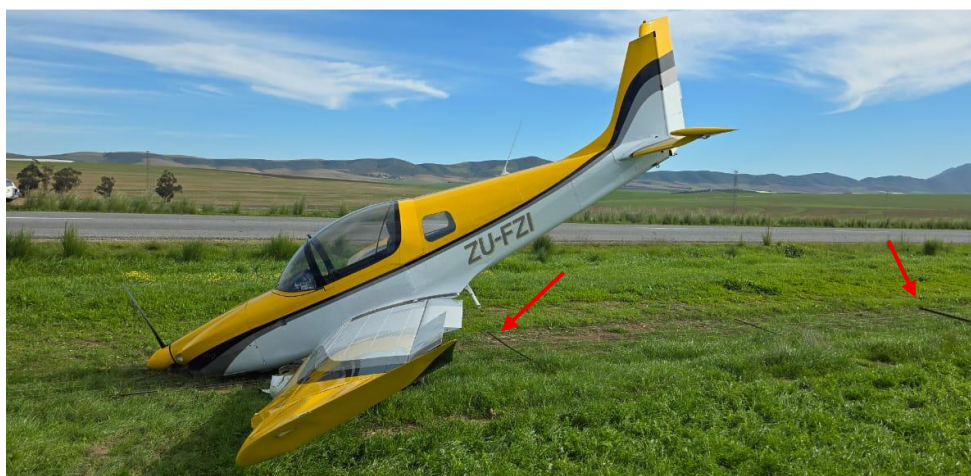
The pilot surveyed the area and spotted a field (farm) on the right side of the flight path and next to the R45 public road on which to conduct a forced landing. He turned the aircraft to the right towards the farm and aligned it southward (parallel to the furrows). However, after noticing a flock of sheep, he turned the aircraft towards the west. With insufficient height and the airspeed decaying, he landed the aircraft after initiating a slight right turn to align with the furrows. During the landing roll, approximately 90 metres (m) after the aircraft touched down, the nose landing gear struck a berm, bent backward and the main wheel spats broke. Consequently, the nose gear collapsed, and the propeller struck the soft ground. The aircraft impacted the perimeter fence post during which one of the blades was severed. The aircraft came to a halt with the tail tilted high. After the serious incident, the pilot turned off the fuel and master switches. The aircraft sustained substantial damage. No person was injured during the serious incident.

**Figure 2:** The aircraft after the serious incident. The red arrows point to the perimeter fence. (Source: Pilot)

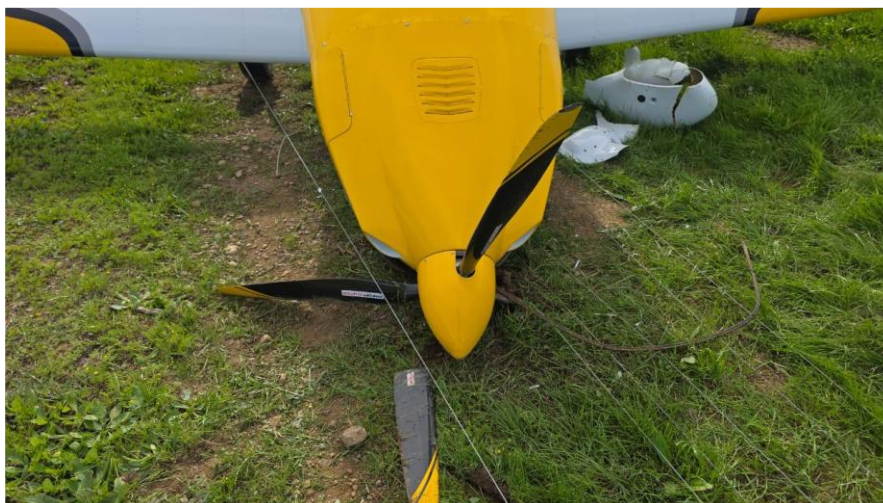
**Figure 3:** The damaged nose section and the severed propeller blade. (Source: Pilot)

Engineers later reassembled the right carburettor bowl. The nose gear that had bent backward during landing was replaced, and a loaner propeller was fitted to the engine to enable the ground run test. The engine started normally and power was increased in stages. The engine met all the parameters outlined in the aircraft maintenance manual (AMM).

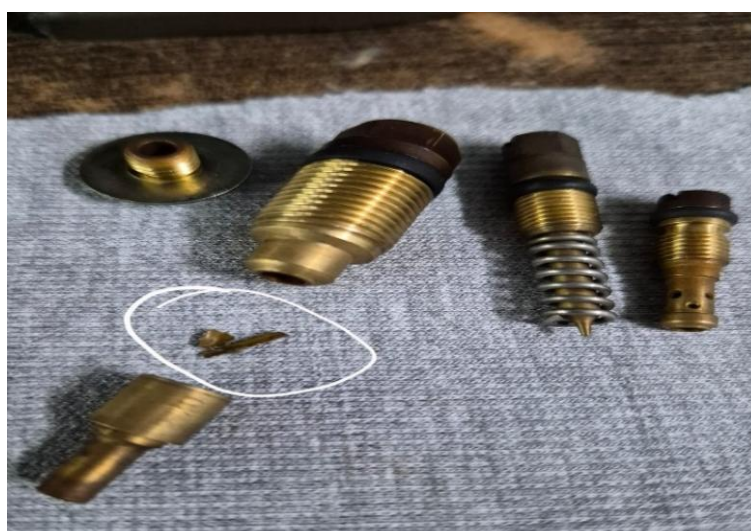
After the serious incident, engineers at the aircraft maintenance organisation (AMO) opened the carburettor bowls and found pieces of what appeared to be Polysulfide Rubber Compound (PRC) sealant remnants in the right carburettor bowl float chamber which blocked fuel to the right carburettor main jet, resulting in engine being starved of fuel and, hence, the engine power loss during climb. Examination of the aircraft technical documentation showed no evidence of maintenance performed on the aircraft fuel system in which PRC sealant was used.

**Figure 4:** The right carburettor bowl main jet and pieces of what appeared to be PRC sealant.  
(Source: AMO)

| <p><b>Probable Cause</b></p> <p>Loss of engine power after take-off due to fuel starvation caused by PRC sealant remnants which blocked the right carburettor main jet. The pilot conducted an unsuccessful forced landing on a field.</p> |

| <p><b>Safety Message</b></p> <p>The AMO is advised to emphasise the use of a thin film of PRC sealant or as directed by the manufacturer during training programmes and in maintenance briefings.</p> |

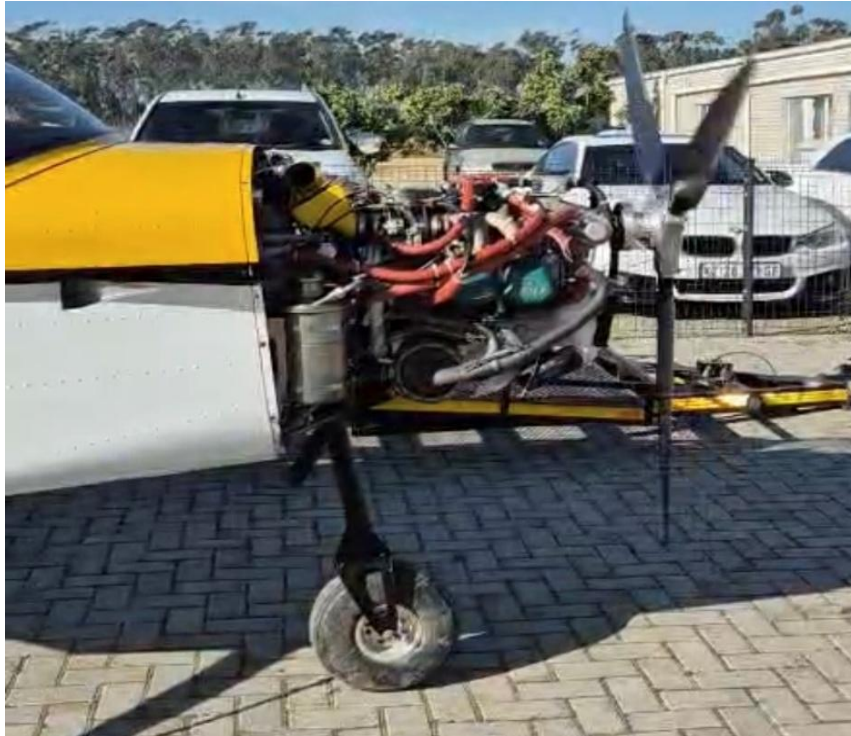
**Figure 5:** The aircraft during the engine ground run. (Source: AMO)
