Section/division **Accident and Incident Investigations Division**

## LIMITED OCCURRENCE INVESTIGATION REPORT – FINAL

| <b>Reference Number</b> | CA18/3/2/1554 | | | | | | |
| Registration | ZS-DPN | | | | | | |

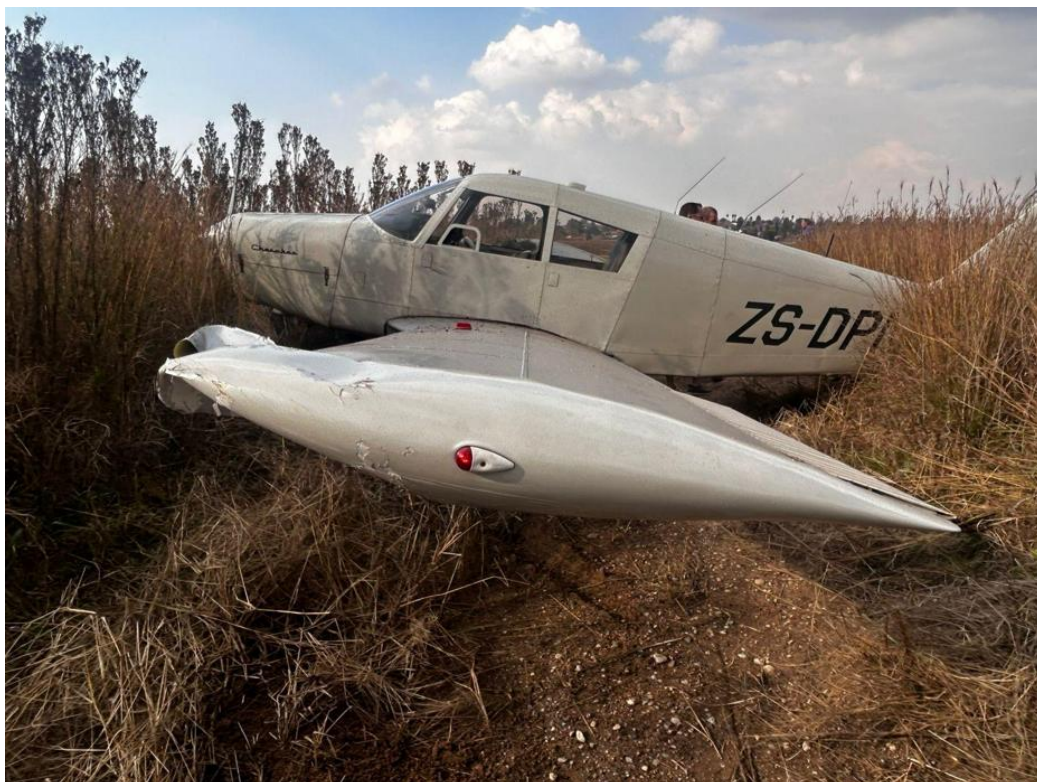
was not successful. The aircraft drifted off the runway and came to rest in the bushes. The wing tip, propeller blade and the nose gear were damaged. The pilot sustained minor injuries.

**Figure 2:** Final resting position of the aircraft. (Source: Operator)

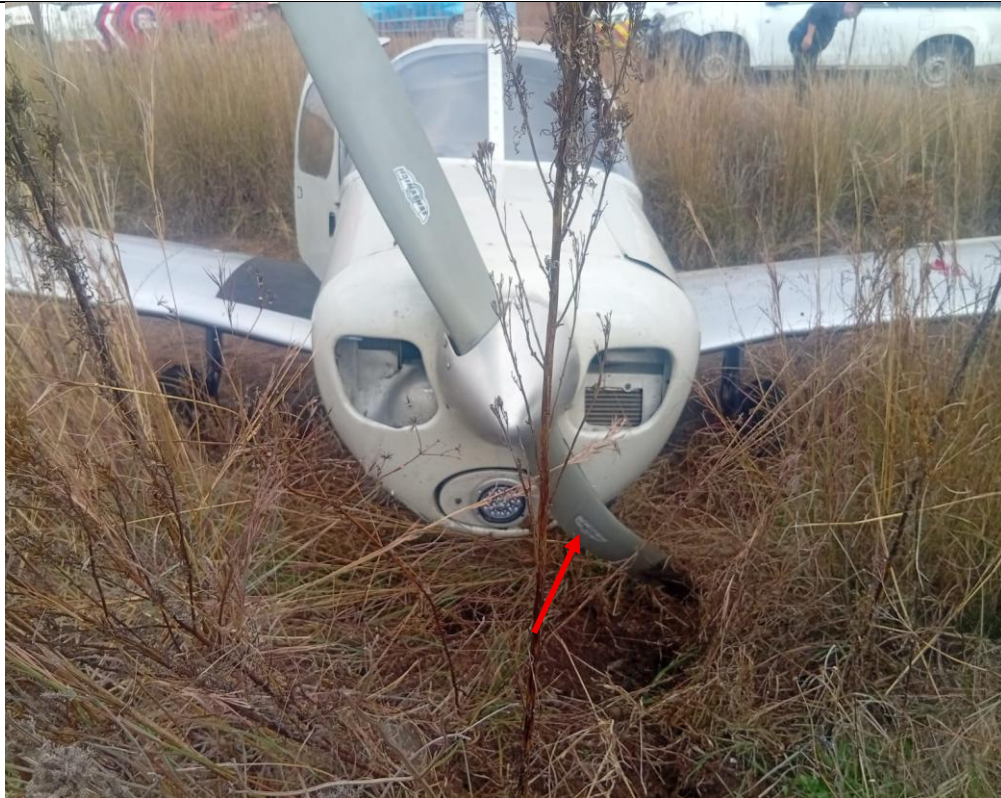
**Figure 3:** The damaged propeller blade.
