Section/division **Accident and Incident Investigations Division**

## LIMITED OCCURRENCE INVESTIGATION REPORT

| <b>Reference Number</b> | CA18/3/2/1557 | | | | | | |
| Registration | ZS-WMM | | | | | | |

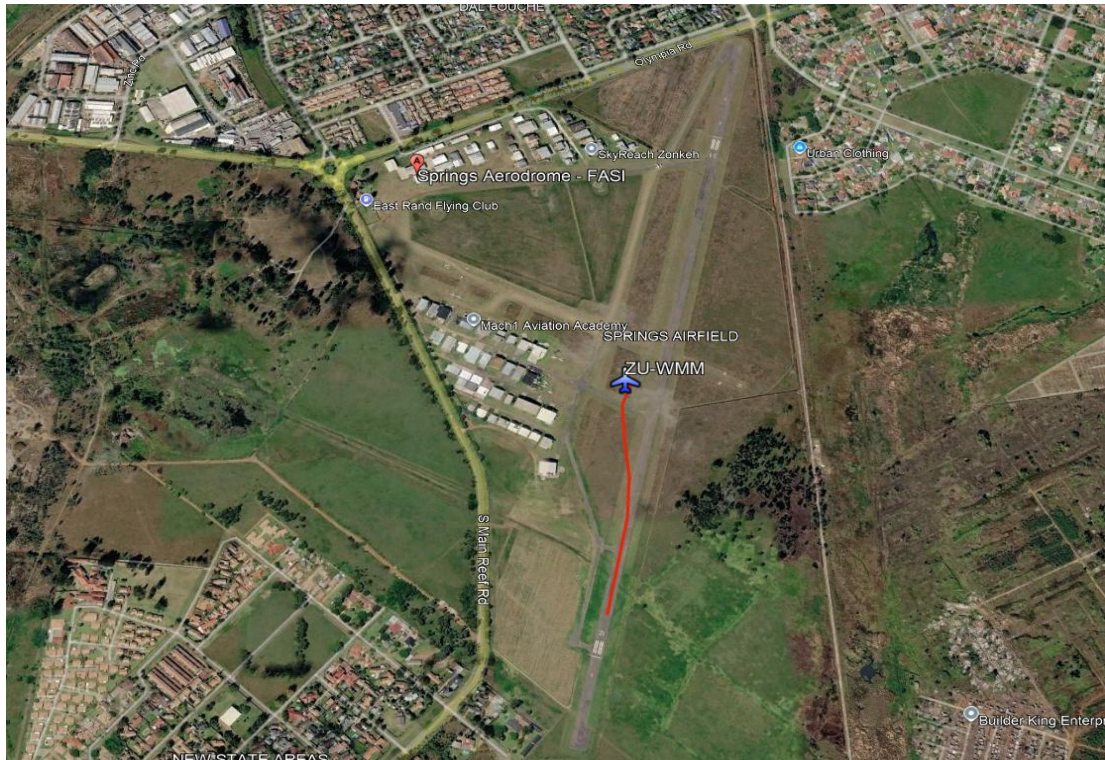
**Figure 1:** An aerial view of the airfield and the serious incident site. (Source: Pilot)

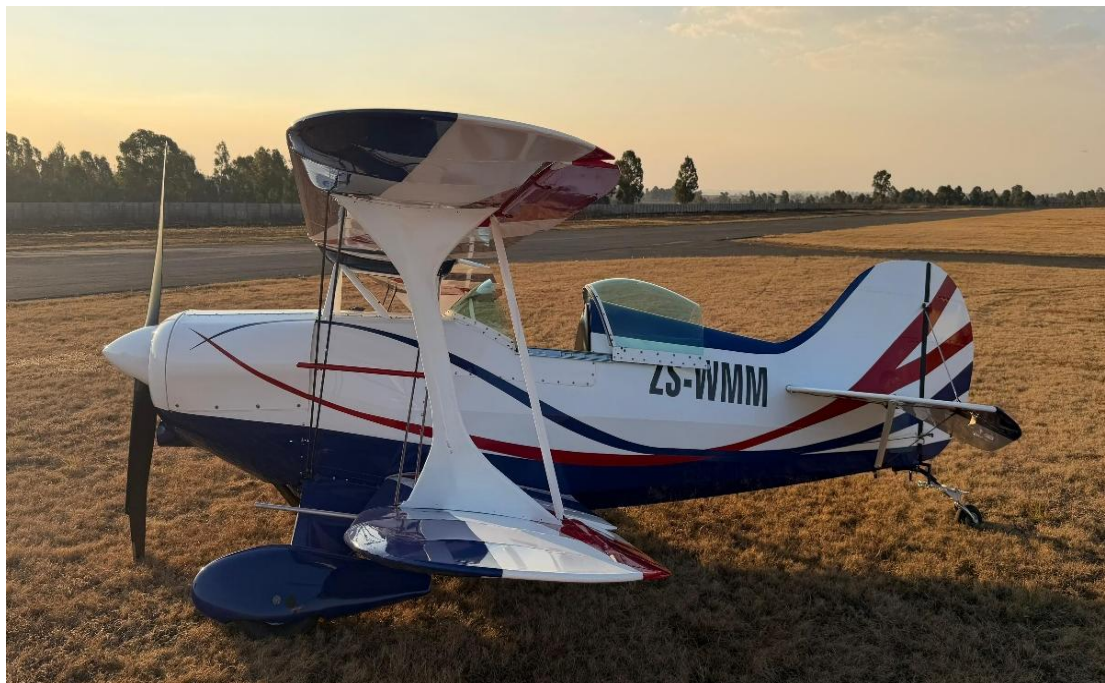
The pilot was not injured; the aircraft sustained substantial damage to the right main landing gear.

**Figure 2:** The aircraft after it had come to rest. (Source: Pilot)

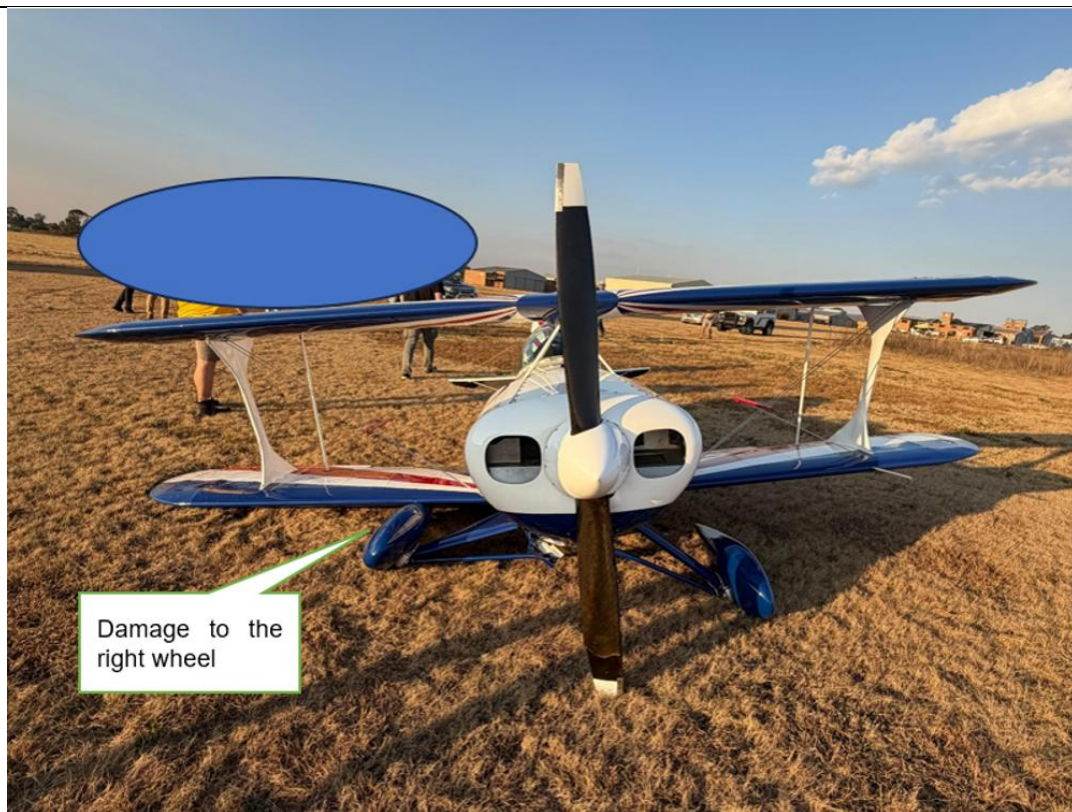
**Figure 3:** The damaged right wheel. (Source: Pilot)

Loss of directional control during the landing roll at a high landing speed; subsequently, the aircraft veered off the runway, and the right main landing gear wheel impacted a concrete drain lip and collapsed.
