## LIMITED OCCURRENCE INVESTIGATION REPORT – FINAL

| <b>Reference Number</b> | CA18/3/2/1559 | | | | | |
| Registration | ZS-EOX | | | | | |
| Make; Model; S/N | Piper PA-28-180 Cherokee (Serial Number: 28-3378) | | | | | |

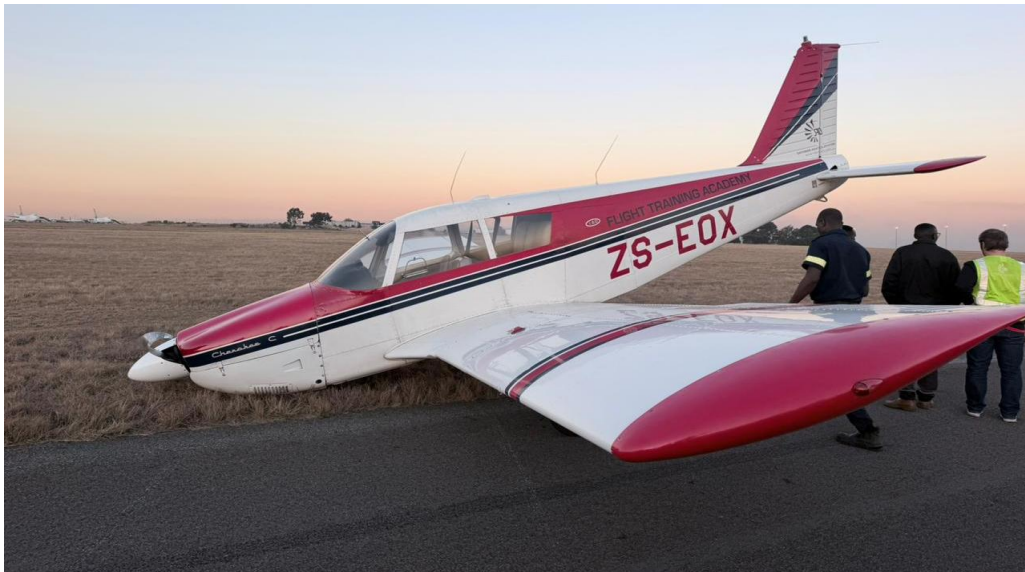
cowling and came to rest on the right side of the runway. The Airport Rescue and Firefighting (ARFF) personnel responded to the scene. The aircraft sustained minor damage to the engine lower cowling, nose gear strut and propeller blades. The SP disembarked from the aircraft unassisted; she was not injured.

**Figure 1:** The aircraft at the serious incident site. (Source: Operator)

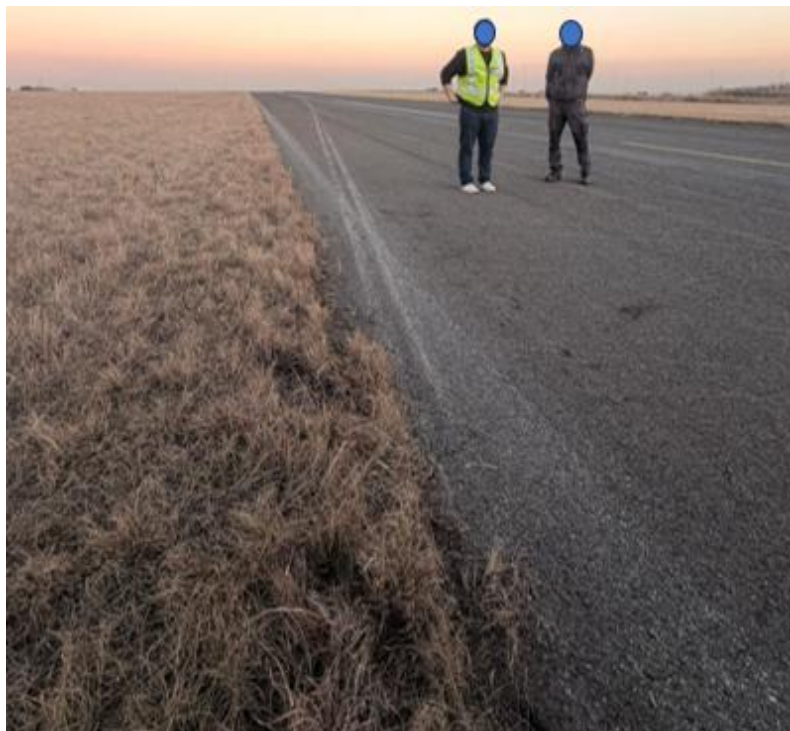
**Figure 2:** The aircraft's skid marks on the runway. (Source: Operator)

| The aircraft landed hard with its nose gear due to an incorrect landing technique. Subsequently, the nose gear broke off, and the propeller struck the runway before the aircraft skidded on its nose during which the student pilot lost directional control. |

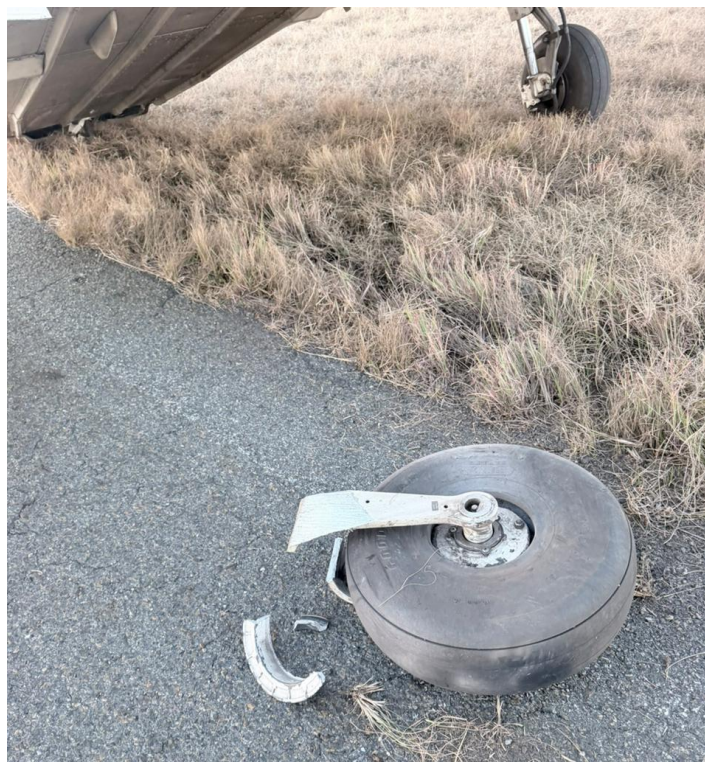
**Figure 3:** The severed nose gear fork and well assembly. (Source: Operator)
