## LIMITED OCCURRENCE INVESTIGATION REPORT – FINAL

| <b>Reference Number</b> | | CA18/3/2/1566 | | | | | |
| <b>Registration</b> | | ZS-EBL | | | | | |
| <b>Make; Model; S/N</b> | | Piper; PA28-140 Cherokee (Serial Number: 28-20435) | | | | | |

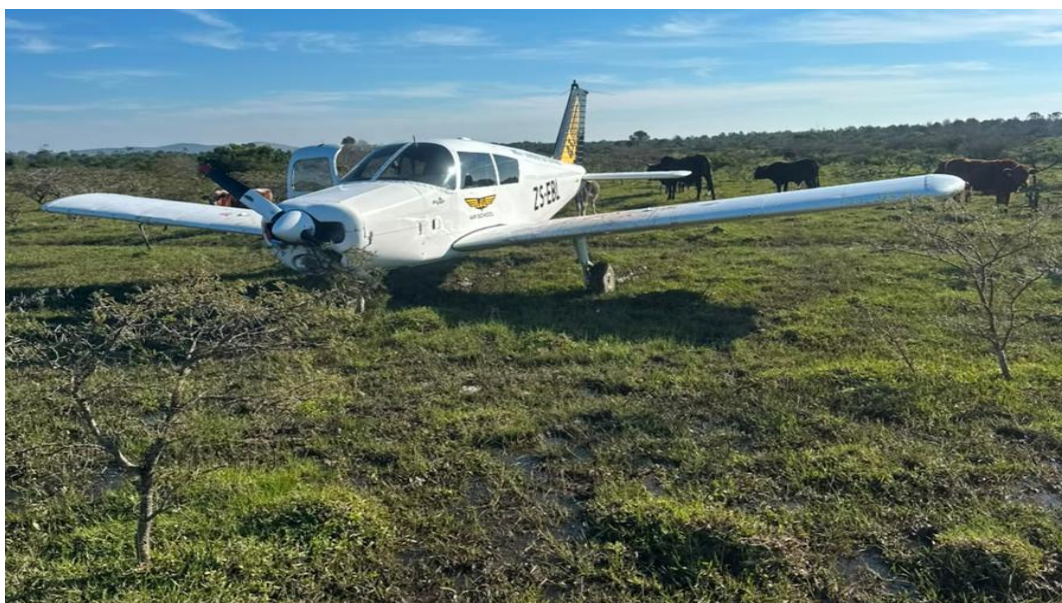
After the aircraft had stopped, the crew switched off the master switch and disembarked from the aircraft. The aircraft sustained minor damage, and none of the occupants was injured.

**Figure 2:** The aircraft after the serious incident. (Source: Operator)

The aircraft was inspected and the engine was run (started) on site. The aircraft was later recovered to the operator's maintenance facility at FAPA where the engine inspection was conducted by turning the propeller, which moved freely. Further assessments of external damage were conducted, and all was found to be in good condition. Moreover, an engine run-up check was carried out and the engine started normally; all engine parameters were met.
