**PRELIMINARY ACCIDENT REPORT**

**Accident and Incident Investigations Division**

Accident  
- Preliminary Report -  
AIID Ref No: CA18/2/3/10673

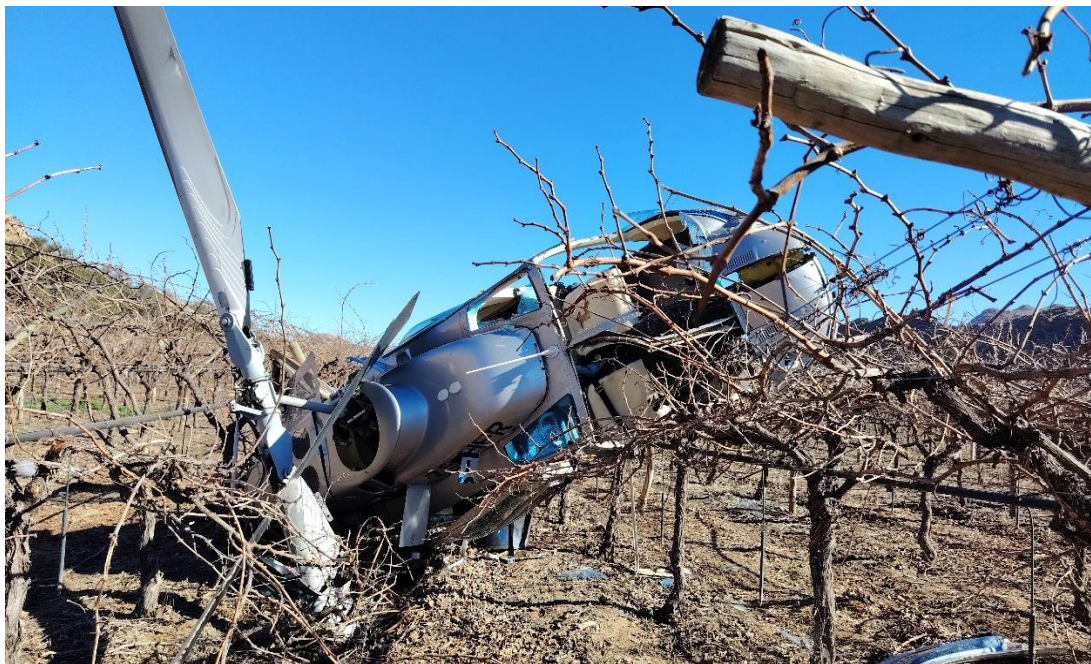
1.3.1. The helicopter was destroyed.

**Figure 3:** The wreckage of ZS-HFR.

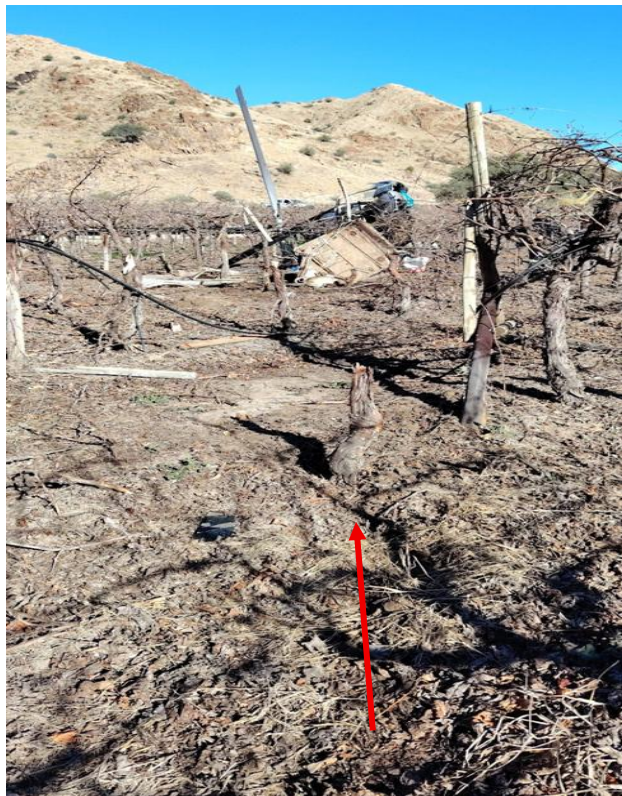
1.12.1. The time of accident was 0623Z on a grape vineyard at Karsten Boerdery in the Northern Cape. The helicopter impacted the ground in a nose-down attitude at an angle of approximately 45°. The distribution of the wreckage was consistent with a high-energy impact followed by structural separation of several components.

**Figure 4:** Initial impact on the ground. The red arrow indicates the direction of the helicopter after the impact.

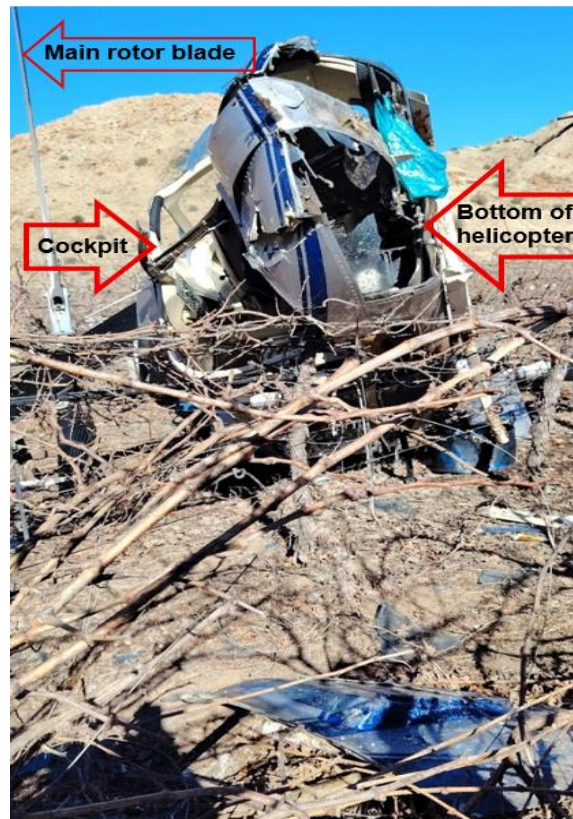
**Figure 5:** The damage pattern indicates that the helicopter impacted the ground in a nose-down attitude.

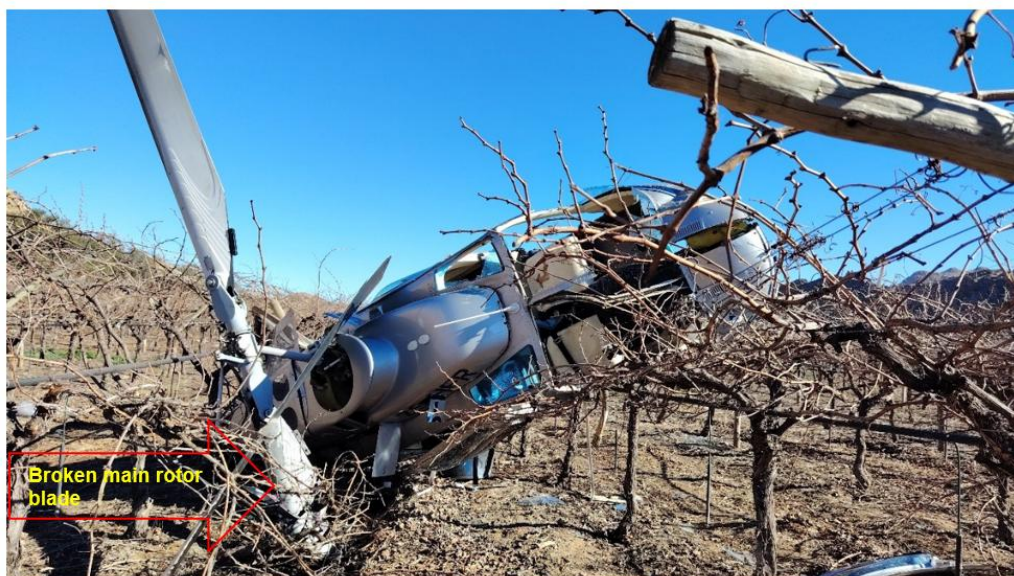
1.12.2. One of the main rotor blades struck the ground first and broke off whilst the other main rotor blade remained intact; as a result, the helicopter's nose impacted the vines. Both skids separated from the helicopter and the lower compartment containing the pesticide ruptured, spilling it (pesticide) to the ground.

**Figure 6:** The topside of the helicopter after it had rested.

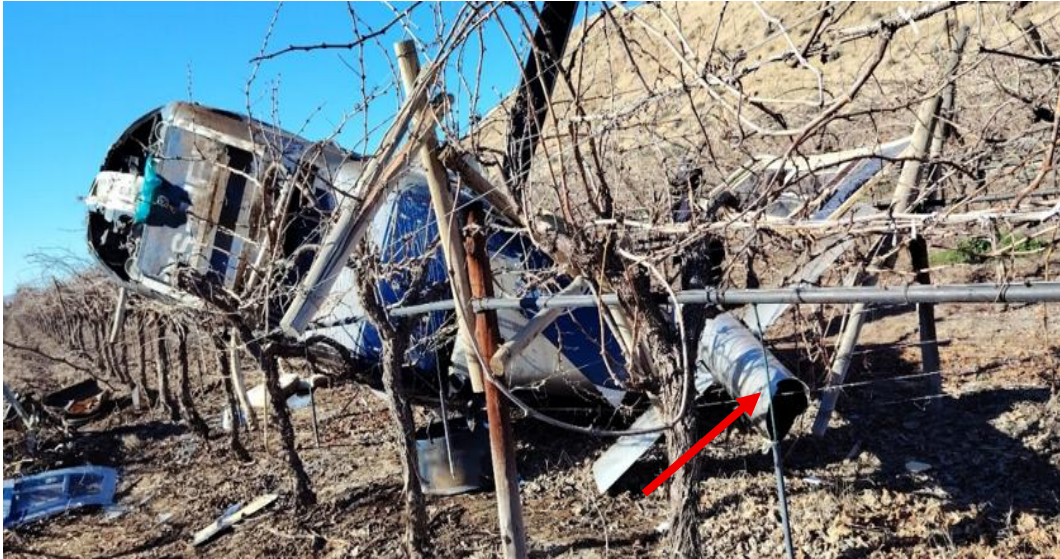
**Figure 7:** The bottom side of the helicopter; the red arrow points to the tail boom.

1.12.3. The tail boom was severed from the main wreckage. The remaining aft section showed signs of secondary damage near the tailfin (vertical stabiliser). The tail rotor assembly was found approximately 15 metres (m) from the main wreckage. During the impact sequence, the doors separated from the main wreckage and the windshield shattered. The helicopter came to rest on its right side.

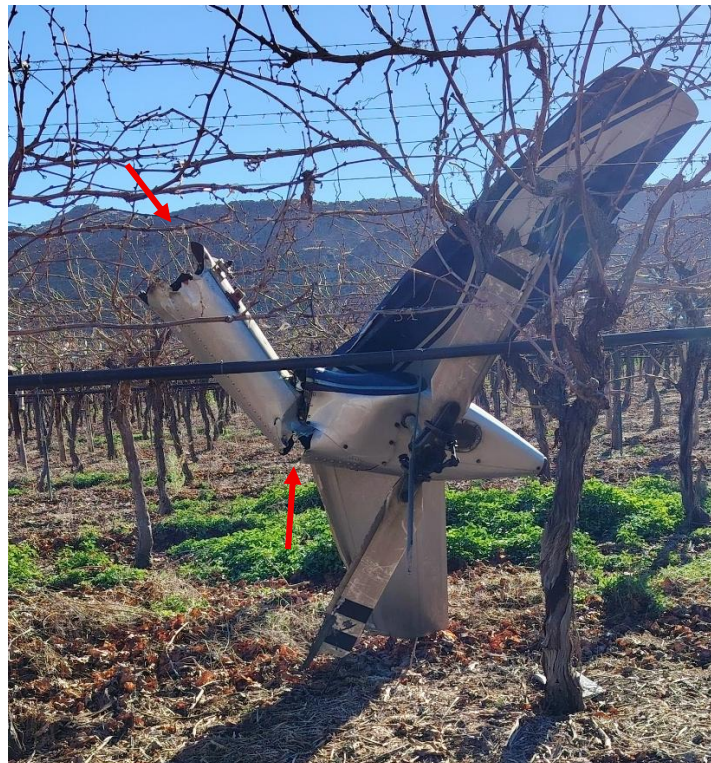
**Figure 8:** The tail rotor assembly found 15m from the main wreckage (the red arrows indicate the breakage points).

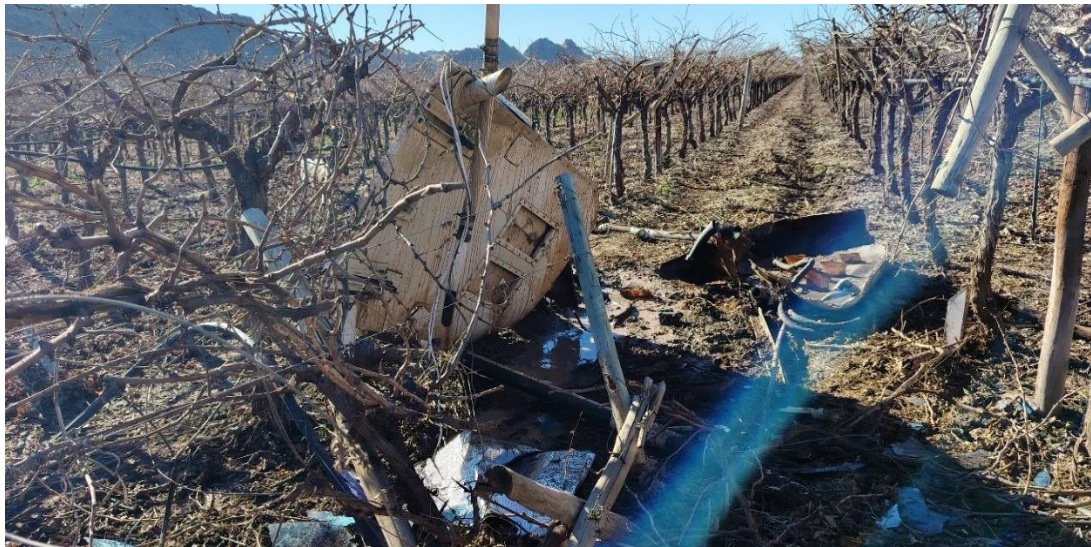
**Figure 9:** The lower compartment of the helicopter which housed the pesticide.
