**PRELIMINARY ACCIDENT REPORT**

**Accident and Incident Investigations Division**

Accident  
- Preliminary Report -  
AIID Ref No: CA18/2/3/10655

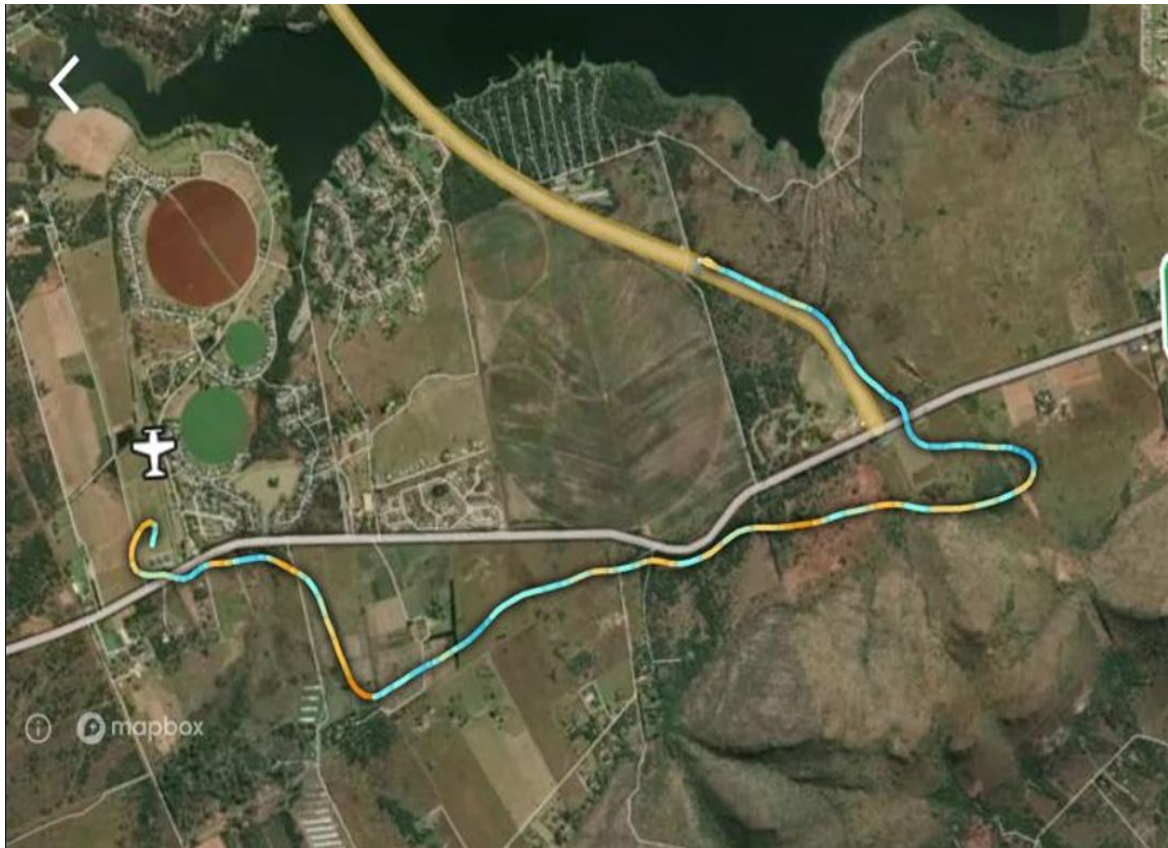
- 1.1.2. The paraglider pilot had difficulty launching the paraglider during the first two take-off attempts. He launched the paraglider successfully on the third attempt. The wind speed was north-north-east, gusting 8 knots (kts) with an air temperature of 22°C. According to the Gaggle Flight Recorder application used by the South African Hang-Gliding and Paragliding Association (SAHPA) for their flight tracking, the paraglider departed from the launch site at approximately 1347Z and proceeded east along the Regional Road 512 (R512). (*The Gaggle Flight Recorder primarily records GPS position, altitude, speed and live tracking of a flight path data in the form of video footage*). At approximately 1352Z, the paraglider turned left towards Hartbeespoort Dam, flying north along the right side of the R512 at about 63 kilometres per hour (km/h) and approximately 345 feet (ft) above ground level (AGL). The recorded flight path showed a descent to about 203ft with speed reducing to about 43 km/h. At approximately 1354Z, the paraglider's speed and height decreased rapidly during a sharp 90-degree turn to the left after which it impacted the ground on the left side of the R512.

**Figure 2:** The recorded flight path of the paraglider. (Source: SAHPA)

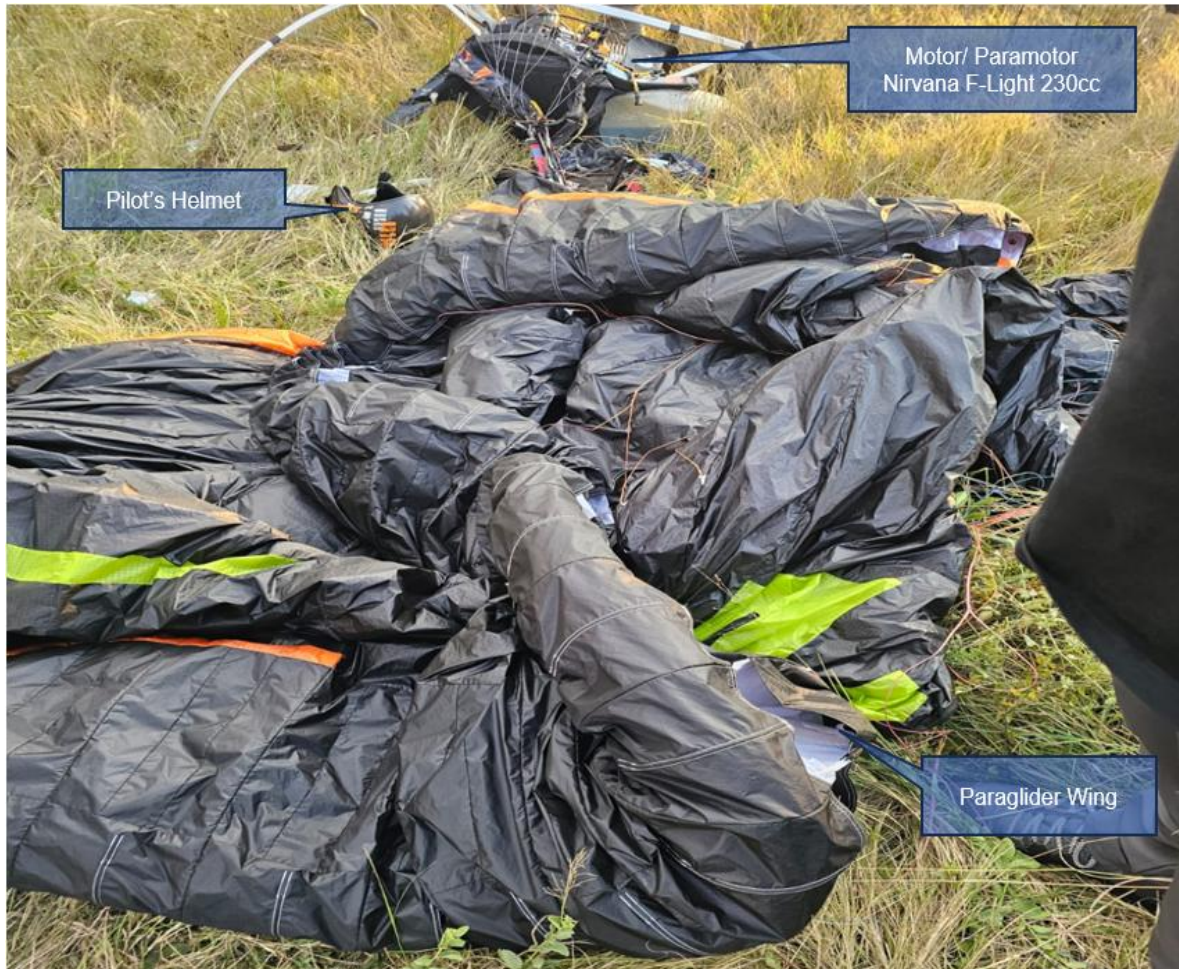
1.3.1. The motor-powered paraglider was substantially damaged during the accident sequence.

**Figure 3:** The damaged paraglider after the accident. (Source: First Responders)

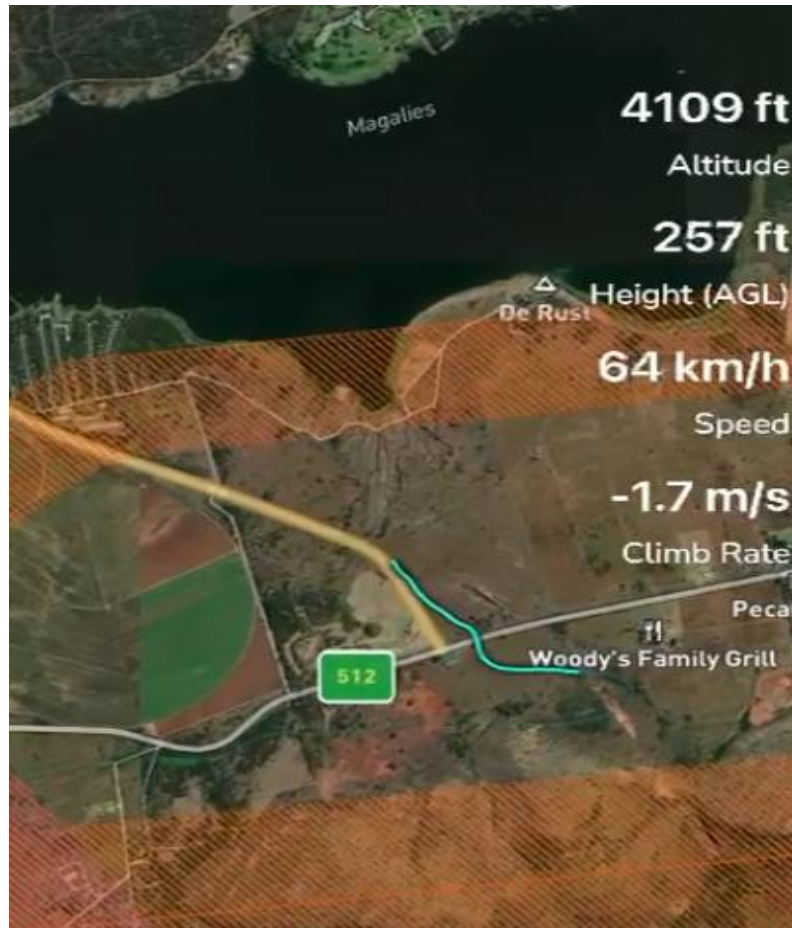
1.7.2. The weather conditions in the vicinity were characterised by thermal activity, gusty surface winds, cumulus cloud development and elevated wind speeds. Local pilots reported that the accident area was prone to rotor activity at low altitude. The Gaggle Flight Recorder track log and video footage indicated that the pilot descended to a lower altitude, likely to avoid stronger winds aloft and improve ground speed. The pilot's on-board video footage also showed evidence of thermal and rotor activity near the accident site.

**Figure 6:** Thermal in the vicinity around the accident site.  
(Source: Gaggle Flight Recorder Data Application)

1.7.3. Thermal activity during the flight was assessed from the recorded flight data and available video footage of the Gaggle Flight Recorder Application. Data showed active pilot input, including the use of the tip-steering handles, consistent with the pilot managing thermal lift and turbulence. Gaggle Flight Recorder Application data, including thermal strength, sink rate and G-force values, provided objective corroboration of the dynamic atmospheric conditions encountered during the flight.

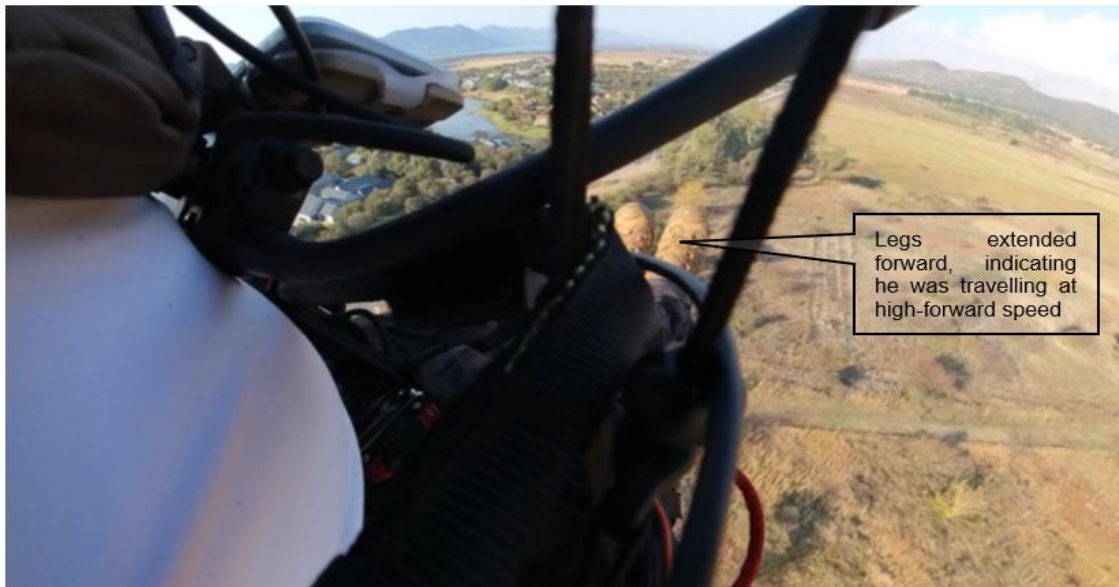
**Figure 8:** The picture shows the pilot with his legs extended forward, consistent with speed-bar position.

1.11.3. Approximately 1 minute and 06 seconds before the accident, the on-board camera showed the pilot with his legs extended forward, consistent with speed-bar usage. About a second before the initial collapse, the speed bar remained partially applied, estimated at 50% travel, and the trimmers were fully open at No.12 setting. The wing was, therefore, operating in an accelerated, high-speed configuration with reduced margin for recovery after collapse.

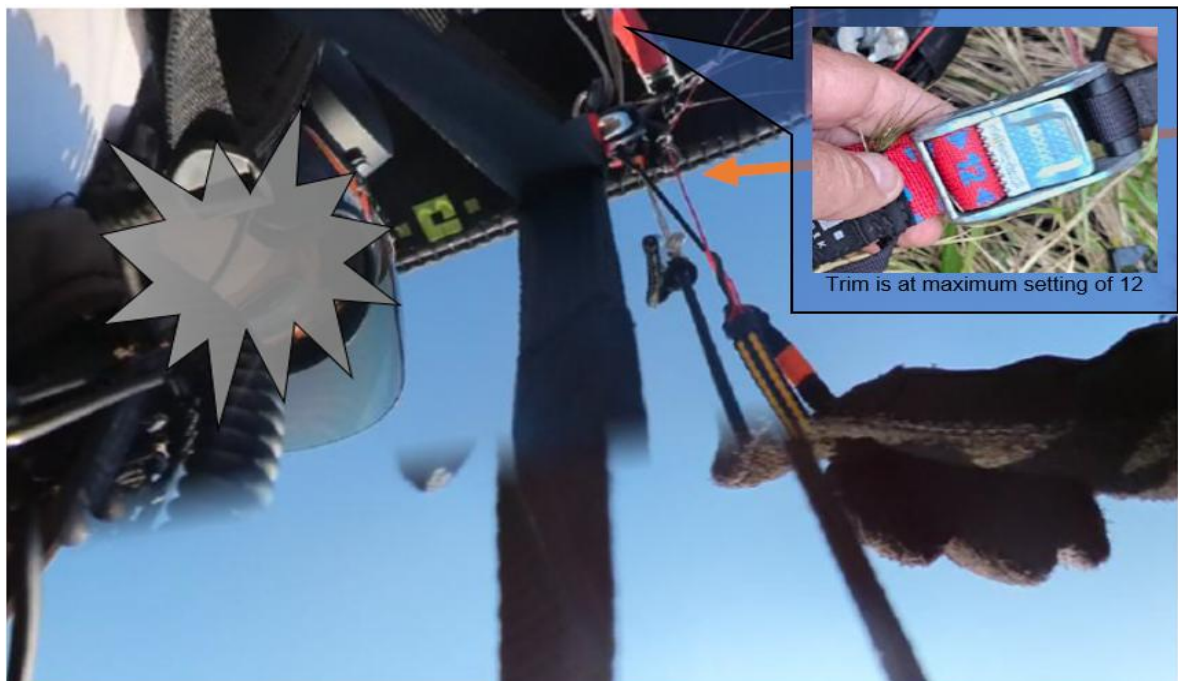
**Figure 9:** The pilot is observed flying a tip-steering pattern indicated by the yellow and black handle.

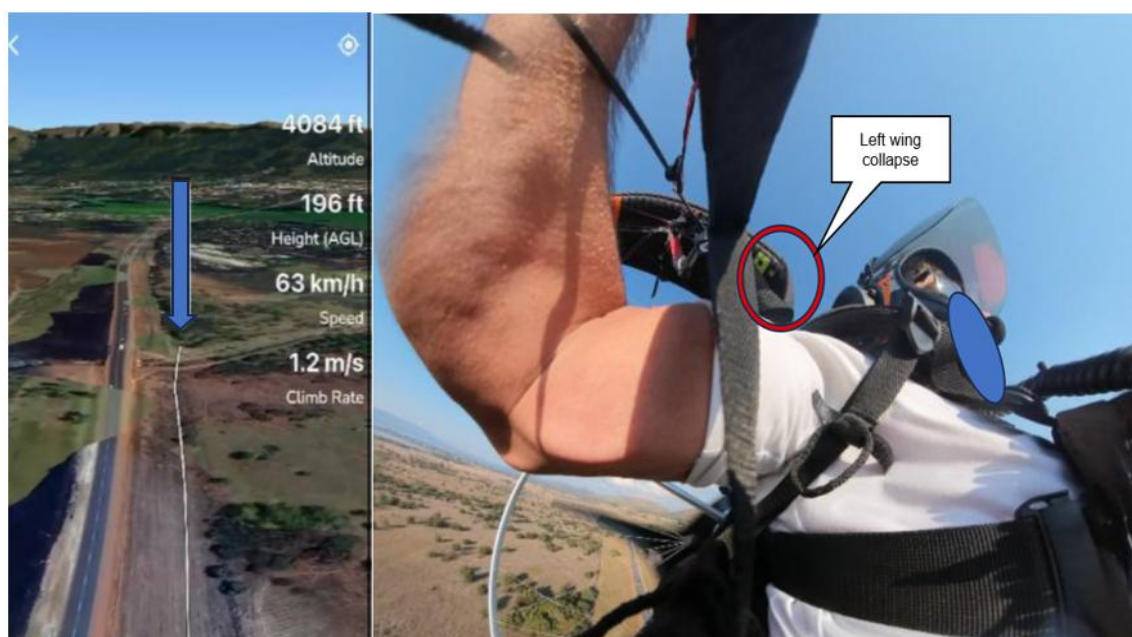
1.11.4. At 6:40.72, the first disturbance on the left wing was visible. The wing developed an asymmetric profile, consistent with the onset of a partial left-side tuck. The pilot remained on the speed bar and continued making inputs through the tip-steering handles. At 6:40.95, approximately 0.2 seconds later, the left side of the wing collapsed asymmetrically. The canopy folded inward and the wing began to fall rearward whilst the pilot was still in the accelerated configuration.

At 6:41.19, the pilot began releasing the speed bar whilst continuing to use the tip-steering handles with an estimated pull of about 300 millimetres (mm). *The left side of the wing was outside the camera view in Figure 8.* The wing pitched violently rearward and entered a rapid backwards-rotating attitude, consistent with an unrecovered asymmetric collapse in an accelerated trim configuration. At 6:41.45, the speed bar had been fully released, but the pilot was still applying tip-steering input. The wing had pitched rearward, the pilot's body was approximately 60° rearward relative to the horizon, and the wing had rolled left to an estimated 90° bank. The combined pitch, roll and collapse indicated a rapidly developing uncontrolled rotation.

**Figure 10:** The left-wing side edge begins to collapse.

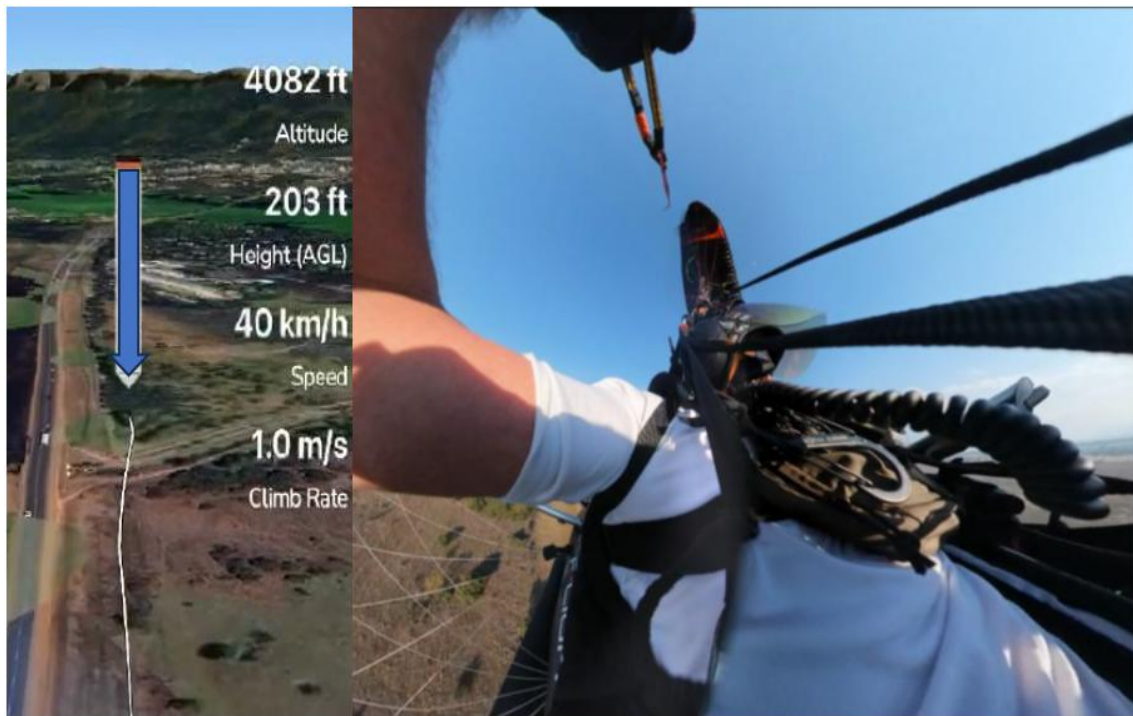
1.11.5. At 6:41.75, the wing partially re-inflated but did not return to controlled flight. Instead, it continued rotating, entered a steep left-diving trajectory and collapsed again. The flight path had changed from a rearward pitch rotation into a high-energy, left-diving rotating descent.

**Figure 11:** The wing is pulled (dragged) rearwards.

The initial left collapse sequence from onset to partial re-inflation lasted approximately 1 second. The re-inflation was not a controlled recovery; it was followed by further collapse and a steep left nose-down surge which aggravated the loss of control. At 6:41.92, the left side of the wing remained deflated; the wing-and-pilot system had entered a fully developed uncontrolled spin. The pilot's body had rotated almost opposite the wing's direction of travel. Engine power remained applied, which likely steepened and accelerated the descent.

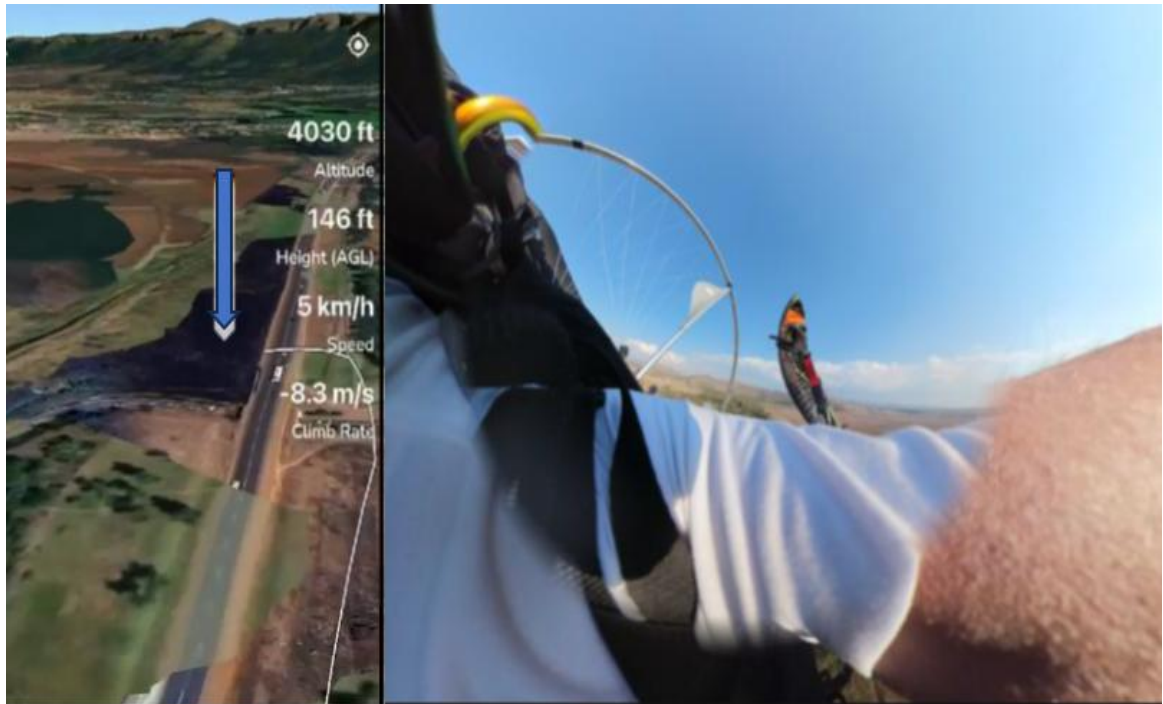
1.11.6. At 6:43.01, the wing recovered into an approximate 45° nose-down dive rather than a normal flight. The pilot was also oriented nose-down after the preceding spin. Engine power remained on, and the pilot continued applying tip-steering inputs whilst in the steep dive with a limited height for recovery.

**Figure 12:** The wing facing downwards at an almost uncontrollable attitude.

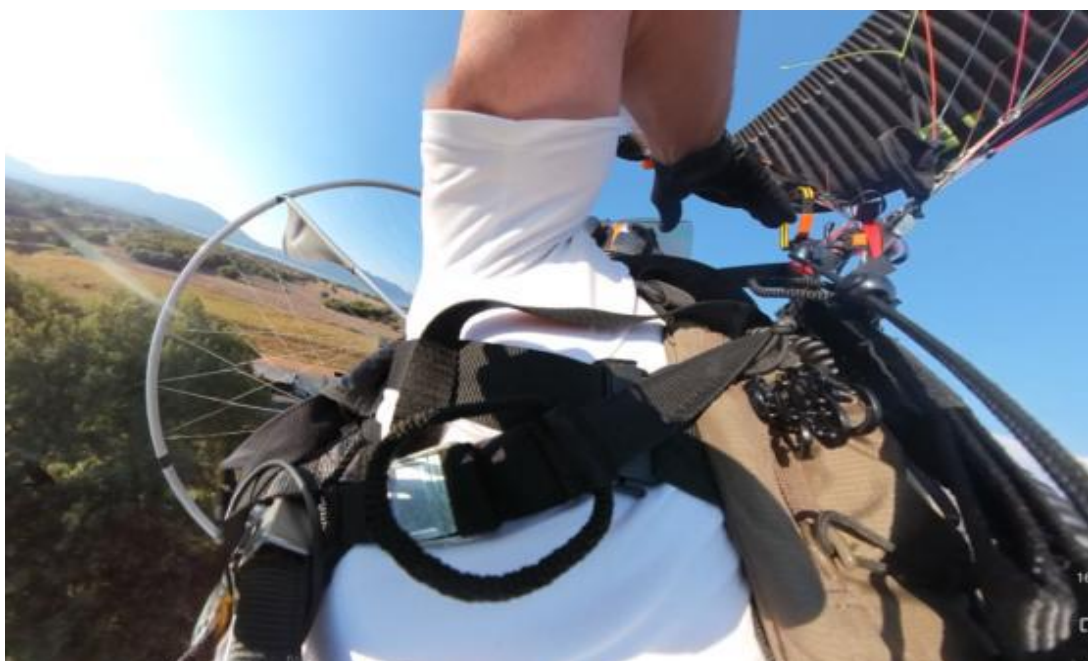
At 6:43.11, approximately 0.1 seconds after the partial recovery, the wing sustained a full symmetric collapse whilst already in a steep dive. Engine power remained applied, and the pilot was pulling the tip-steering handles with the visible input estimated at 450mm. *The pilot's left hand was outside the camera view and could not be assessed.* At 6:43.47, the pilot's left hand became visible holding the throttle. Significant pull on the tip-steering lines was apparent. The pilot had progressed to a near-vertical, ground-facing attitude with engine power still applied. At this point, the combination of collapse, thrust, attitude and low altitude was unrecoverable for the paraglider.

**Figure 13:** The pilot is seen with his hand free from the controls and the wing at a steep dive.

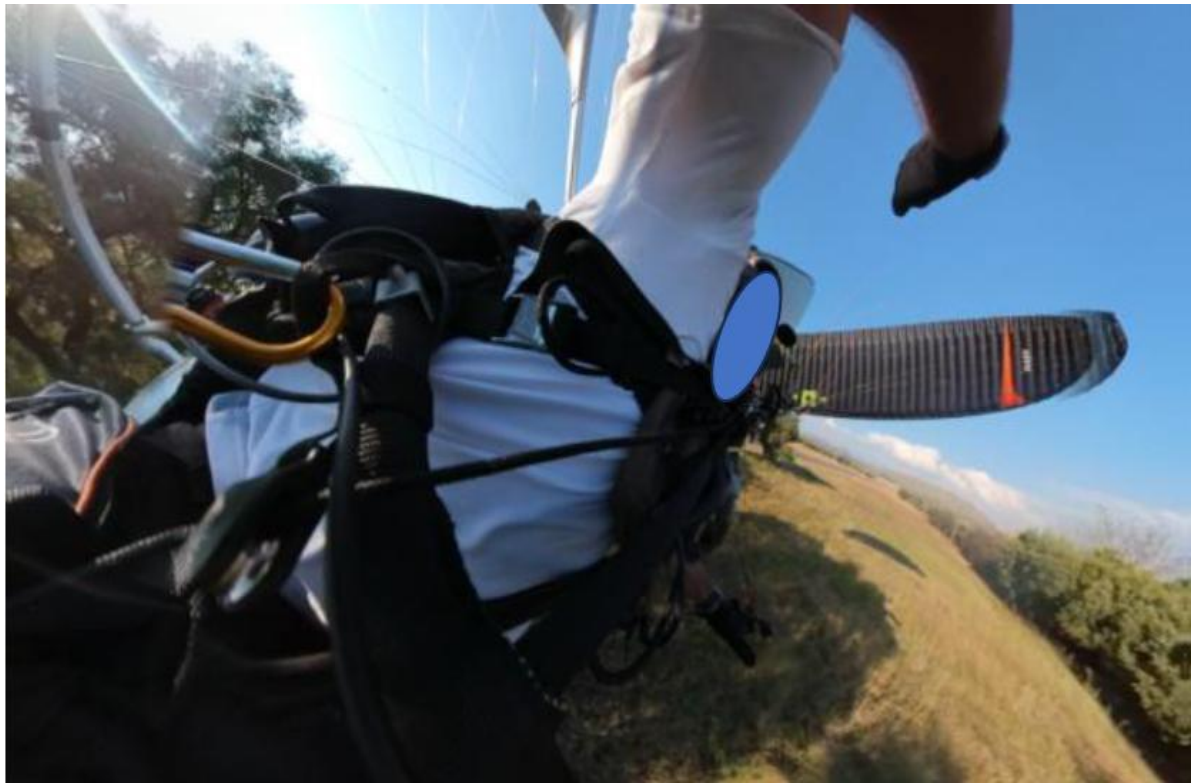
1.11.8. At 6:46.70, the wing appeared nearly fully inflated but remained in an almost horizontal nose-down dive. The pilot was facing toward the ground and was between 60° and 90° opposite the wing's heading. Ground contact was imminent and no altitude remained for corrective action. At 6:46.85, the wing and pilot contacted the ground almost simultaneously. The wing was in a nose-down attitude. The pilot impacted predominantly on the left side at approximately 45° to the ground, consistent with the video footage, first responder observations, and physical evidence at the accident site. At 6:46.93, the pilot was seen on the ground and on his left side while still holding the left tip-steering handle and throttle. Although the pilot had released the right tip-steering handle at 6:44.80, the footage indicated that he tried to re-engage them during the final seconds of descent in an apparent last corrective attempt.

**Figure 14:** The pilot and the wing nearing the ground before impact.

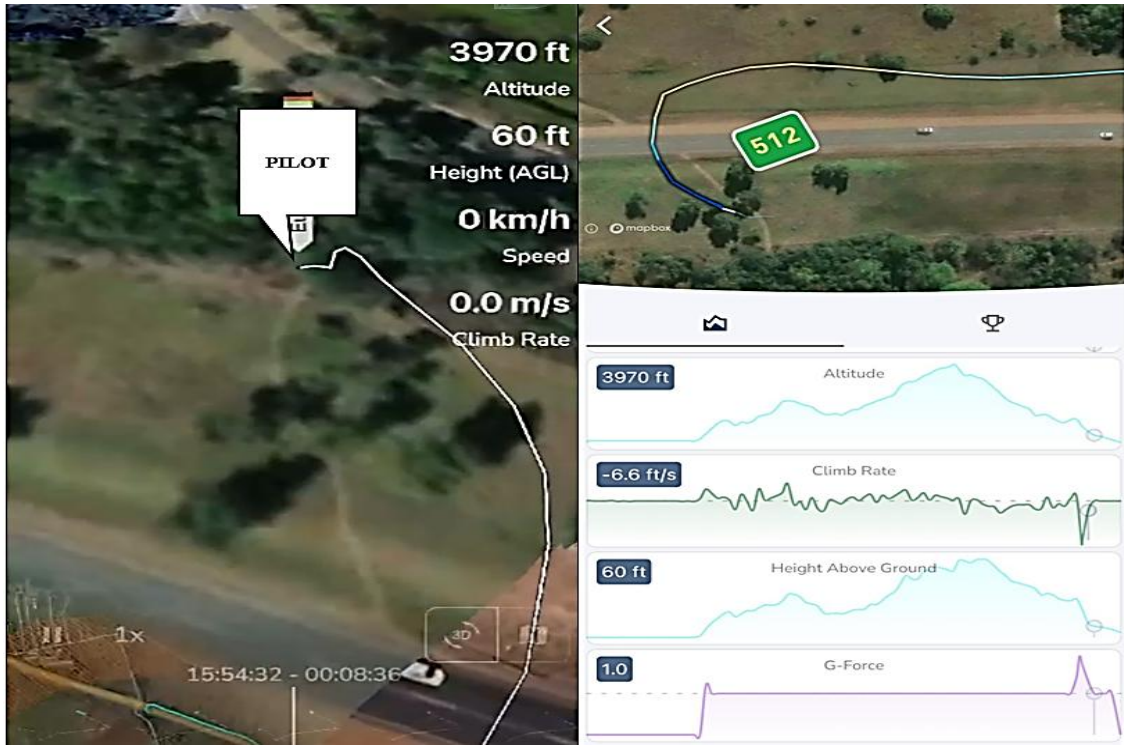
1.12.1. The paraglider accident site was located approximately 25m from the left edge of the R512 near Hartbeespoort Dam, North West province. The impact occurred in an open area after a sharp left turn with reduced forward speed. The site consisted of overgrown grass with a few trees within a 10m radius.

**Figure 15:** The flight recording leading to the accident.

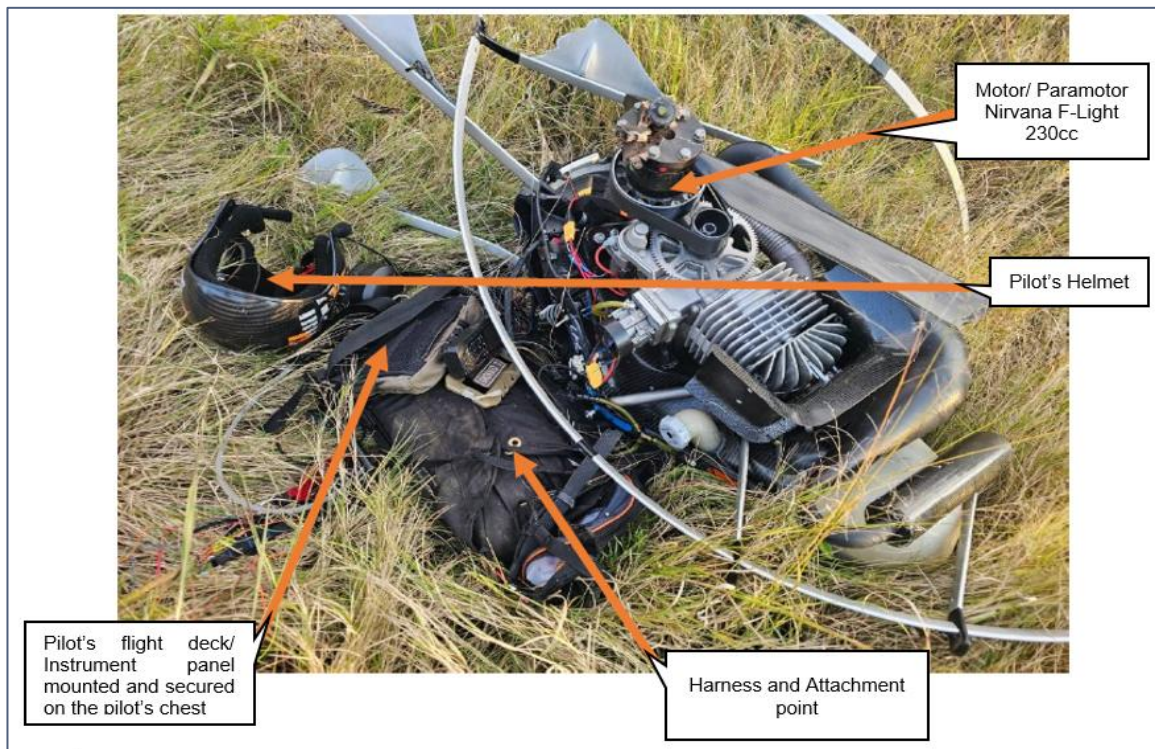
The wreckage was concentrated within a radius of approximately 10m, consistent with a near-vertical, high-angle descent into terrain. This pattern indicated an uncontrolled dive from height, with minimal or no forward speed, and aligns with the recorded flight data. The impact signature, ground strike pattern, and single-point wreckage concentration further supported this assessment.

**Figure 16:** The paraglider motor and the canopy.

- 1.12.3. The paramotor securing fan was destroyed, and all three propeller blades had separated from the propeller hub, consistent with the forces generated during the impact sequence.

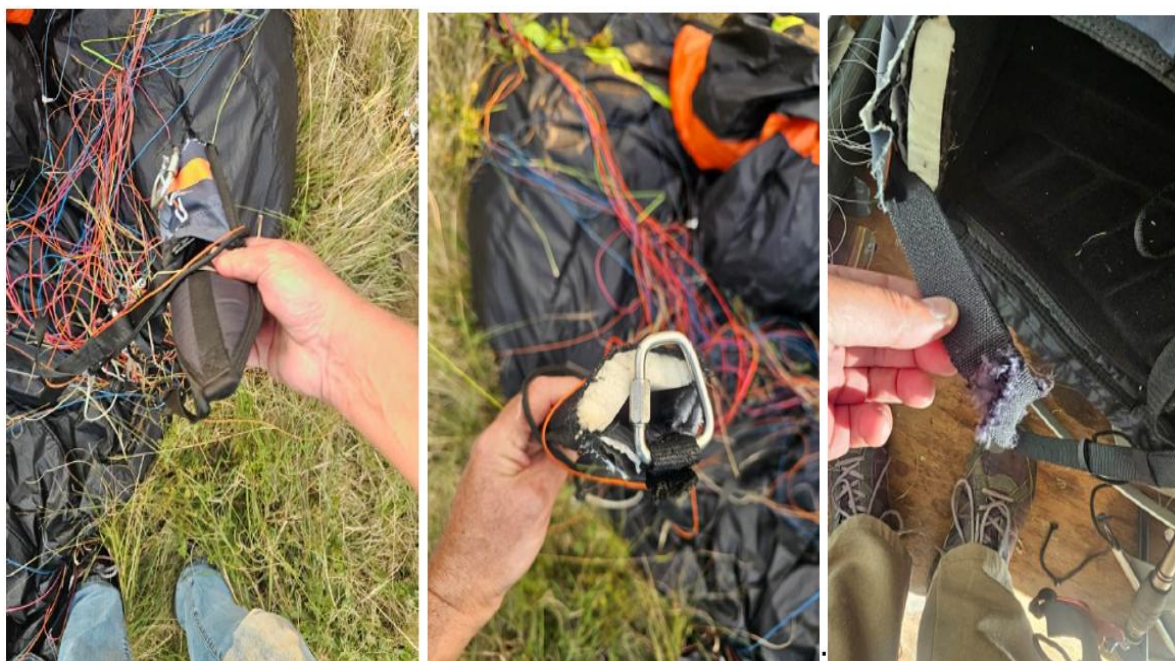
- 1.12.4. The pilot's harness and associated attachment points, including the carabiners connecting the wing to the harness, were examined. It was established that the first responders had cut the harness to rescue the pilot, and to administer cardiopulmonary resuscitation (CPR). The severed components included the left and right shoulder straps, chest strap, abdominal strap and both leg straps. These alterations were identified and accounted for during the on-site investigation.

**Figure 17:** Cut-off harnesses by first responders: shoulder, leg straps and the stomach harnesses.

- 1.12.5. Notwithstanding the post-impact cutting off of the harnesses, examination of the remaining attachment points and structural components revealed no evidence of in-flight structural failure or separation. This was subsequently corroborated by available video footage which showed the harness and attachment points remaining intact throughout the recorded portion of the flight.

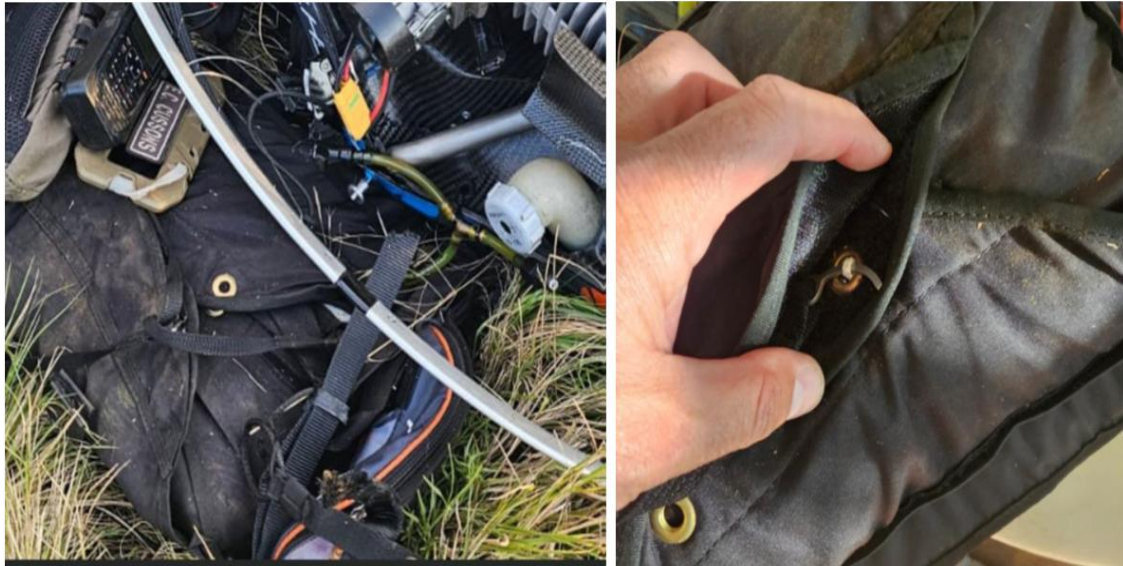
**Figure 18:** The reserve parachute with one securing pin missing.

1.12.6. The reserve parachute housed in a container beneath the harness seat remained within its deployment bag. Examination of the reserve parachute assembly revealed that one of the two safety pins was displaced from its retention position, and the deployment handle was loose and detached from its normal attachment point on the harness. The reserve parachute container remained closed, and the canopy did not deploy. Available evidence indicated that no attempt was made to deploy the reserve parachute before or during the accident sequence. It could not be determined whether the displaced safety pin and detached deployment handle resulted from impact forces or if they existed before the accident. This aspect remains under investigation.

1.15.2. The paraglider was equipped with a reserve parachute fitted to the paramotor harness. At the accident site, the reserve parachute was found undeployed and remained in its deployment bag. One of the two safety pins was displaced, and the deployment handle was loose and detached from its secured position on the harness seat area.

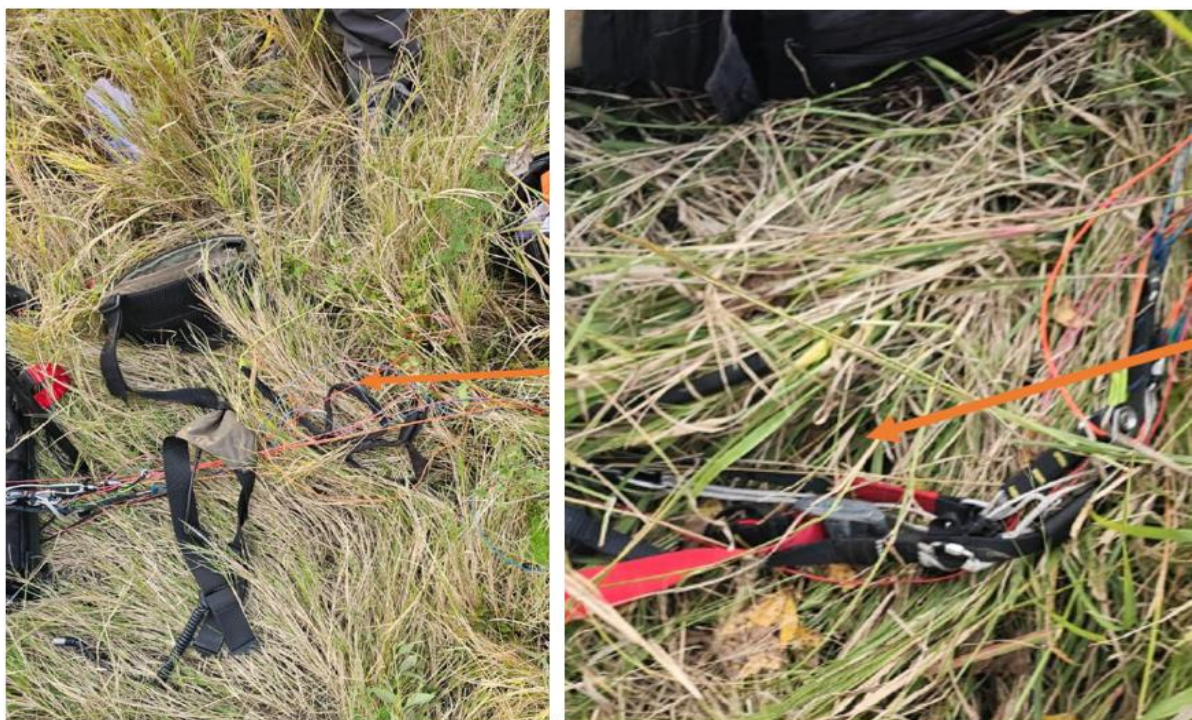
**Figure 19:** The cut straps, brake handle, wing riser strap and the speed.

1.12.7. The brake handles were found cut at the accident site. The wing risers remained attached to both the paramotor unit and the harness and had not been cut or interfered with during the first responder extraction procedure. Physical examination of the risers and associated carabiners revealed no evidence of structural damage, deformation or in-flight failure. All components appeared intact at the time of examination.

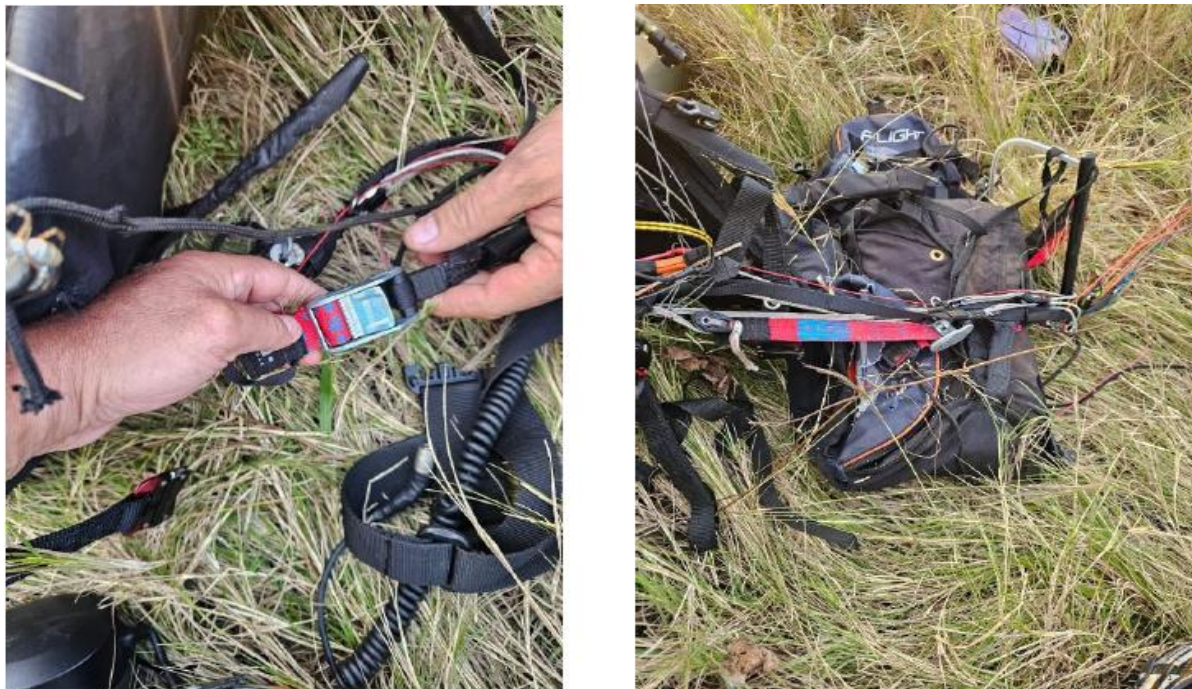
**Figure 20:** The wing riser trimmers were set to a maximum position No.12 as indicated.

1.12.8. Upon examination, the wing riser straps were found partially beneath the pilot's body at the accident site, having been cut by the first responders during the emergency extraction procedure. Notwithstanding the post-impact cutting of the riser straps, a thorough examination of all accessible riser components and carabiners revealed no indication of any structural damage, deformation or in-flight failure. All attachment hardware appeared intact and serviceable at the time of examination. The wing trim and the wing riser trim were both found on fully open for high-speed and low-angle-of-attack configurations.

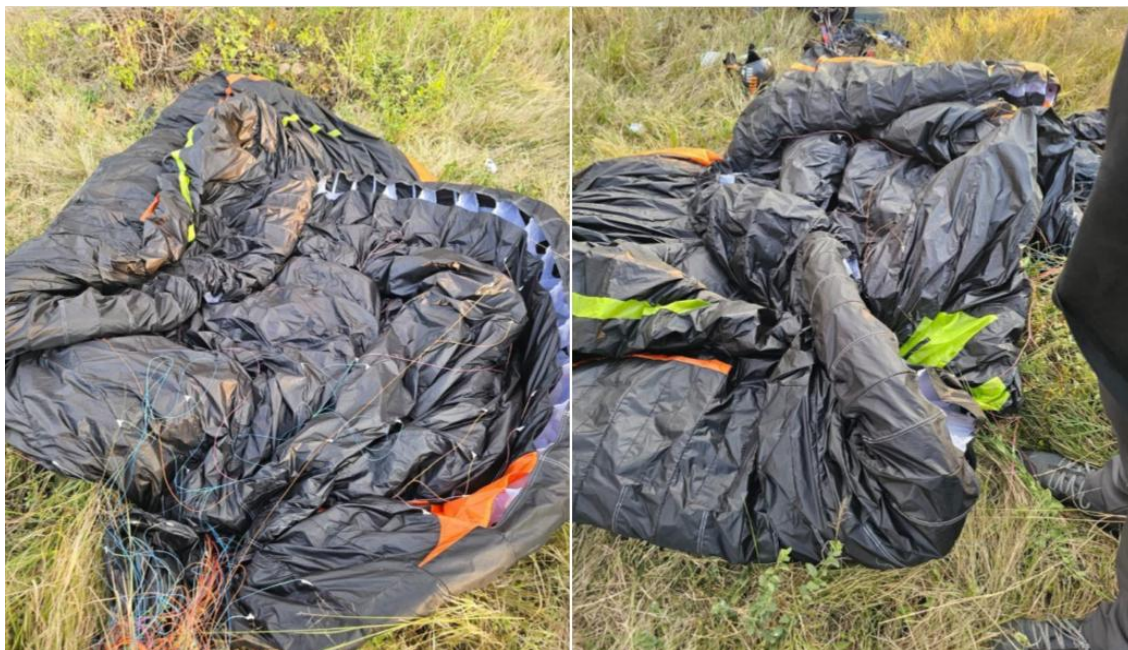
**Figure 21:** The wing after it was moved after the accident.

1.12.9. The wing was moved from its position after impact as it was used to cover the pilot's body. The wing inspection revealed no damage.
