**PRELIMINARY SERIOUS INCIDENT REPORT**

Serious Incident  
- Preliminary Report -  
AIID Ref No: CA18/3/2/1550

On 11 May 2026, an Airbus A320 aircraft with registration ZS-SZE, operated as a scheduled passenger flight SA327, departed from O.R. Tambo International Aerodrome (FAOR) to Cape Town International Aerodrome (FACT) with six crew members and 137 passengers on-board.

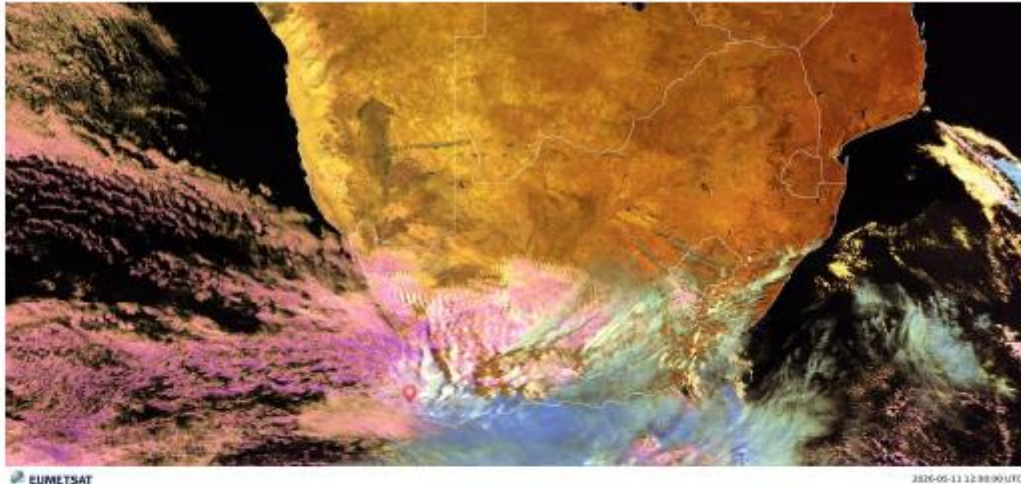
The MeteoSat Third Generation (MTG) Cloud Phase RGB satellite imagery was taken at 12:00 Z on 11 May 2025, which is when the incident has been reported to have occurred. A cold front system was moving past the area of incident resulting in a mixture of clouds around FACT (red location pin). The cloud phase RGB shows pinkish to yellowish clouds in FACT, which are indicative of thick water clouds with a mixture of small and large water droplets (Figure 2). Severe mountain waves can also be observed in the vicinity with corrugated patterns of the clouds.

Figure 2: The MeteoSat Third Generation (MTG) Cloud Phase RGB satellite imagery was taken at 12:00 Z on 11 May 2026 (copyright Eumetsat).

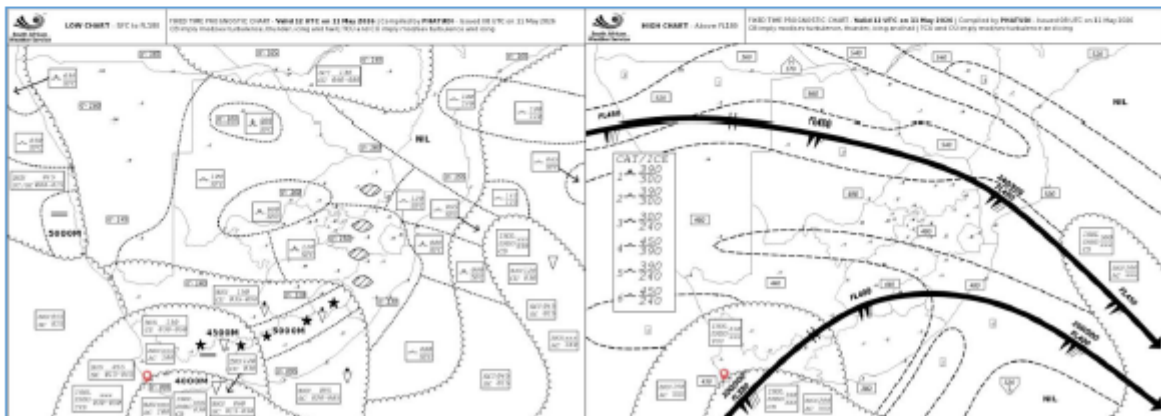
The Significant Weather (SigWx) low-level and high-level charts below are valid for 12:00Z which was when the incident occurred (Figures 4). FACT is in an area where a mixture of significant clouds were expected at 12Z. Broken Stratocumulus clouds with bases as low as 1500-4500 ft were expected, together with broken Altopcumulus (ACs) clouds with bases of 10 000ft and isolated embedded Towering Cumulus (TCUs) clouds as well as isolated embedded Cumulonimbus (CBs) clouds at 3000-5000 ft which inherently pose a hazard of moderate to severe turbulence and icing. Visibility was expected to reduce to 4000 m due to showers and rain while the freezing level was expected to be at 9500 ft.

Figures 4: The 12:00 Z low-level and high level SigWx charts for 11 May 2026.

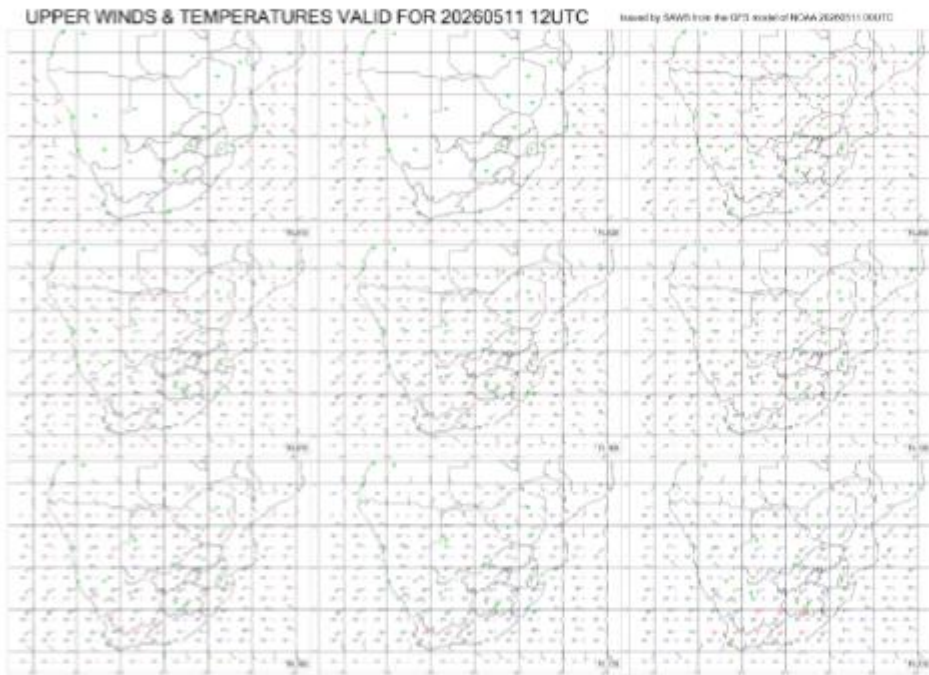
Figure 5: Upper winds and temperature forecasts valid till 12:00Z

Unfortunately there was no afternoon upper air ascent done on this day to verify the wind-flow above the surface.

The forecasted wind was 290 degrees at 05/10KT at 6000 feet based on the previous night Numerical Weather Products model run.
