PRELIMINARY ACCIDENT REPORT

Accident and Incident Investigations Division

Accident
- Preliminary Report -
AIID Ref No: CA18/2/3/10640

Reference Number : CA18/2/3/10640
Occurrence Category : Accident (Category 1)
Type of Operation : Agricultural Operations (Part 137)
Name of Operator : Natal Aerial Spray
Aircraft Registration : ZS-XAP
Aircraft Make and Model : Air Tractor (AT-502A)
Nationality : South African
Place : Qwaggavlake Farm, north-west of Wesselsbron
Date and Time : 25 February 2026 at 1252Z
Injuries : Fatal
Damage : Destroyed

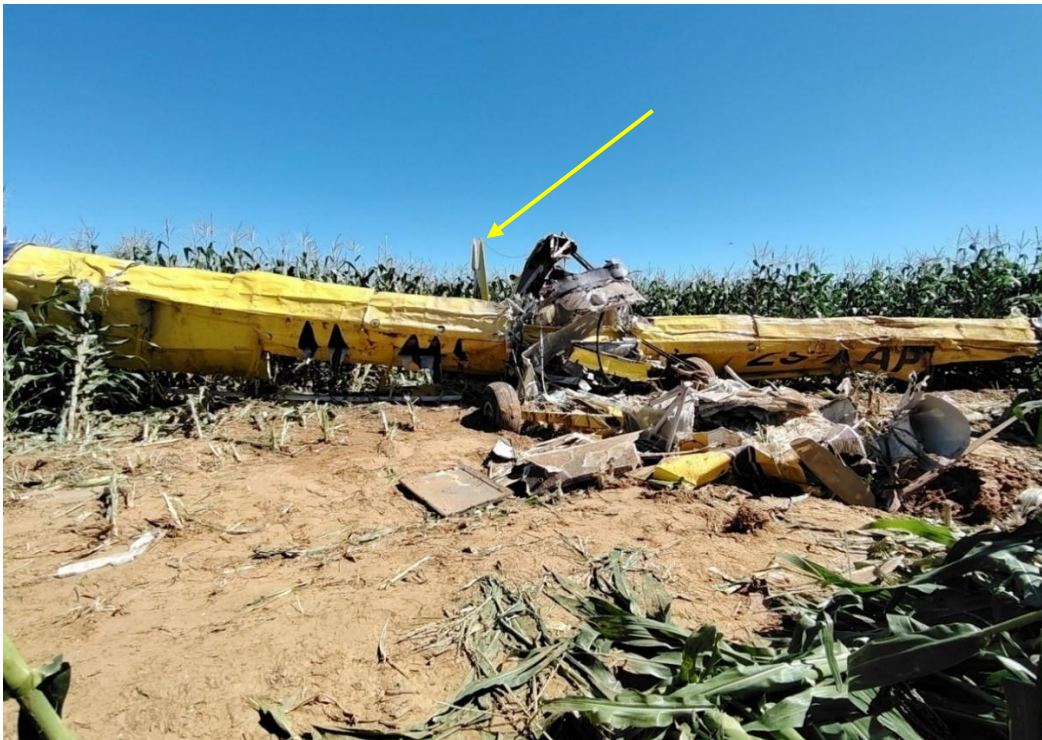
1.3.1. The aircraft was destroyed.

Figure 3: The aircraft at the accident site with the tail protruding between the maize crops (yellow arrow).

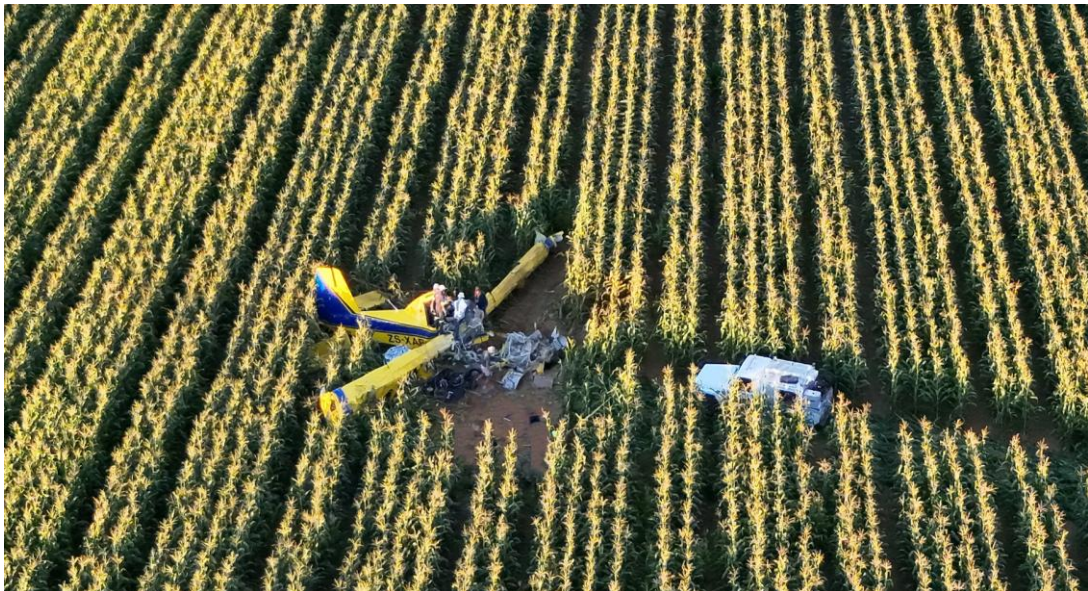
1.12.1. The accident occurred at 1252Z on a maize field in Qwaggavlake Farm, north-west of Wesselsbron. Evidence at the site indicated that the aircraft impacted the ground in a nose-down attitude. After impact, the leading edges of both wings contacted the ground. The left-wing fuel tank ruptured and fuel spilled out. The hopper tank also ruptured, and the remaining insecticide spilled out. The aircraft came to rest in an upright position facing east.

Figure 4: An aerial view of the aircraft at the accident site.
(Source: Drone from the farming community)

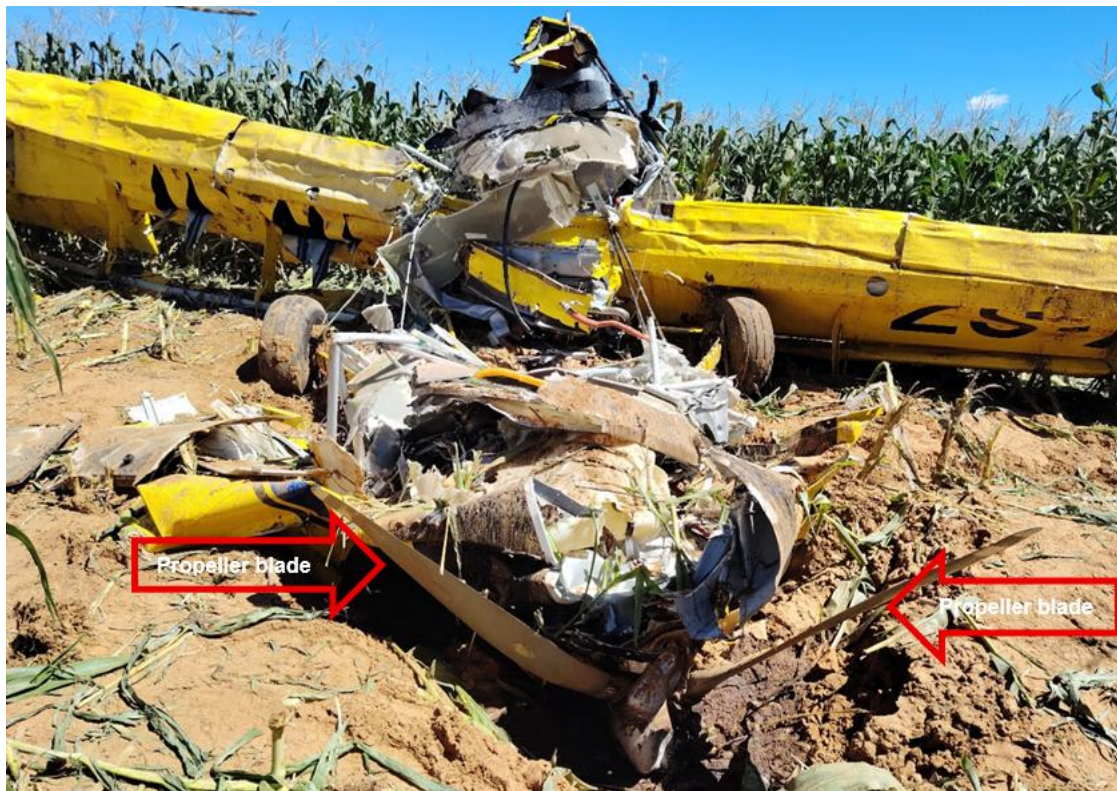
1.12.2. All components of the aircraft were accounted for at the accident site. The front portion of the aircraft was destroyed by impact forces, and the leading edges of the wings were flattened (see Figure 6). The cockpit/cabin was damaged. Only two of the four propeller blades were intact. The spray boom equipment had remained attached to the fuselage. The aft part of the fuselage and empennage sustained minimal damage.

Figure 5: The front portion of the aircraft and the two propeller blades that had remained intact.

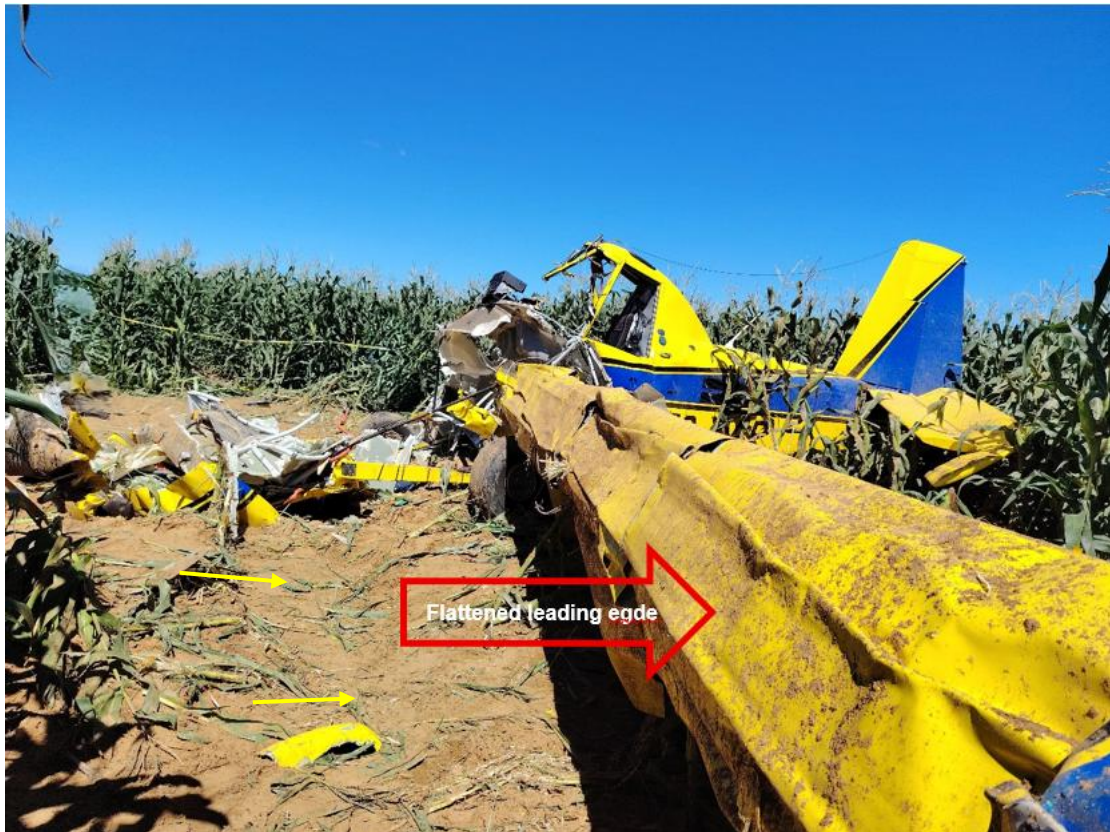
Figure 6: The flattened leading edge of the left wing and the impact mark on the ground (yellow arrows).
