PRELIMINARY ACCIDENT REPORT

Accident and Incident Investigations Division

Accident
- Preliminary Report -
AIID Ref No: CA18/2/3/10644

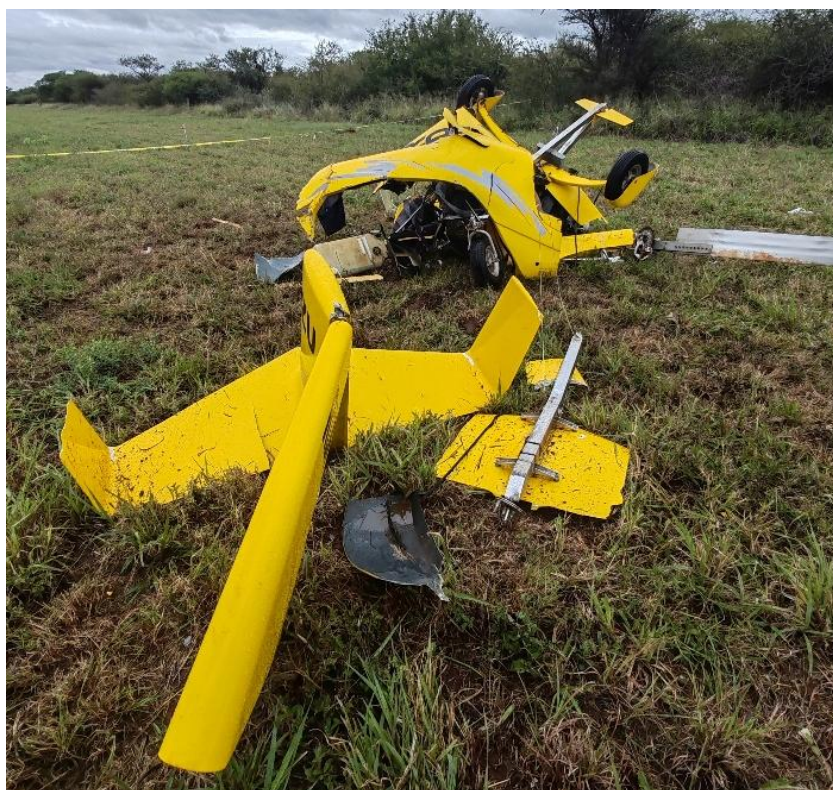
1.3.1. The aircraft was destroyed during the accident sequence.

Figure 3: The wreckage at the accident site.

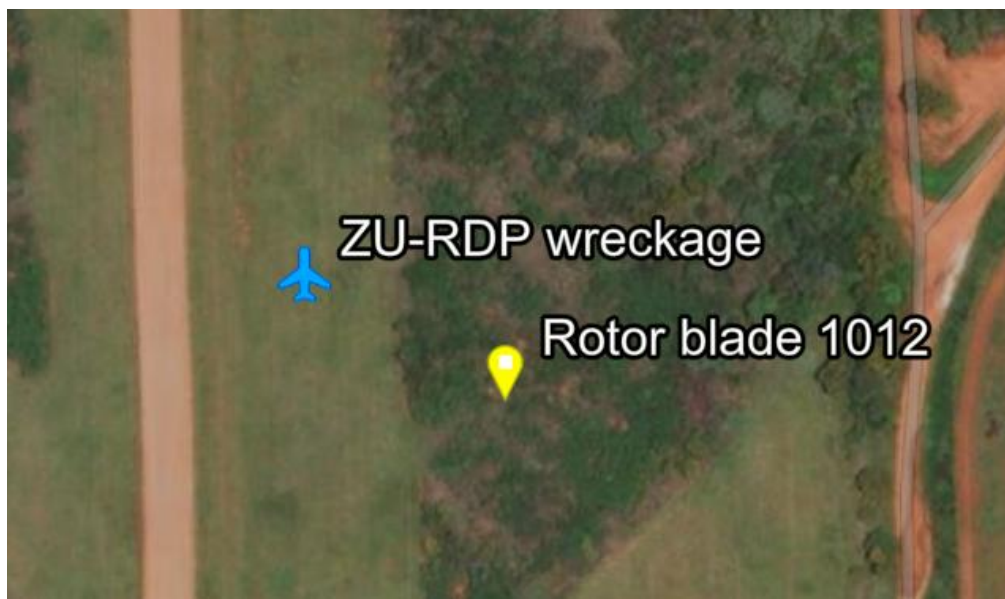
Figure 4: The aerodrome layout and the approximate area where the separated blade was found (yellow pin).

- 2.2.7. The main rotor blade with serial number 1012 broke off in-flight near the rotor hub bar and the detached portion of the blade was found in a bushy terrain approximately 205ft south-east of the main wreckage. The failed piece of the main rotor blade was recovered for further analysis.

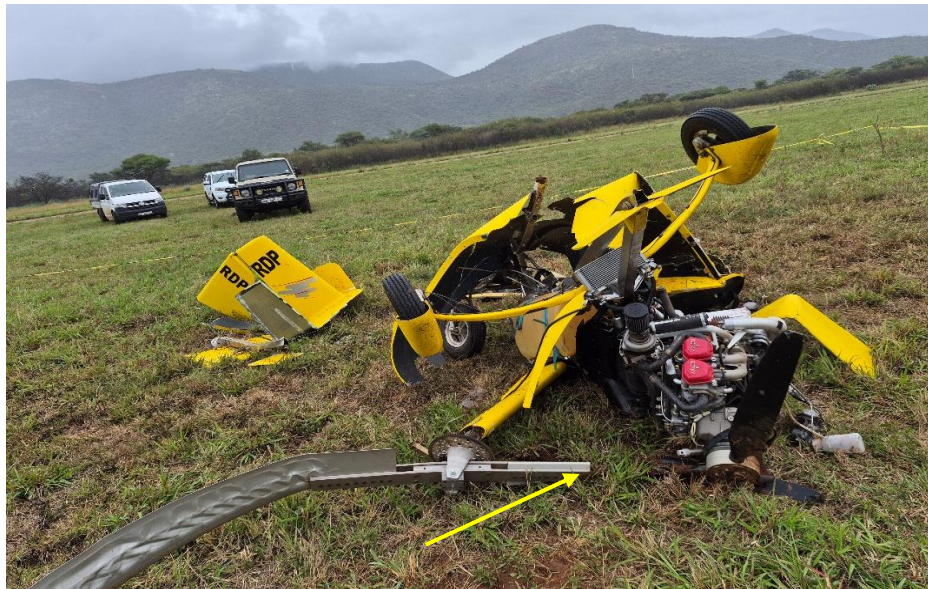
1.12.1. The aircraft impacted the ground in a low forward speed and at a low angle with a high rate of descent and a heading of approximately 19°. On the main wreckage, the investigators noticed that one of the main rotor blades with serial number 1012 had broken off in-flight near the rotor hub bar; the detached portion of the blade was found in a bushy terrain approximately 205ft south-east of the main wreckage. Impact marks were observed on the leading edge. By placing the detached blade opposite the cabin, it was observed that the longitudinal extent of the impact zone on the blade corresponded to the location of the parts found (farther from the main wreckage).

1.12.2. These observations led to the conclusion that the rotor blade hit the gyrocopter's right front section in-flight, as well as the pilot's body. Examination of the rotor control linkage revealed several ruptures at the rotor control fork, as well as damage at the fixed connection point between the rotor control fork and the rotor. Other examinations of the wreckage did not reveal any other damage prior to ground impact. The propellers indicated that the engine was producing a substantial amount of power at impact.

Figure 5: The wreckage at the accident site and the main rotor blade that failed (yellow arrow).

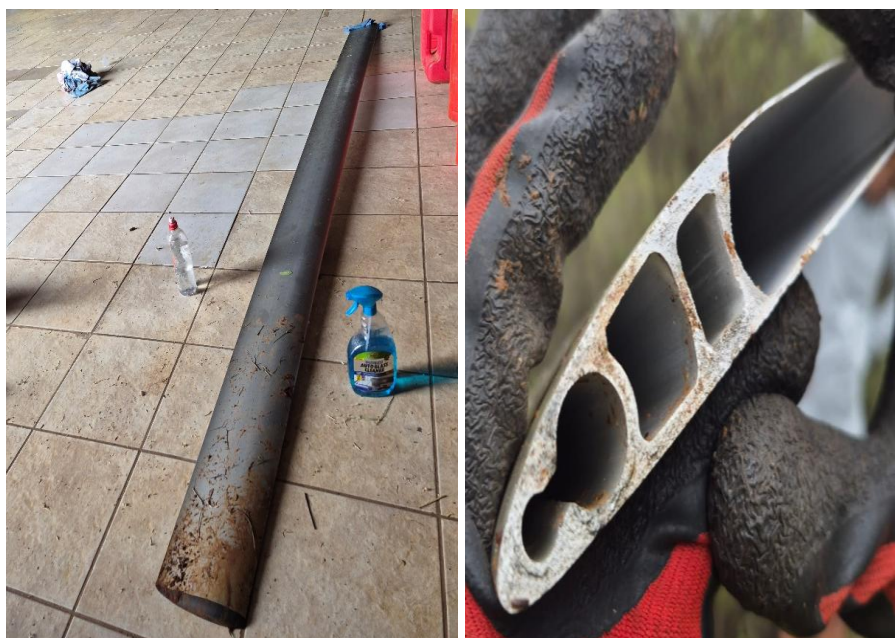
Figures 6 and 7: The portion of the main rotor blade that broke off (left picture). The close-up picture of the blade and the area where it snapped (right picture).
