AIRCRAFT ACCIDENT REPORT AND EXECUTIVE SUMMARY

Reference:	CA18/2/3/10097			
Aircraft Registration	ZS-NRJ	Date of Accident	3 January 2022			Time of Accident	0610Z	
Type of Aircraft	Jetstream 41			Type of Operation		Commercial (Part 121)		
Pilot-in-command Licence Type	Airline Transport Pilot Licence (ATPL)		Age	42		Licence Valid	Yes	
Pilot-in-command Flying Experience	Total Flying Hours			6 851.0		Hours on Type	2 136.9	
First Officer	Commercial Pilot Licence (CPL)		Age	34		Licence Valid	Yes	
Pilot-in-command Flying Experience	Total Flying Hours			2 401.6		Hours on Type	510	
Last Point of Departure	O.R. Tambo International Airport (FAOR), Gauteng Province							
Next Point of Intended Landing	Venetia Mine Airfield (FAVM), Limpopo Province							
Damage to Aircraft	Substantial							
Location of the accident site concerning easily defined geographical points (GPS readings if possible)								
On Runway 08 at FAVM and at Global Positioning System (GPS) co-ordinates determined to be 22°26'54.69" South 029°20'13.68" East, at an elevation of 2 333 feet (ft)

Reference Number : CA18/2/3/10097
Occurrence Category : Category 1
Type of Operation : Commercial (Part 121)
Aircraft Registration

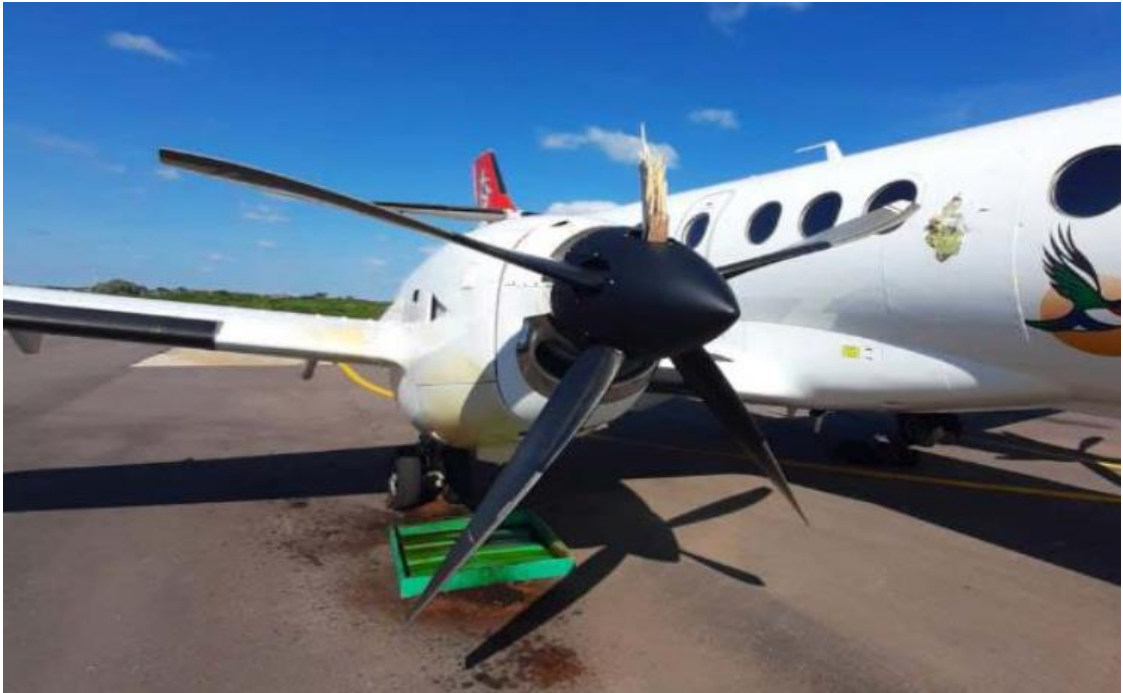
1.3.1. The aircraft was substantially damaged during the accident sequence.

Figure 2: Damage to the propeller.

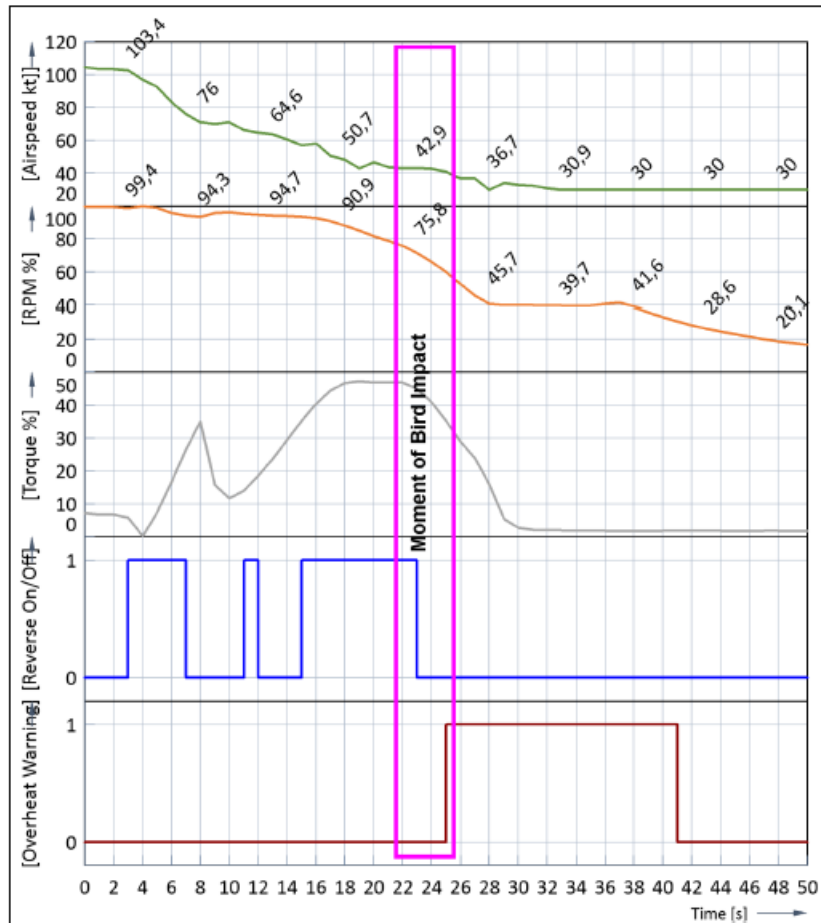
- *The actual bird strike case with an approximately 18kg (40lb) bird exceeded the certification envelope of the airplane and propeller by at least factor five and was not able to withstand a force of up to approximately 3.6kg (8lb). The extremely low collision speed with a slow-moving bird in combination with the low propeller speed and reverse blade angle is unusual and the resulting unfavourable impact angle contributed to the extent of damage on the propeller.*

- The graph above shows that when the bird collided with the right-side (RH) propeller, the airplane was already on the ground. The affected engine was in “reverse mode” with a negative blade angle, with 50-35% reverse torque and approximately 76% (1180RPM) propeller speed. The collision occurred at a speed of approximately 43kts.

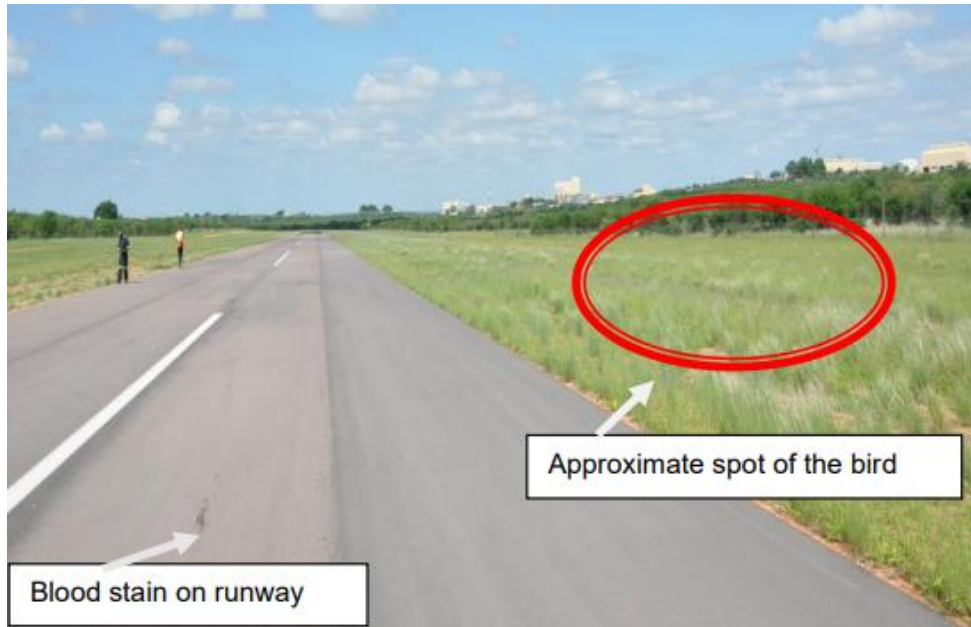
1.12.1. During the landing roll phase, a Kori Bustard bird got airborne from the right-side of the runway with overgrown grass and flew in the direction of the aircraft. Thereafter, the bird collided with the right propeller blade of the aircraft. One of the propeller blades was severed near the root, and the blade fragments penetrated the fuselage and caused damage inside the cabin.

Figure 5: The approximate location where the bird took flight.

4.2.1. The accident could have been avoided had there been adequate personnel to monitor and deter birds foraging in the grass next to the runway. Thus, it is recommended that there should be an addition of adequately trained staff during aircraft operations to monitor wildlife and aircraft operations.

4.2.2. It is also recommended that a mock runway (a cleared patch covered with grass) be prepared for birds to fly to when chased from the active runway while there are aircraft operations.

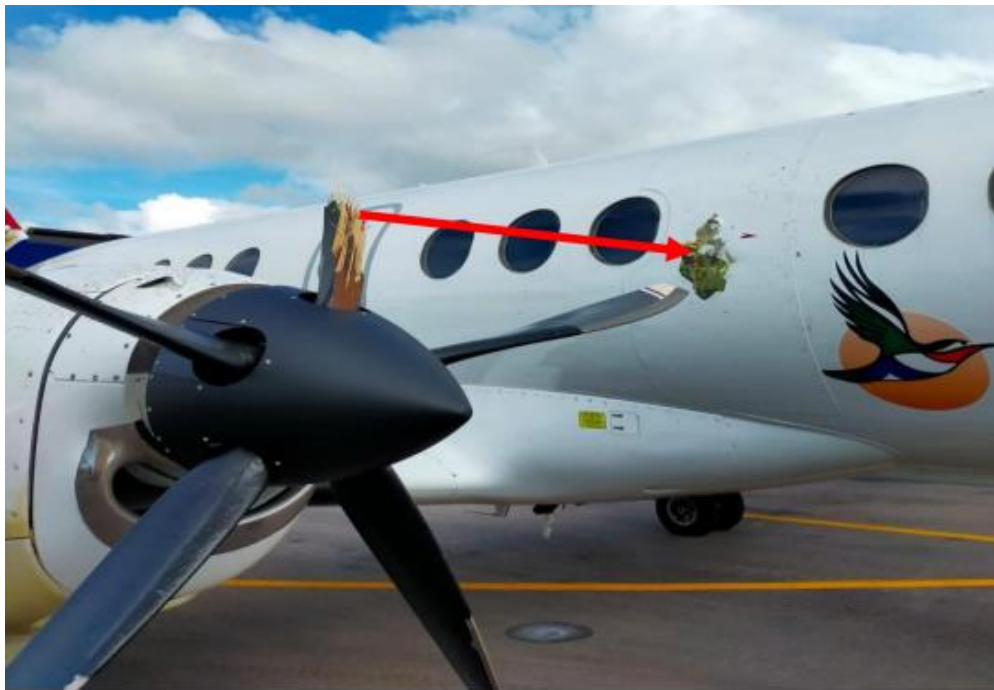
Figure 6: Fragments of the propeller blades penetrated the fuselage.

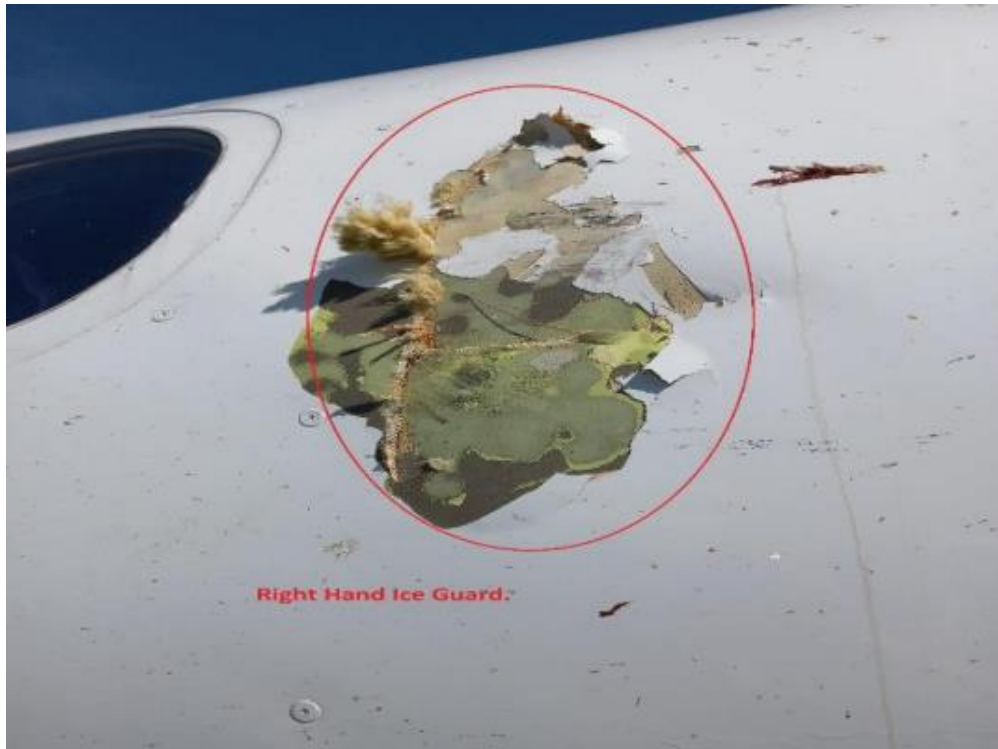
Figure 7: The damaged fuselage.

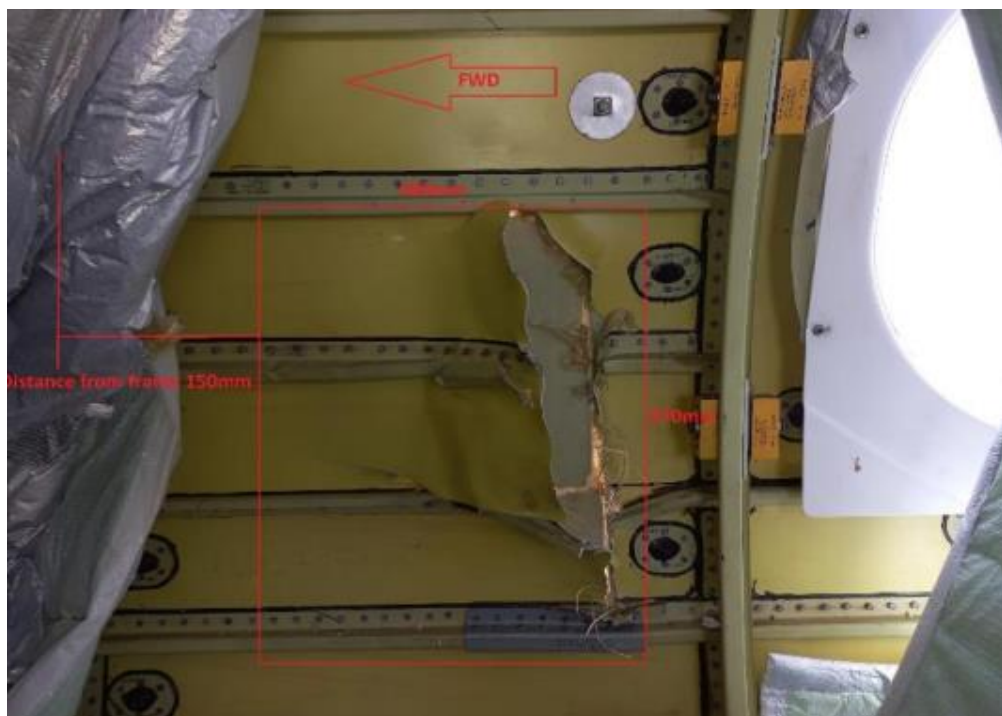
Figure 8: Damage to some of the stringers.

1.12.2. Some fragments of the propeller blade penetrated the fuselage and damaged some of the stringers just below the seat track. Minor damage was noted on the seat track area and extensive damage was on the DADO panel. The front outboard engine mount failed.

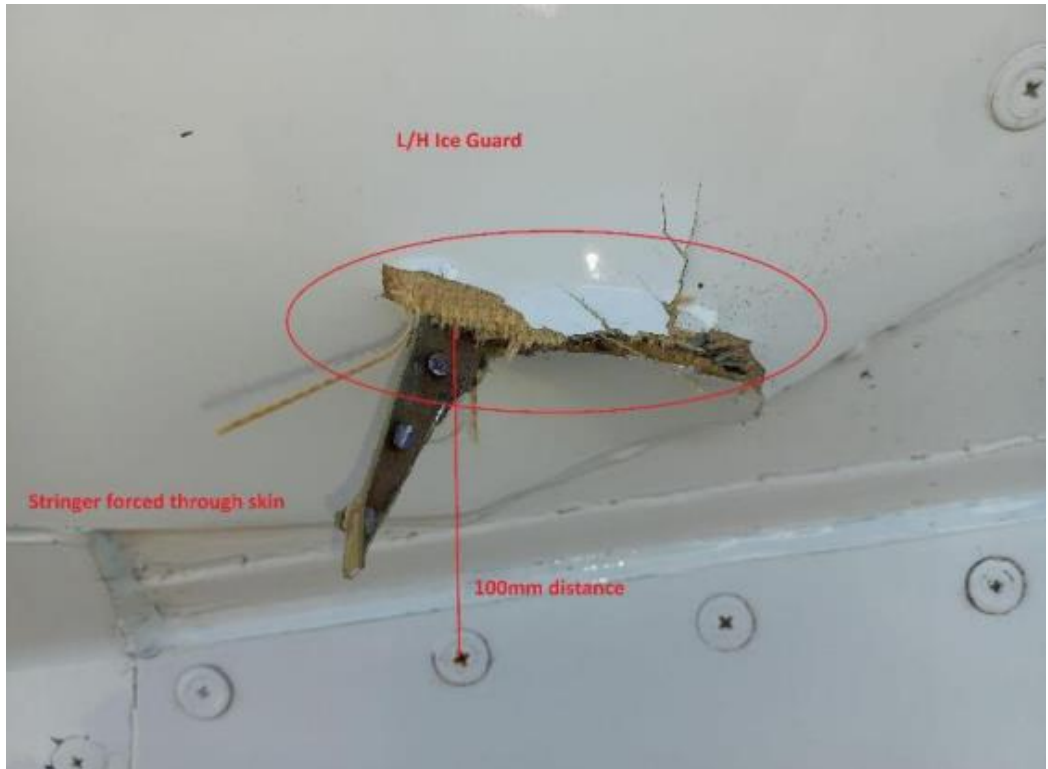
Figure 9: The left-side of the fuselage.

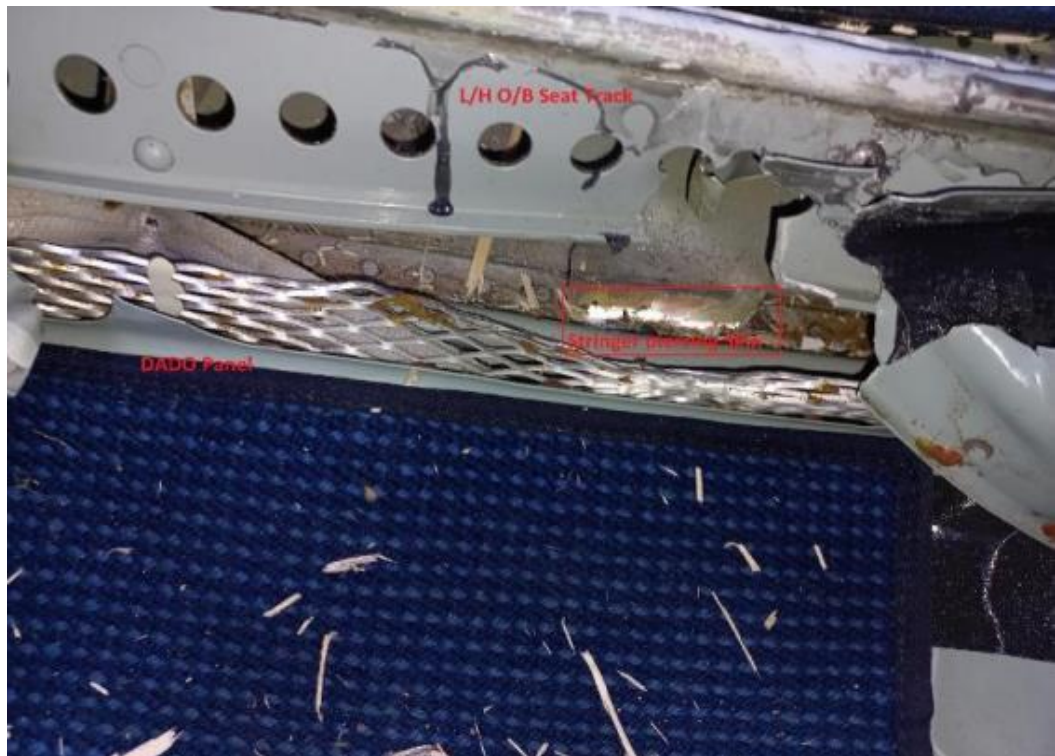
Figure 10: The interior left-side of the fuselage.

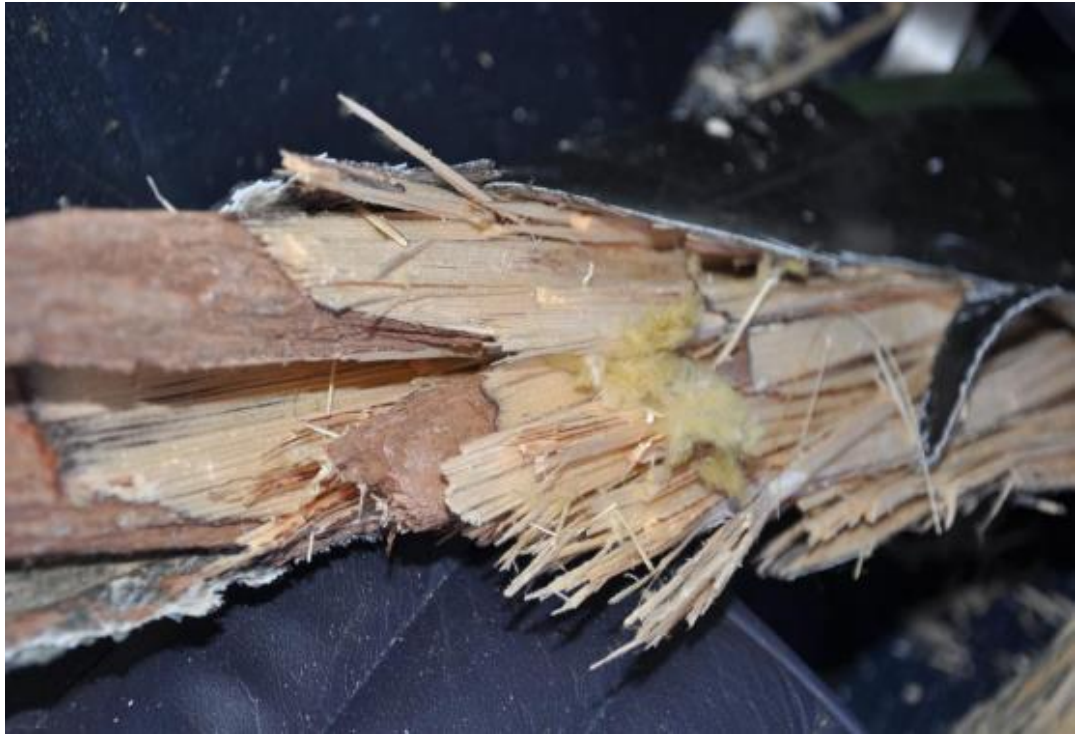
Figure 11: Fragments of the propeller blade.

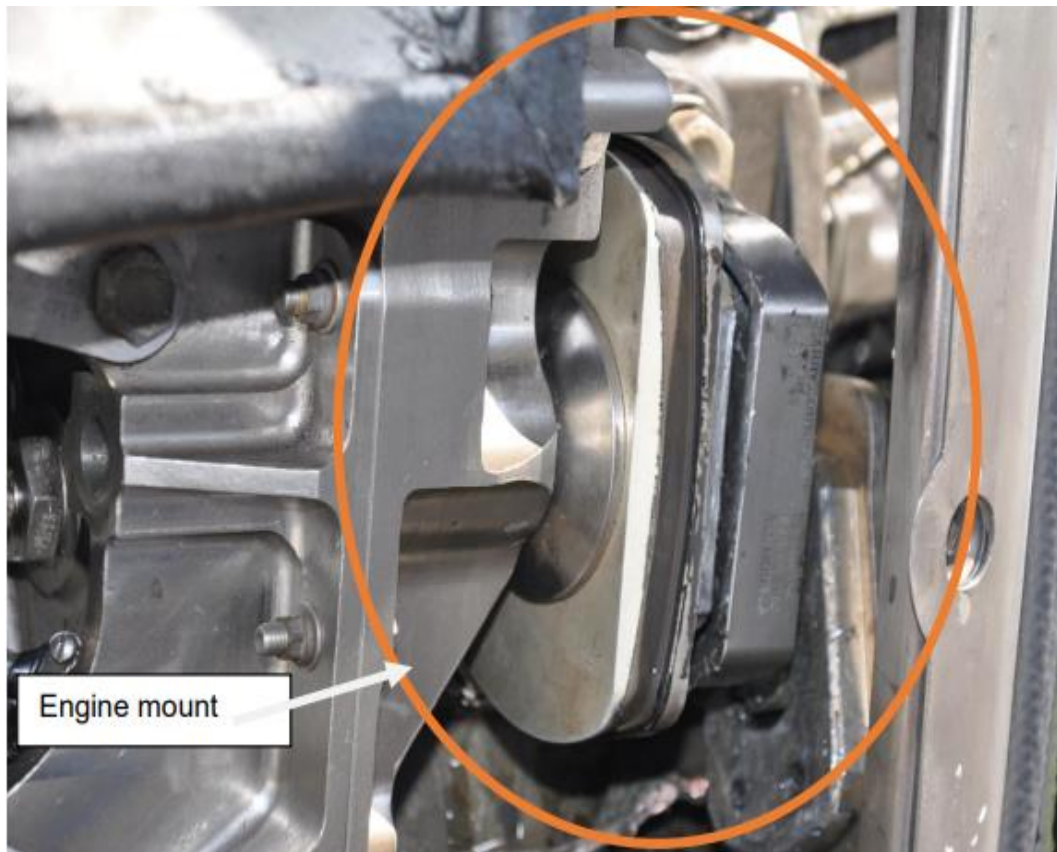
Figure 12: Failed front outboard engine mount.

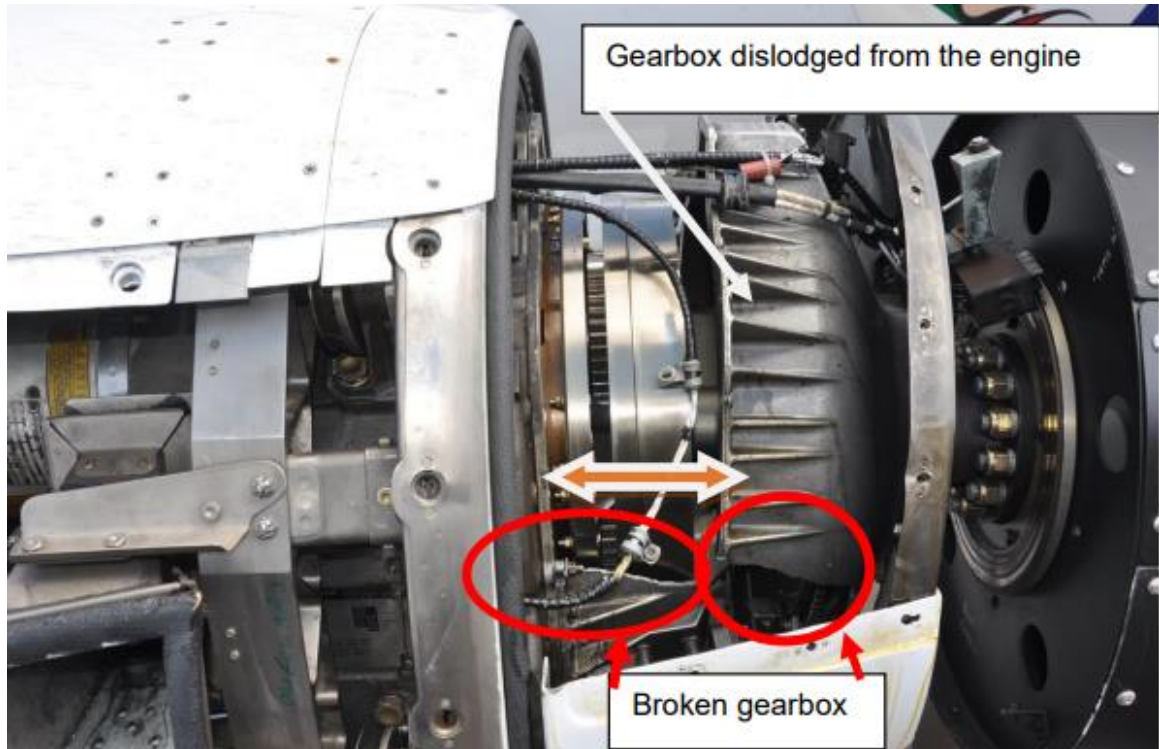
1.12.3. Some components from the engine were damaged during the severe vibration after the bird strike.

Figure 13: The dislodged and broken propeller gearbox.

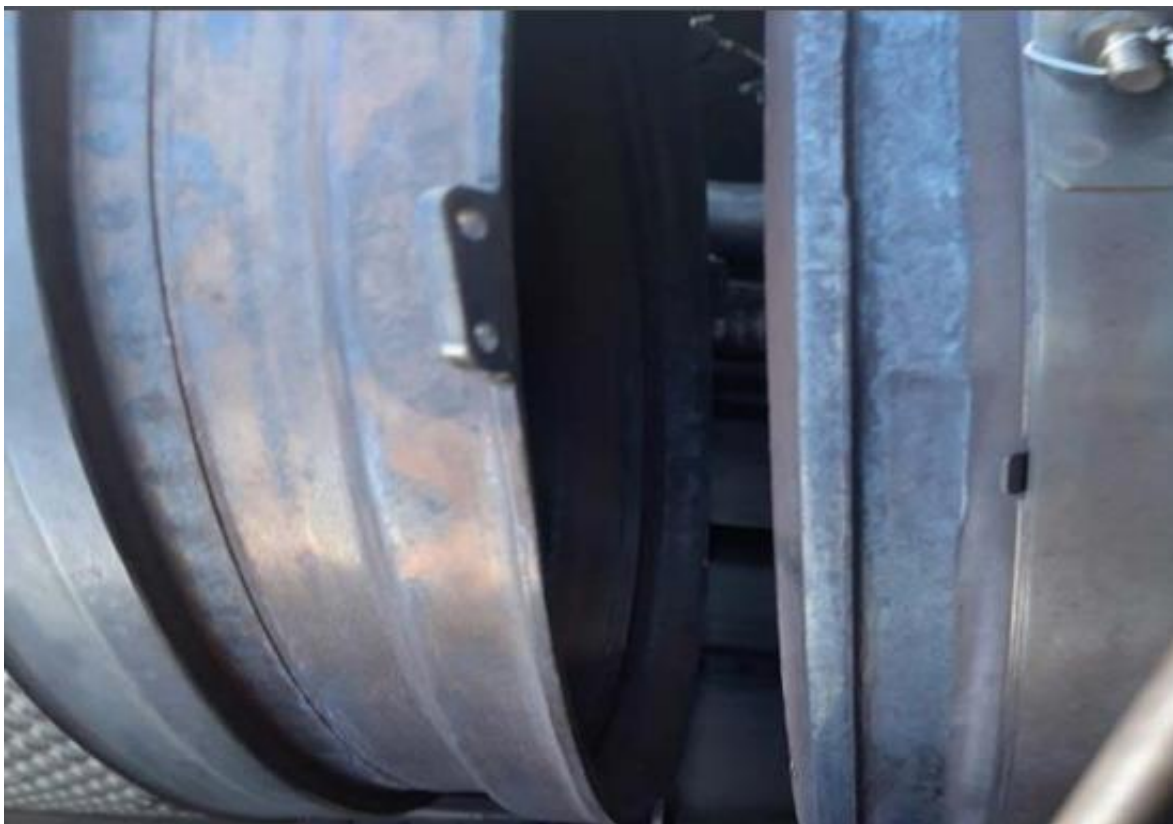
Figure 15: The dislodged combustion casing.

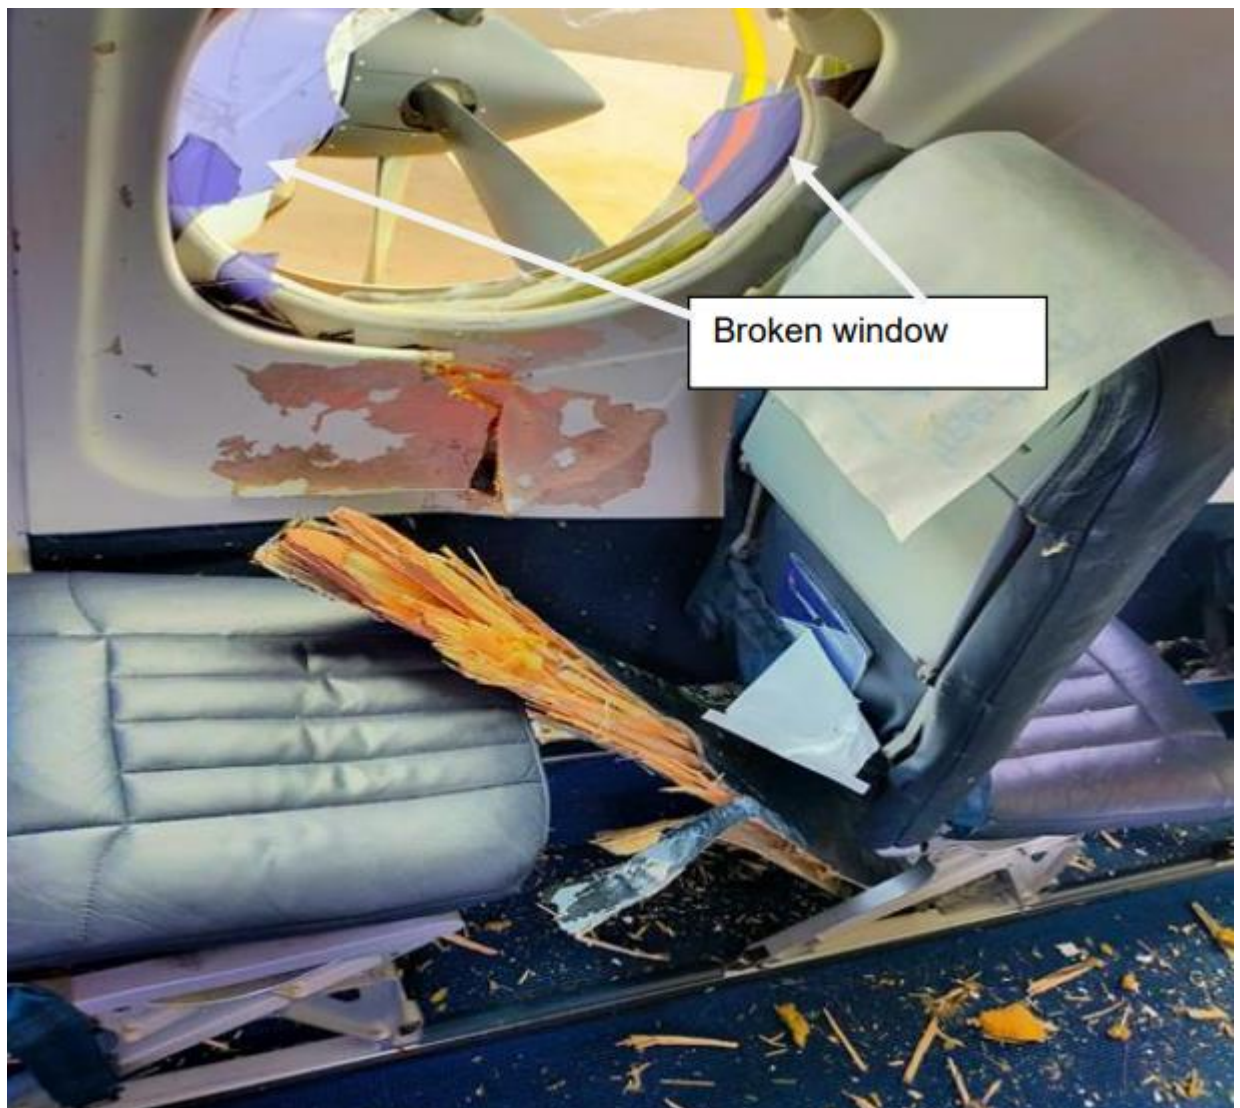
1.15.1. The accident was considered survivable as no person was seated at seat row number 3 during the accident. The cabin crewmember reported that the passenger who was seated in row 3 for weight and balance purposes, vacated the seat during the flight to occupy one of the empty seats at the back of the aircraft.

Figure 16: Damage to the third row of seats.
