AIRCRAFT ACCIDENT REPORT AND EXECUTIVE SUMMARY

Reference	: CA18/2/3/8484	
Aircraft Registration	ZU-DIM		Date of Accident	23 /	April 2008	Time of Acciden	t 0930Z
Type of Aircraft	BUSHB	ABY	450 (Aeroplane)	Туре с	of Operatio	n Private	ŧ
Pilot-in-command Lice	ence Type		Private Pilot	Age	37	Licence Valid	Yes
Pilot-in-command Flyi	ing Experie	ence	Total Flying Hours		64.8	Hours on Type	6.9
Last point of departure New Tempe Aerodron			w Tempe Aerodrome	ne (FATP) (Free State)			
Next point of intended landing New Tempe A			w Tempe Aerodrome	FATP) (I	Free State)		
Location of the accident site with reference to easily defined geographical points (GPS readings if poss				possible)			
On a ploughed maize field at the geographical position S29°01.674' E027°.07.965'							
Meteorological Information Visibility: CAVOK, Temperature: 19°C, Wind: 100° 0-5kts, No Clouds							
Number of people on	board	1+0	No. of people injured		0 1	No. of people killed	0

Name of Owner/Operator	: Schreuder H.A.L.
Manufacturer	: Kitplanes for Africa
Model	: Bushbaby 450
Nationality	: South African
Registration Marks	: ZU-DIM
Place	:Ploughed maize field 2 nm North West of New Tempe Aerodrome (FATP)
Date	: 23 April

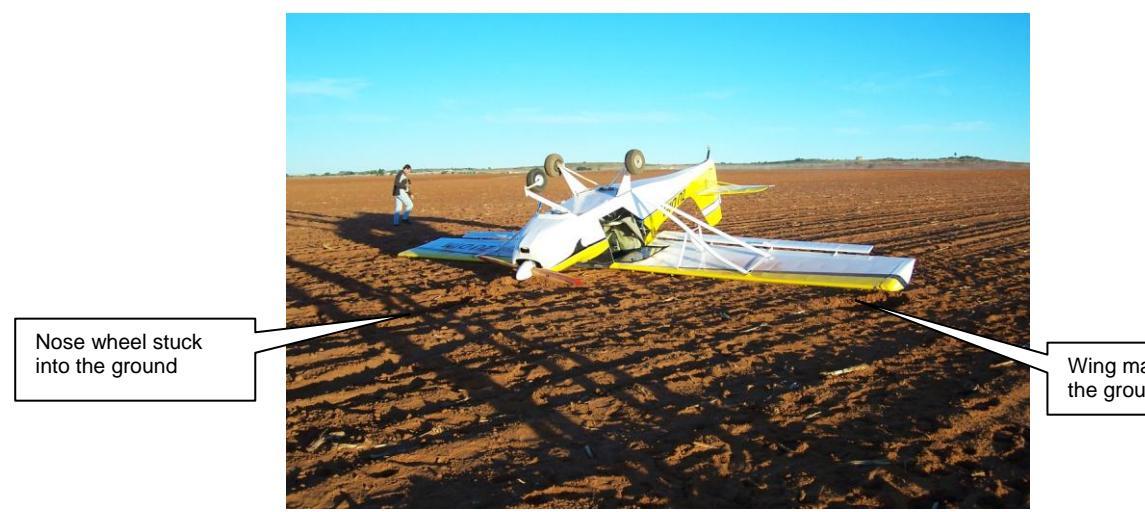
Photo 1.

1.12.1 The accident aeroplane was located in a ploughed maize field about 2 nautical miles North-East from New Tempe Aerodrome. The aircraft landed in a ploughed maize field and as a result of the soft ground, the nose wheel turned sharply to the left, resulting in the right wing tip making contact with the ground. This contact resulted in the aircraft nosing over and coming to rest in an inverted position. (See Photo 1)

Wing made contact with the ground surface

- 1.12.2 Ground marks indicated that after the first contact with the ground, the aircraft bounced and only made contact with the ground 12 metres after the initial contact point. The aircraft then rolled for 45 metres before it nosed over.
- 1.12.3 No evidence was found of any pre-impact defects on the aircraft that might have affected the flight. All of the aircraft's components and flight control surfaces were accounted for at the accident site, and continuity of the flight and engine controls was established. The flaps were found in the retracted (zero degree) position.
- 1.12.4 Fuel leaking out of the fuel tanks, was evident on the scene.
- 1.12.5 Damage was caused to the wings, V-struts, nose wheel assembly and propeller spinner.

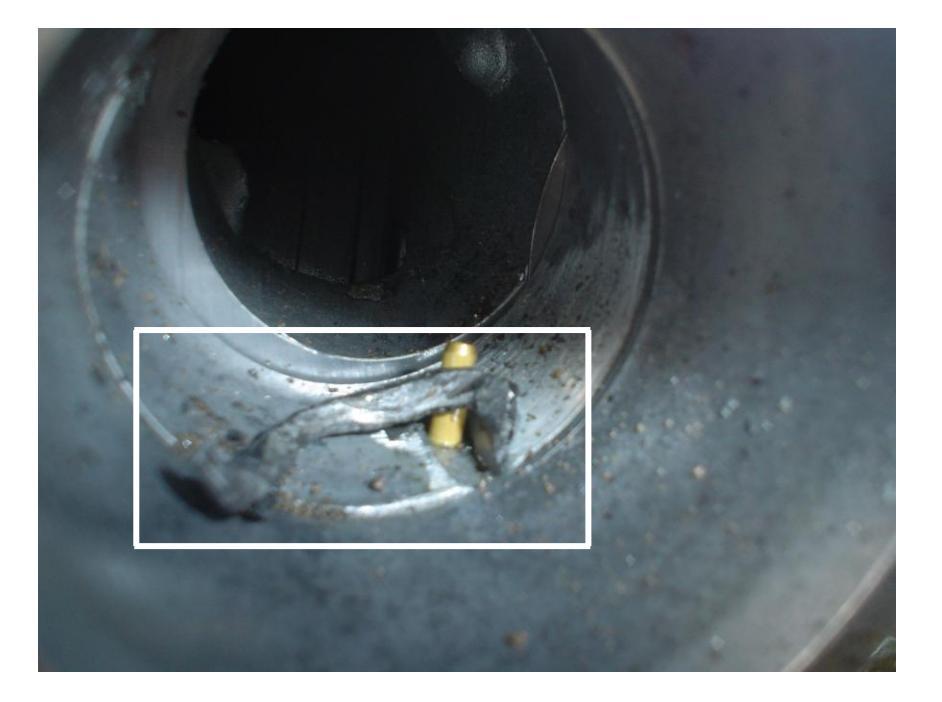
1.17.1 When the engine was removed from the aircraft for further investigation, an unknown piece of metal was found at the intake of No. 1 cylinder. (See Photo 2)

Photo 2 Unidentified piece of metal in the intake of No.1 cylinder

- 1.17.2 When the engine was disassembled after the accident, it was found that a main bearing on the crankshaft had disintegrated and metal particles had entered the cavities of the cylinder head and the rotary valve shaft assembly, which then caused the rotary valve seizure. The destruction of the brass gear finally caused the engine failure. (See Appendix B for complete report)
- 1.17.3 The aircraft was certified, equipped and maintained in accordance with existing regulations and approved procedures. The aircraft showed no evidence of structural or systemic failure.
- 1.17.4 The airframe and flight controls were found to have had no defect prior to the accident and all damage observed was as a result of the accident sequence.
