# AIRCRAFT ACCIDENT REPORT AND EXECUTIVE SUMMARY

Referen	ce:	CA18/2/3/9254	
Aircraft Registration	ZS-CUB		Date of Accident	13 Dec	cember 2	013	Time of Accident	0622Z
Type of Aircraft	Type of Aircraft Cessna 172C (A		Aeroplane)	Type of Operation		Training		
Pilot-in-command Lie	cence Typ	е	Private Pilot's Licence	Age	18		Licence Valid	Yes
Pilot-in-command Fly Experience	ying		Total Flying Hours	70,6			Hours on Type	70,6
Last point of departu	ire	Ma	eng Aerodrome (FAMM, North West)					
Next point of intende	d landing	Ma	ikeng Aerodrome (F	keng Aerodrome (FAMM, North West)				
Location of the accid possible)	lent site w	ith re	ference to easily de	efined g	eograph	ical p	oints (GPS reading	gs if
Left of Runway 04 at F	FAMM (GP	S pos	ition: 25º48'26.8 1" S	outh 02	5°32'40.09	9" Eas	st)	
Meteorological Information	V	/ind: 3	30926 kt, Visibility: 0	CAVOK				
Number of people on board	)	1+0 No. of people injured 0 No. of people ki		of people killed	0

Name of Owner	: Praetor Trust
Name of Operator	: Afrika Union Aviation Academy
Manufacturer	: Cessna Aircraft Company
Model	: Cessna 172C
Nationality	: South African
<b>Registration Marks</b>	: ZS-CUB
Place	: FAMM
Date	: 13 December 2013
T

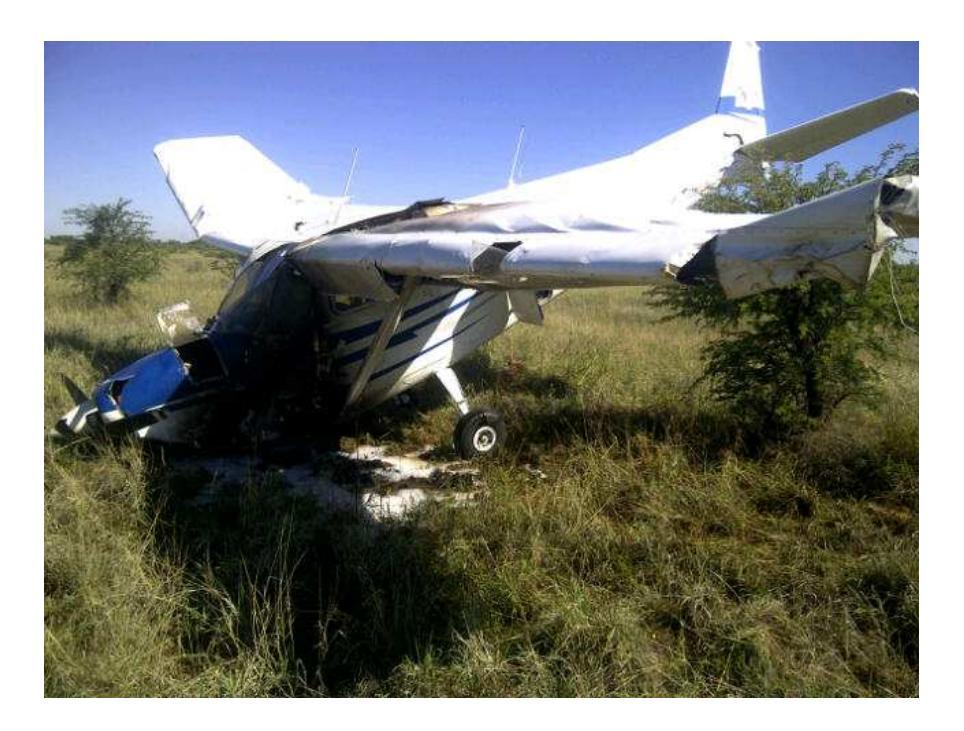
- 1.12.1 The aircraft sustained damage to the nose oleo, propeller, tailplane, right wing, left engine cowling, undercarriage and left wing.
- 1.12.2 The left wing hit a tree on the side of the runway before the aircraft came to rest.
- 1.12.3 The left fuel tank ruptured and shortly afterwards a fire erupted in the area of the engine.

Figure 1: Damage to aircraft
