AIRCRAFT ACCIDENT REPORT AND EXECUTIVE SUMMARY

| | | | | Reference: | | CA18 | CA18/2/3/10124 | | |
| Aircraft Registration | n ZS-EUC | | Date of Acc | cident | 24 February 2022 | | Time | of Accident | 0730Z |
| Type of Aircraft | Mooney N | Mooney M20F | | | Type of Operation | | Priva | Private (Part 91) | |

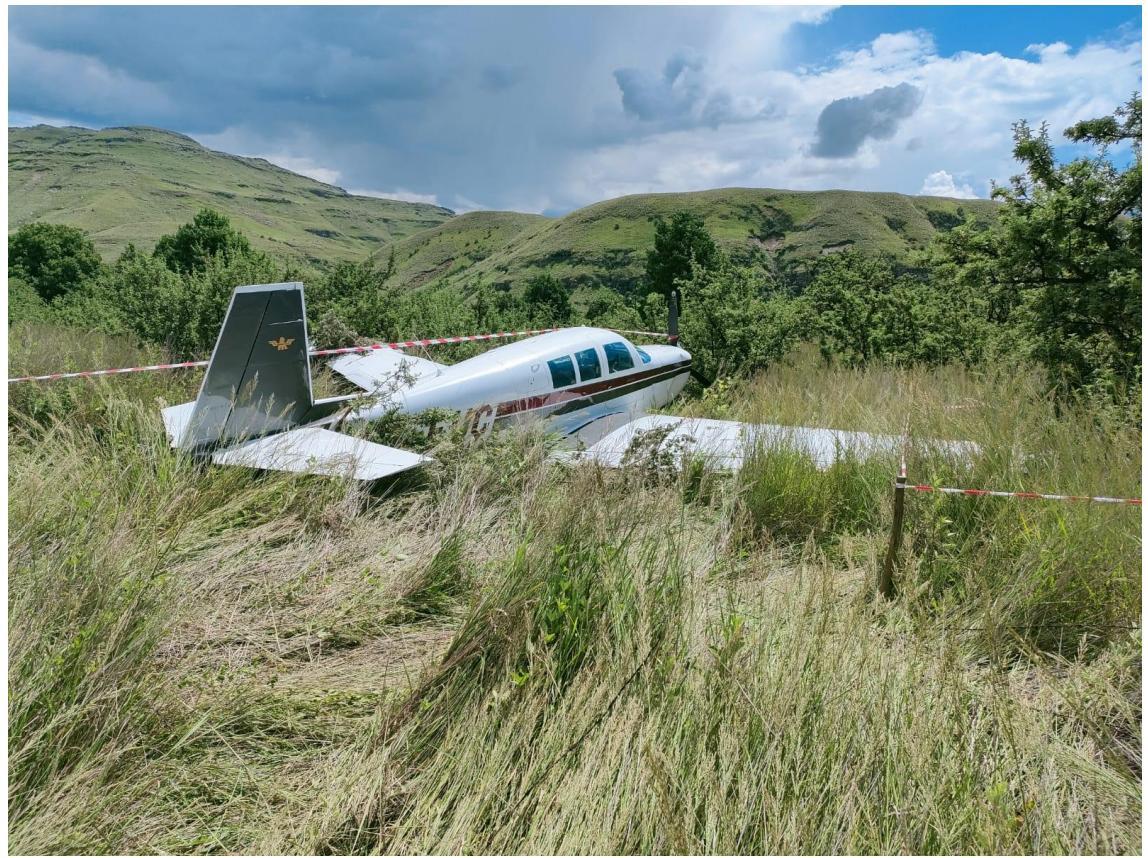
1.3.1 The aircraft sustained substantial damage to both propellers, the left wing leading edge and the nose section.

Figure 2: The aircraft as it came to rest. (Source: Pilot)

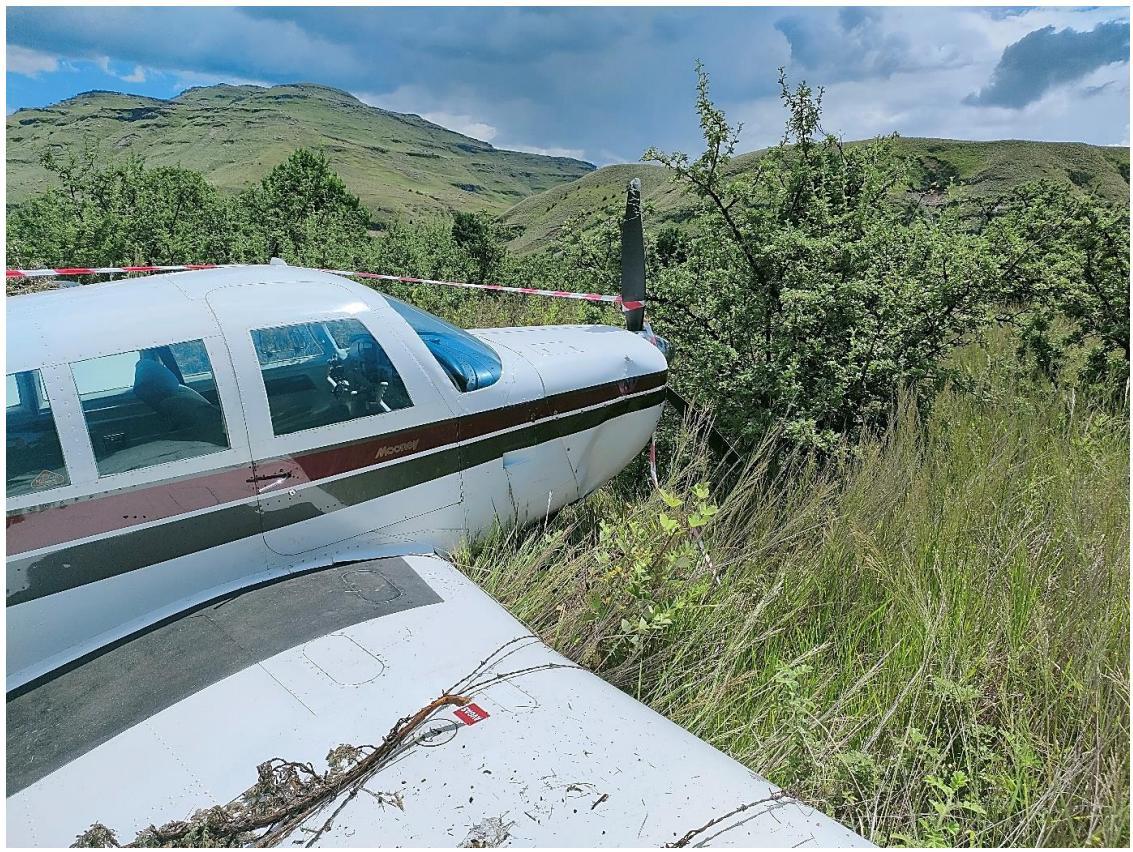
Figure 3: The aircraft against the thorn bush. (Source: Pilot)

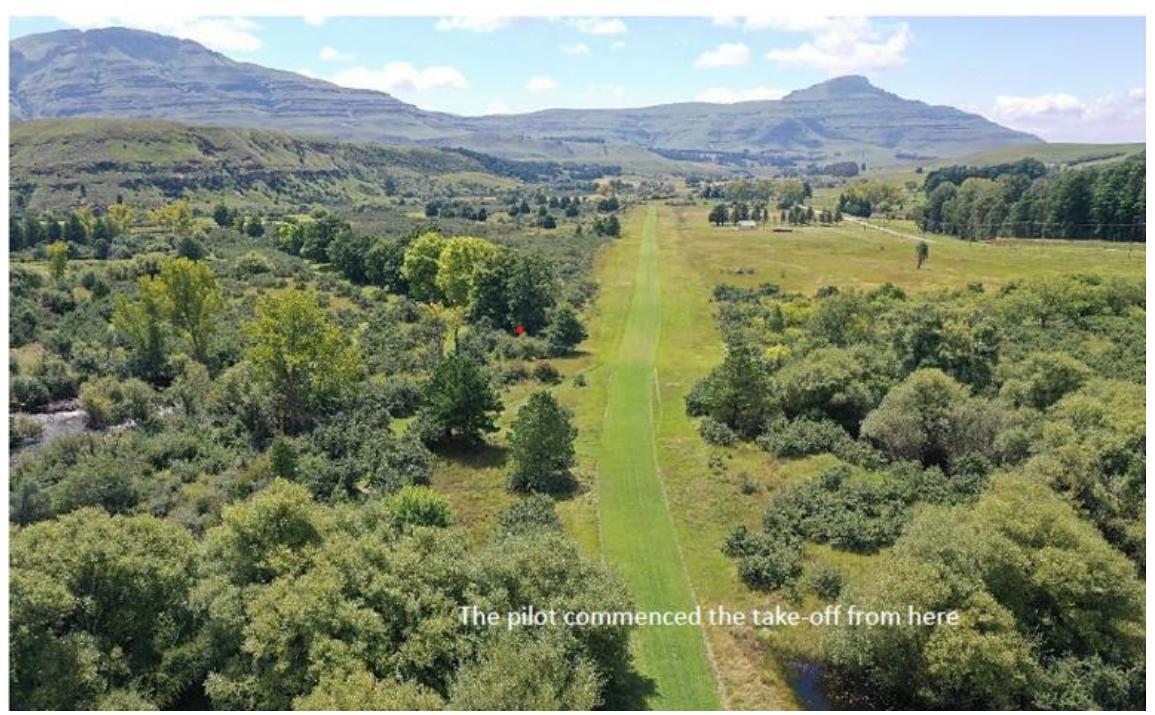
Figure 4: The point where the pilot took off. (Source: Insurance assessor)

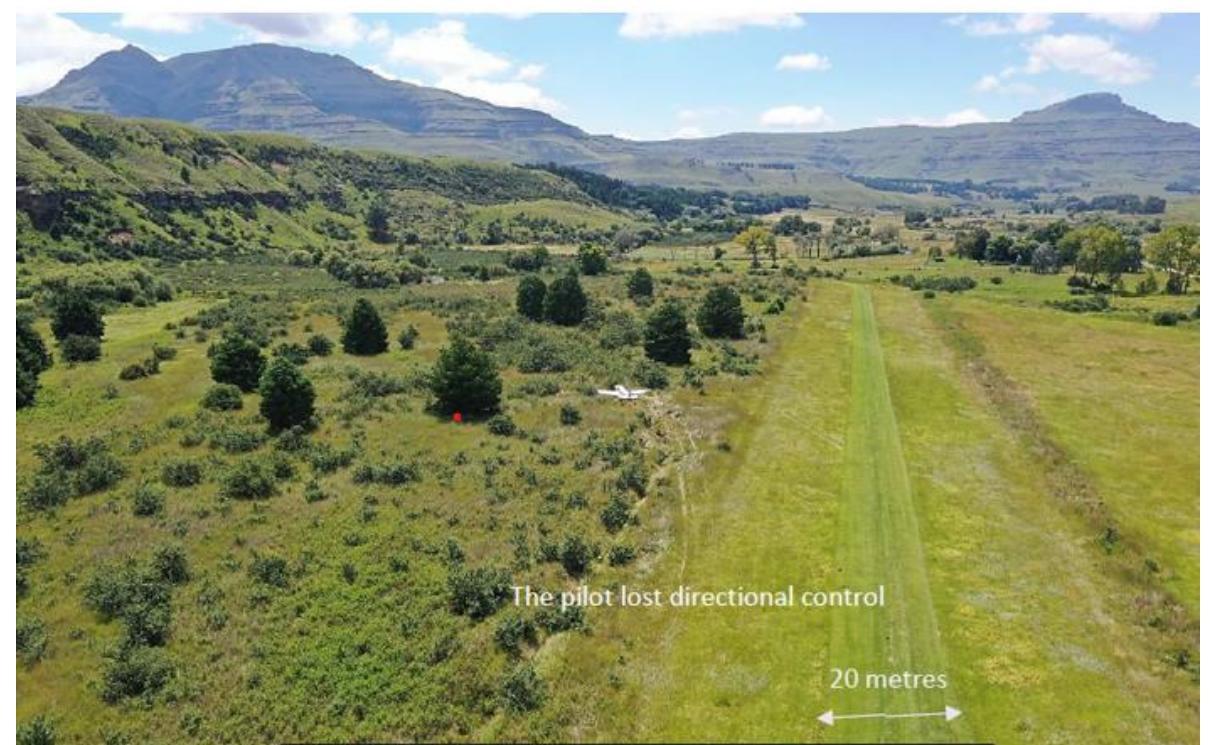
Figure 5: The point where the pilot lost control of the aircraft. The aircraft veered off to the left-side of the runway, leaving the wheel marks on the ground. (Source: Insurance assessor)

- 2.2.4 The pilot reported that the acceleration was slower than normal and that he rotated the aircraft at 66 knots. During rotation, a small bump on the runway surface caused the aircraft to become airborne sooner than expected. The pilot then elected to land back onto the runway, however, the aircraft veered off to the left (of the runway), during which the left wing collided with the boundary fence. The aircraft came to a stop in a dense bushy area. The landing gear wheel markings on the grass next to RWY 09 were an indication that the pilot lost directional control.

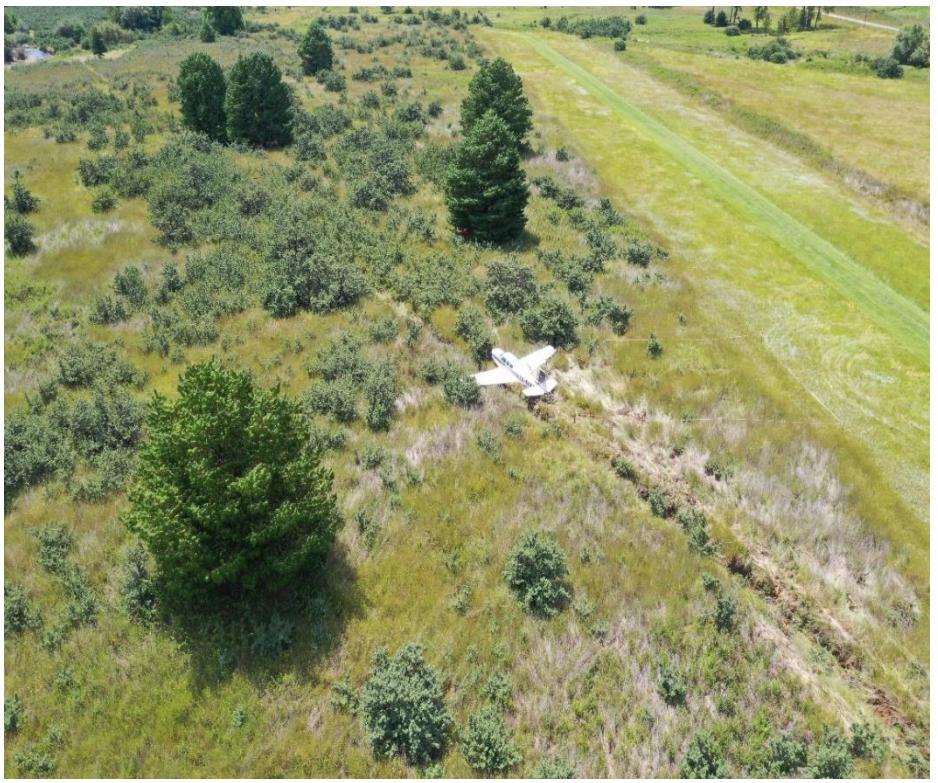
Figure 6: The aircraft's final position after the accident. (Source: Pilot)
