Section/division Accident and Incident Investigations Division

UAS LIMITED OCCURRENCE INVESTIGATION REPORT – FINAL

Reference Num	ıber	CA18/2/3/10343												
Classification		Accident		Da	te	29 June 2023				Time			1723Z	
Type of Operat	ion	Remotely Piloted Aircraft Systems – Aerial Survey (Part 101)												
Location														
Place of Departure		Sasol Syfe Mine in S Mpumala	Sasol Syferfontein Mine in Secunda, Mpumalanga Province			Place of Intended Landing			S S P	Sasol Syferfontein Mine in Secunda, Mpumalanga Province				
Place of Occurrence Sasol Syferfontein Mine in Secunda, Mpumalanga Province														
GPS Co-ordinates		Latitude	26º41'54" S		L	Longitude		029⁰20'59" E			Elevation		5315 ft	
Aircraft Informa	ation													
Registration		ZT-XXM	ZT-XXM		Class			ЗA						
Make; Model; S/	/N	Arace Siri	race Sirin (Serial Number: SIR0077)											
Damage to Aircraft		Substantia	Substantial			Total UAS			Hours 653			.58		
Pilot-in-comma	ind													
Licence Type		Remote Pilot Licence (RPL)		•	Gender		Male				Age	29

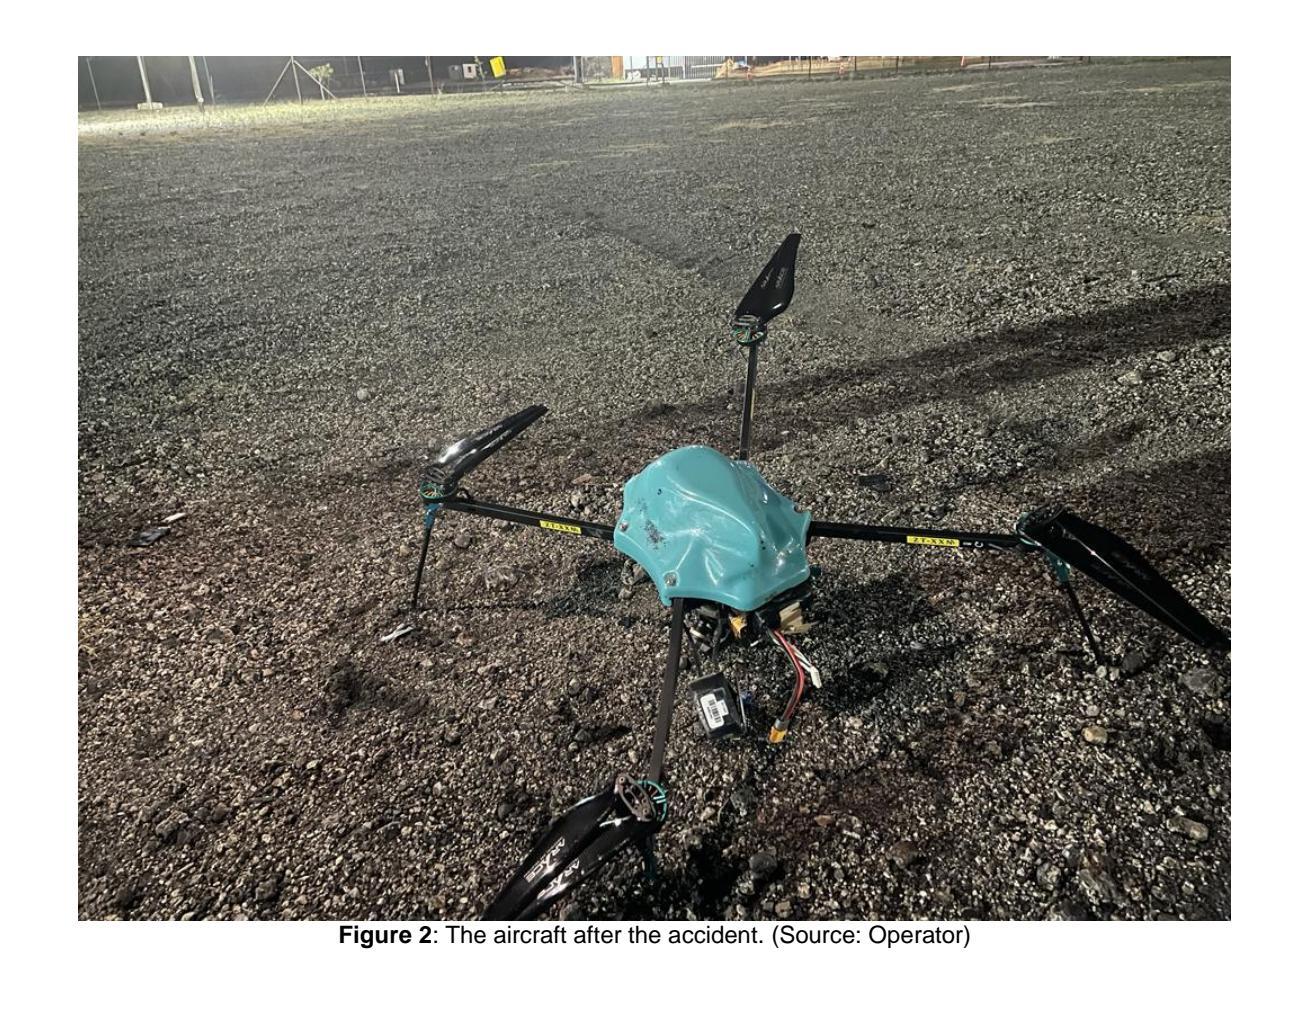
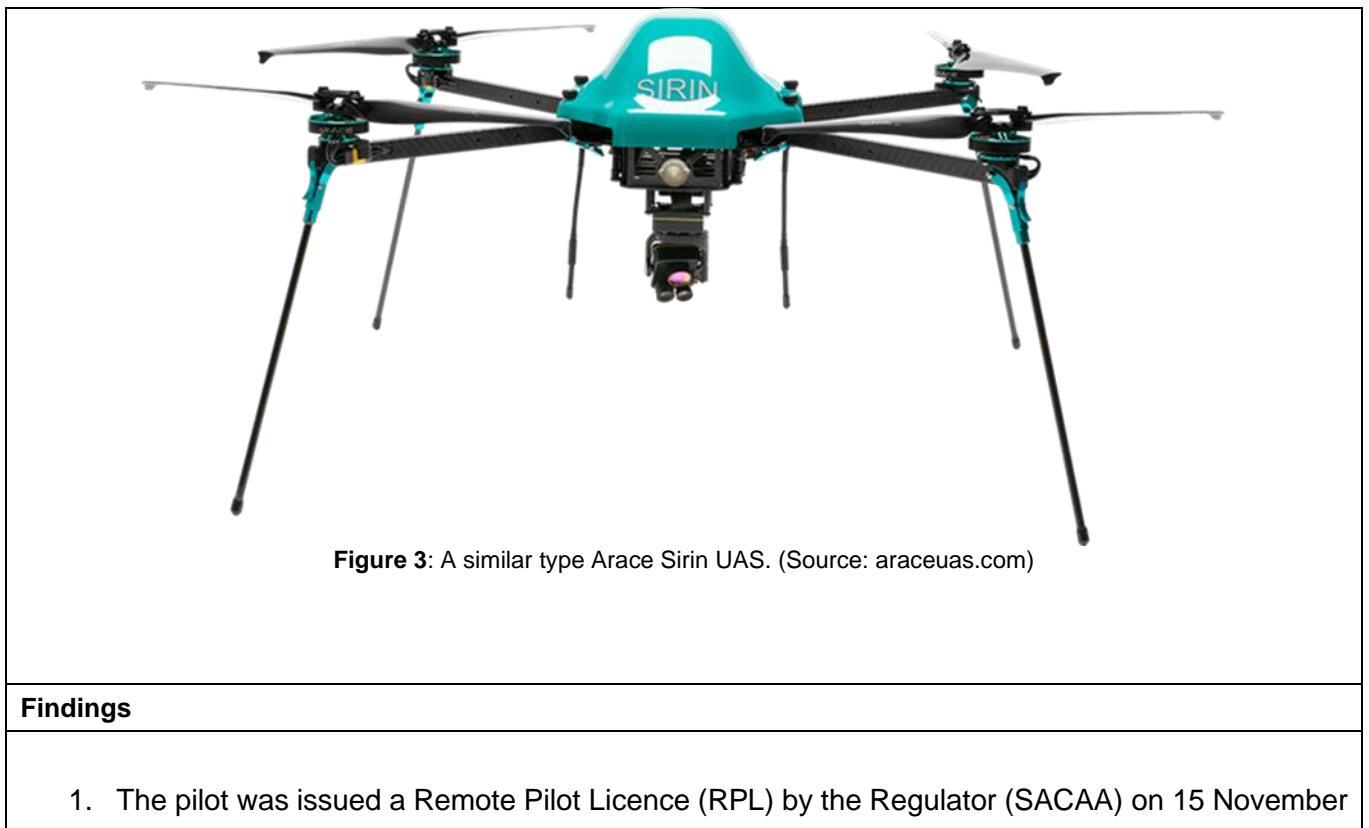
The pilot stated that he conducted pre-flight checks on the UAS with no anomalies detected. Thereafter, he launched the UAS at 1719Z, which climbed to 120 feet (ft) (36m) above ground level (AGL) to conduct after take-off checks whilst the UAS was on hover mode. A few minutes later, the remote pilot station screen display became intermittent before it shut off completely. After a few seconds, the remote pilot station screen came back 'on'; it displayed a 'GPS glitch error' message. As the pilot tried to land the UAS slowly, the UAS entered an uncontrolled fast descent and crashed. The UAS sustained damage to the propellers, camera and the landing gear. There were no reported injuries to persons on the ground.

Interrupted remote pilot station screen display, followed by loss of control and the subsequent crash of the UAS.

Incorrect disarming procedure.
