LIMITED OCCURRENCE INVESTIGATION REPORT – FINAL

Reference Number	CA18/2/3/10639						
Classification	Accident	Date	25 February 2026	Time	0747Z		
Type of Operation	Aerial Work Operations (Part 137)						
Location							
Place of Departure	Denneoord Aerial Fire Base, George, Western Cape Province		Place of Intended Landing	Knysna Highway Aerodrome, Western Cape Province			
Place of Occurrence	On Runway 13, Knysna Highway Aerodrome, Western Cape Province						
GPS Co-ordinates	Latitude	33°57'01.18" S	Longitude	022°58'35.67" E	Elevation	785 feet	
Aircraft Information							
Registration	ZS-PFS						
Make; Model; S/N	Cessna, U206 (Serial Number: U206-0323)						
Damage to Aircraft	Substantial		Total Aircraft Hours	12 218.6			
Pilot-in-command							
Licence Type	Commercial Pilot Licence		Gender	Male		Age	53
Licence Valid	Yes	Total Hours	1 226.2		Total Hours on Type	107.5	
Total Hours 30 Days	34.2		Total Flying on Type Past 90 Days	20.7			
People On-board	1 + 0	Injuries	0	Fatalities	0	Other (on ground)	0

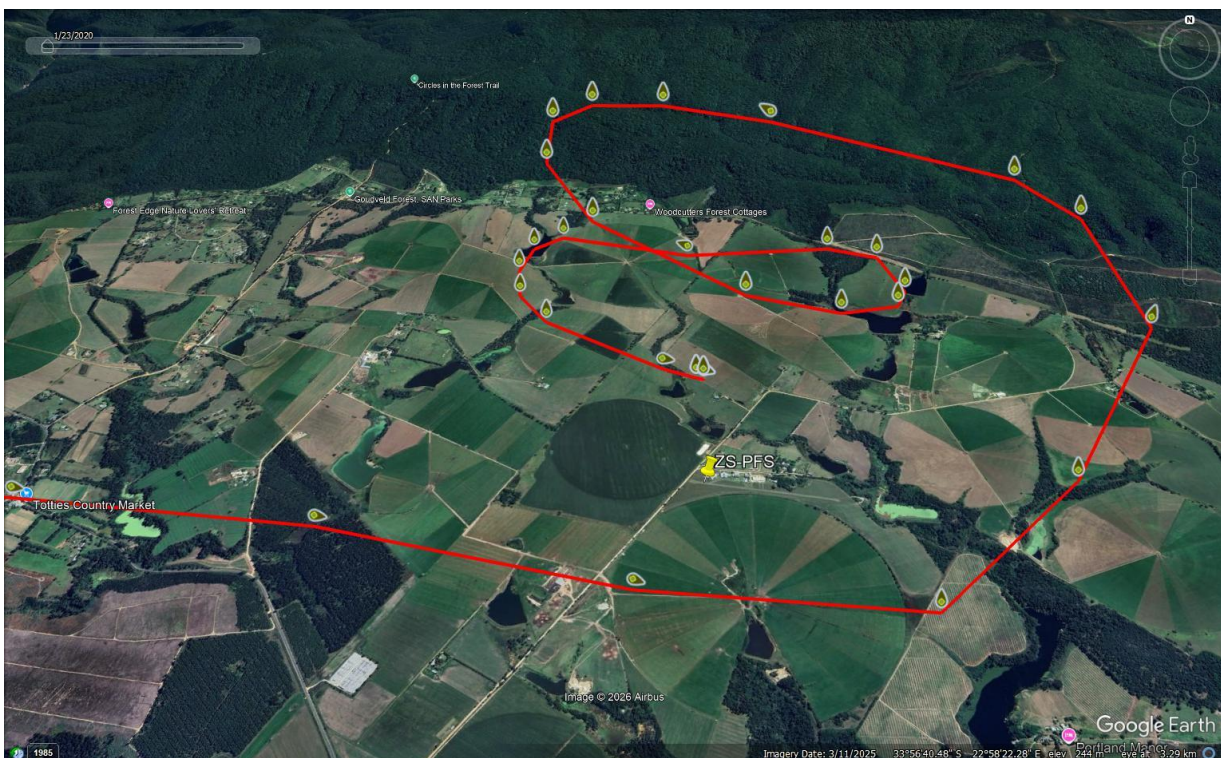
Figure 1: The aircraft was fitted with Spider Tracks. The red line indicates the track flow during the unmanned aerodrome joining procedure. (Source: Google Earth)

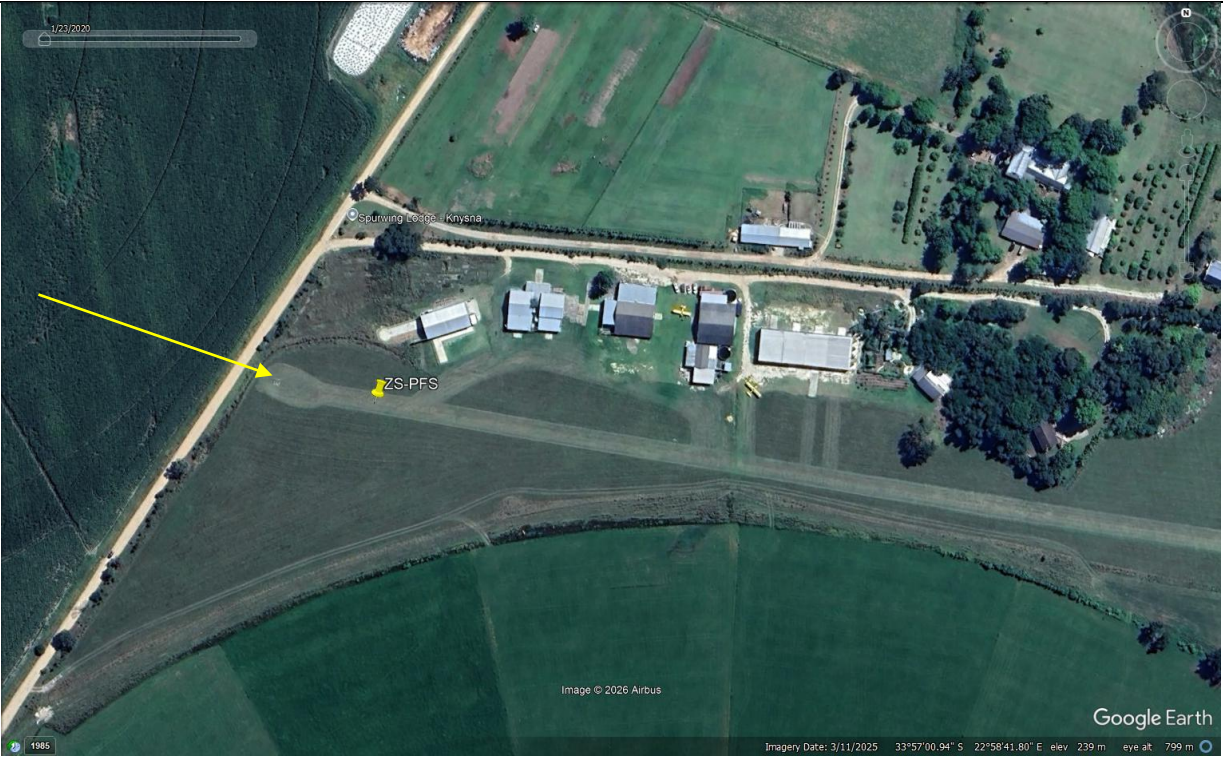
Figure 2: The aircraft approached from the west and came to rest on Runway 13. (Source: Google Earth)

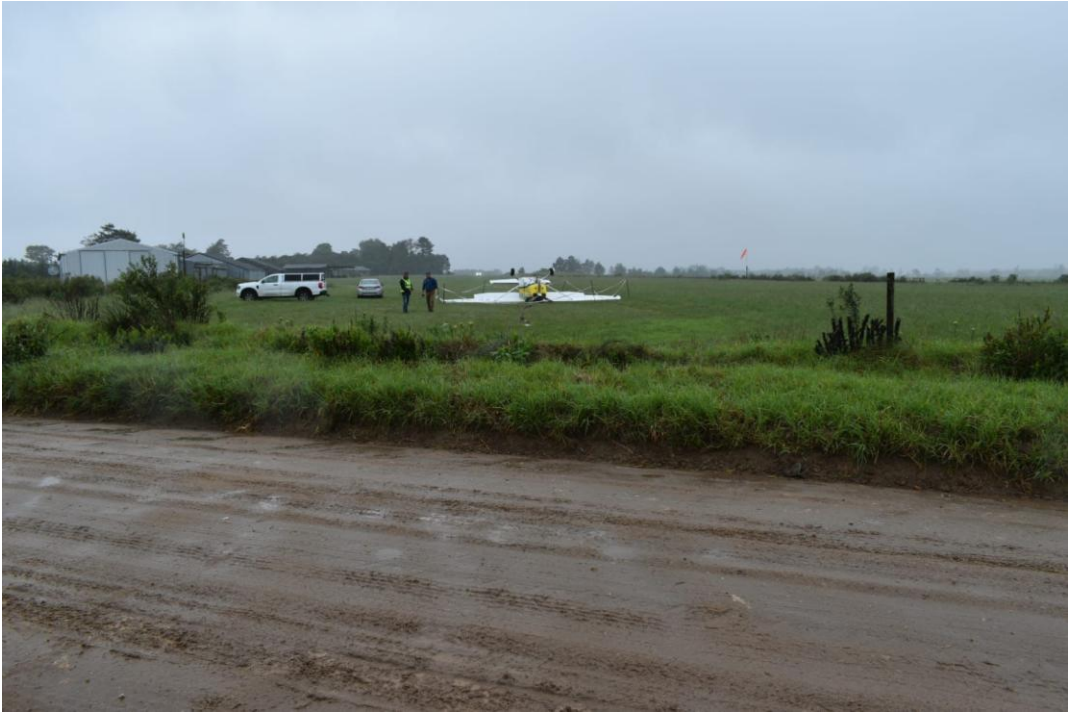
40° with the aircraft's recorded airspeed indicating a progressive decay. The aircraft descended below the optimal glide path whilst on short finals and touched down on a dirt road, approximately 18m short of the runway threshold. Upon initial ground contact, the main wheels struck an embankment next to the road, and the aircraft bounced and came down in a nose-down attitude. After the second ground contact, the nose wheel fork broke off from the landing gear oleo strut, and the nose gear strut assembly dug into the soft soil before the aircraft nosed over. It came to rest in an inverted attitude on the runway.

Figure 3: The dirt road on which the aircraft touched down. (Source: Operator)

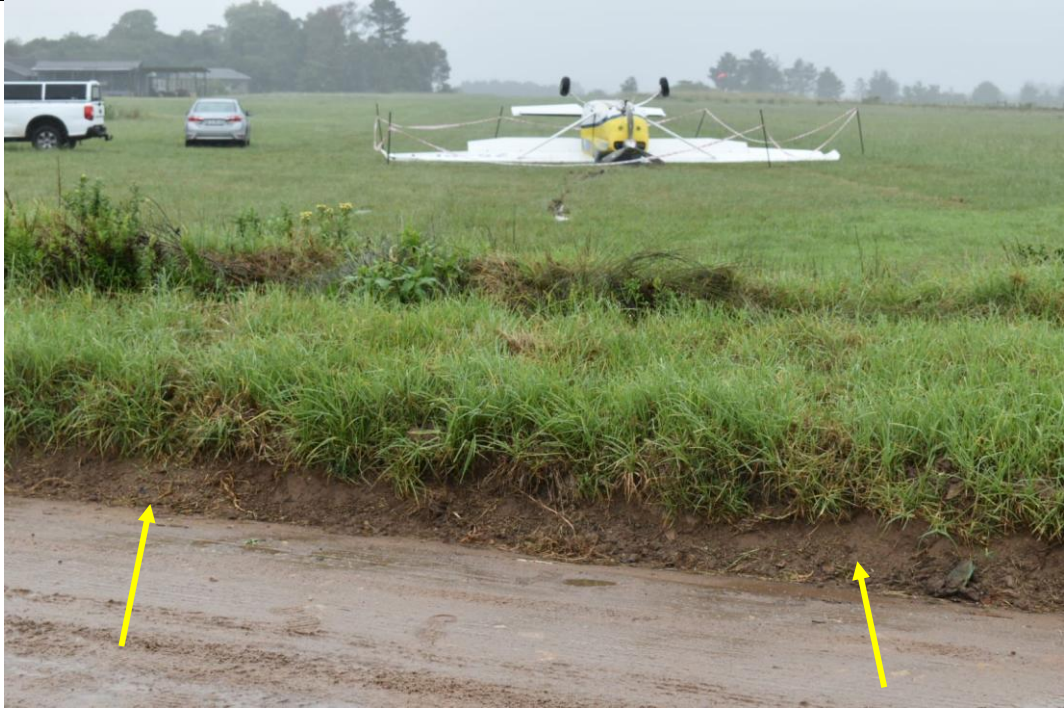
Figure 4: The embankment next to the road impacted by the main wheels. (Source: Operator)

The pilot flew an unstable approach (low and slow on the final segment) and the aircraft touched down on a dirt road short of the runway, struck an embankment with the main wheels, bounced and, on ground contact, the nose wheel fork broke off. The nose gear oleo strut dug into the soft soil and the aircraft nosed over.

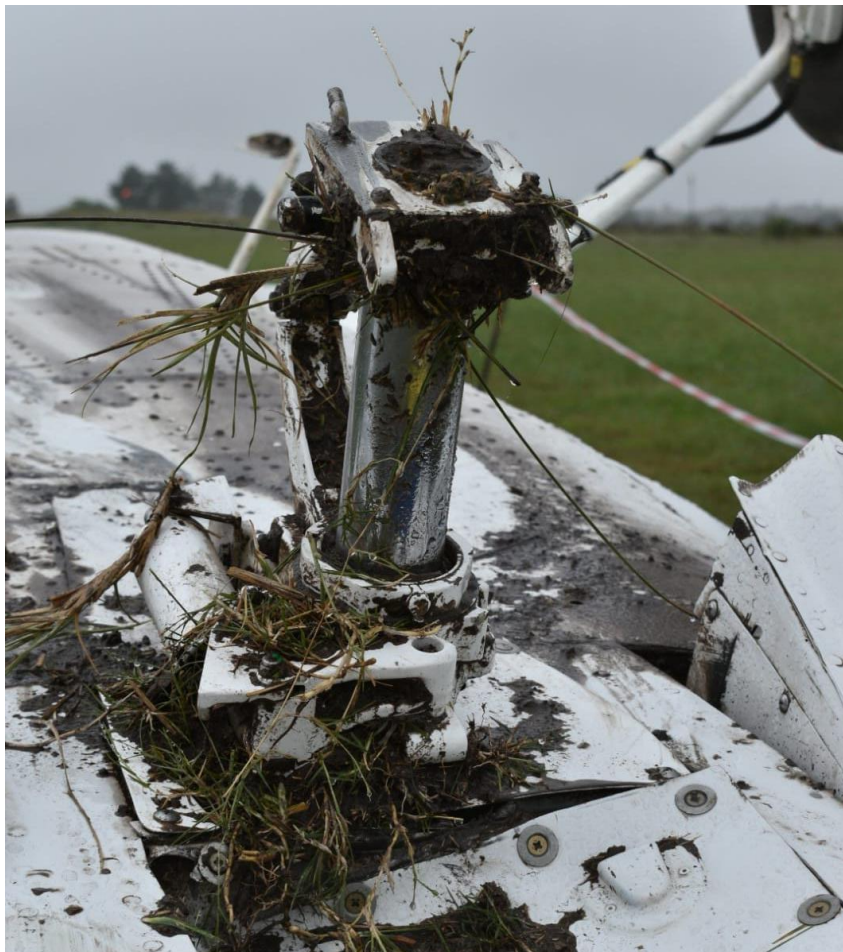
Figure 5: The nose gear oleo strut assembly that dug into the soft soil. (Source: Operator)

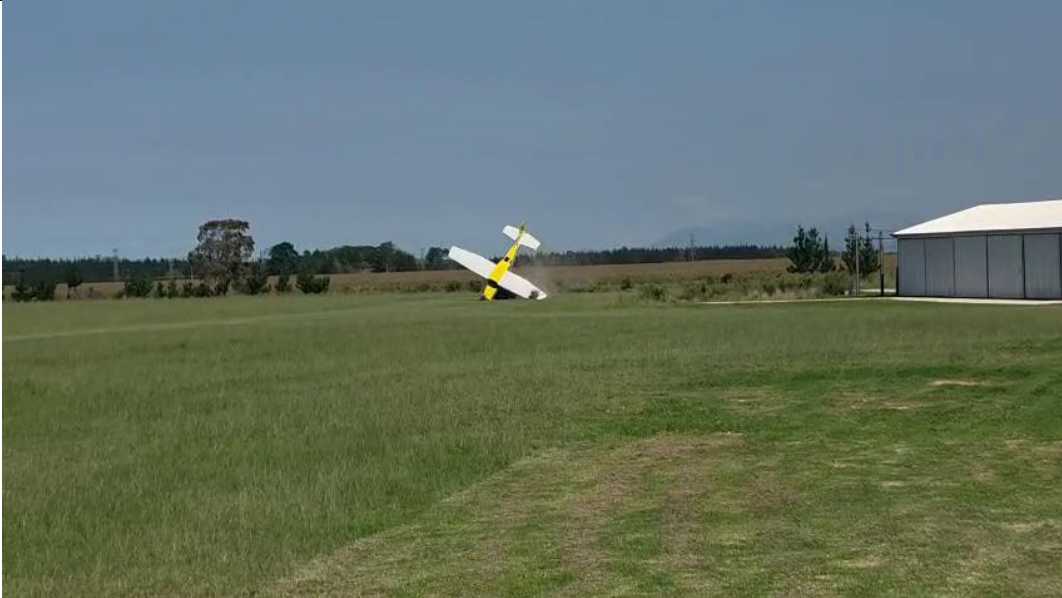
Figure 6: Snapshot from the video footage showing the dug-in left-wing tip as the aircraft nosed over. (Source: Incident Commander)

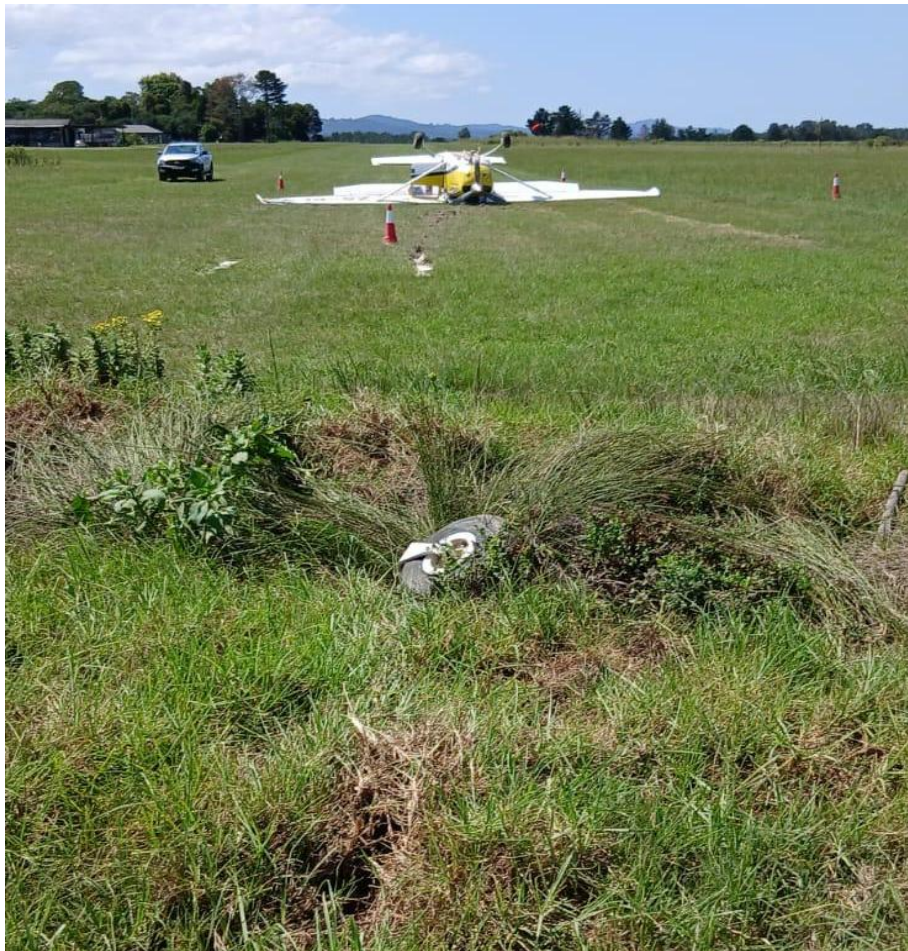
Figure 7: The area where the nose wheel assembly broke off. (Source: Incident Commander)

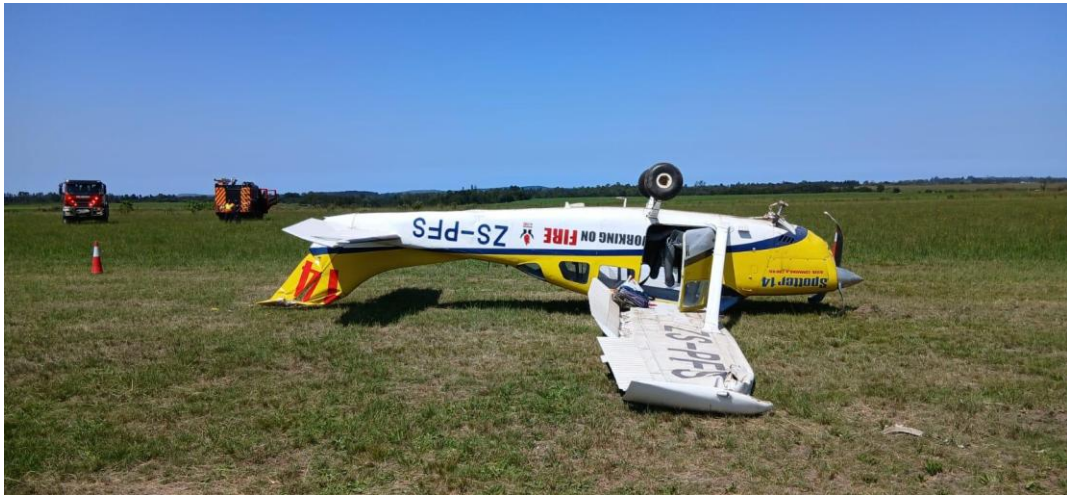
The incident commander recorded a video of the aircraft when it was on final approach for Runway 13 and the subsequent accident sequence using his mobile phone. The aircraft sustained substantial damage to the nose landing gear, propeller, wings and empennage. After the accident, the pilot had disembarked from the aircraft unassisted. The incident commander contacted the Emergency Medical Services (EMS) who assessed the pilot on-site and, later, transported him to a hospital in Knysna; he was kept overnight under medical supervision.

Figure 8: The aircraft in its final rest after the accident. (Source: Incident Commander)

Pilot/s not familiar with the Knysna Highway Aerodrome should ensure that they are aware of the hazards associated with the aerodrome, especially the approach and overrun areas as there is little margin for error. Proper flight planning is essential before making use of this aerodrome. When in doubt during an approach, pilot/s should perform a go-around.
