AIRCRAFT SERIOUS INCIDENT REPORT AND EXECUTIVE SUMMARY

Probable Cause

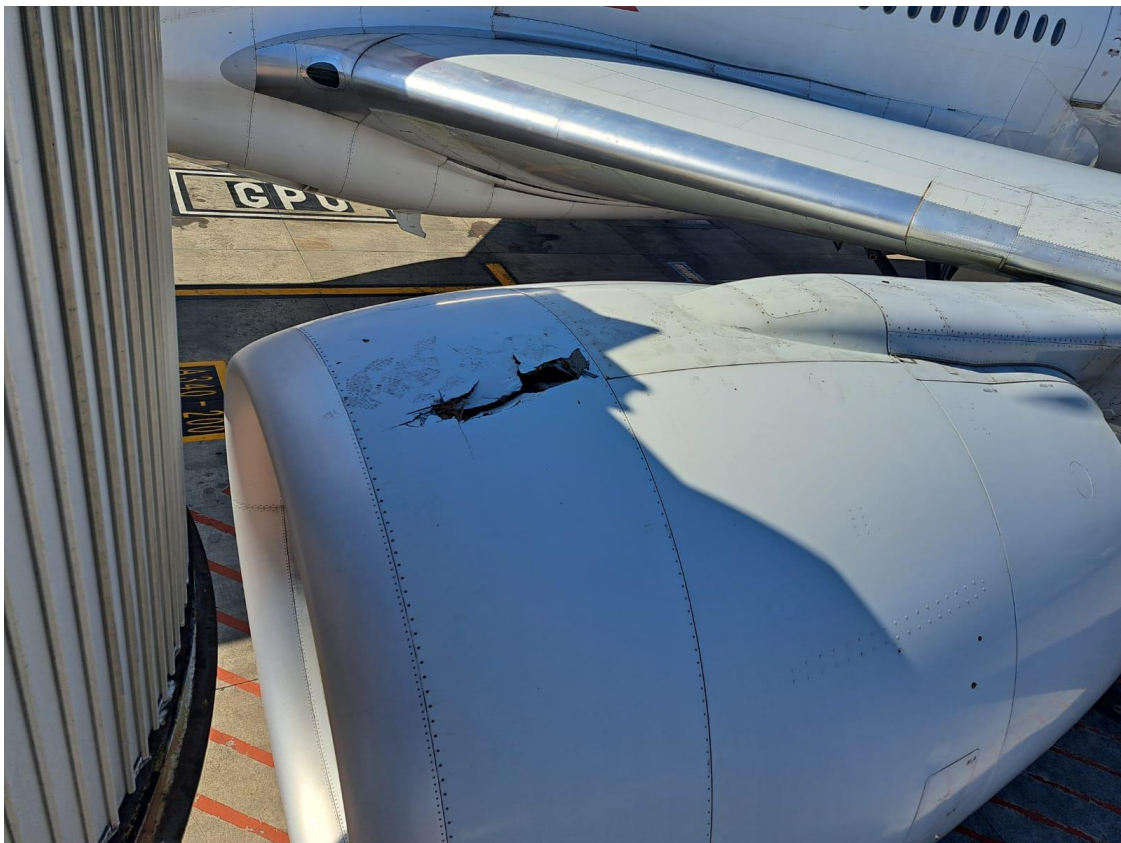
Figure 2: The damage to the No.1 engine inlet cowling.

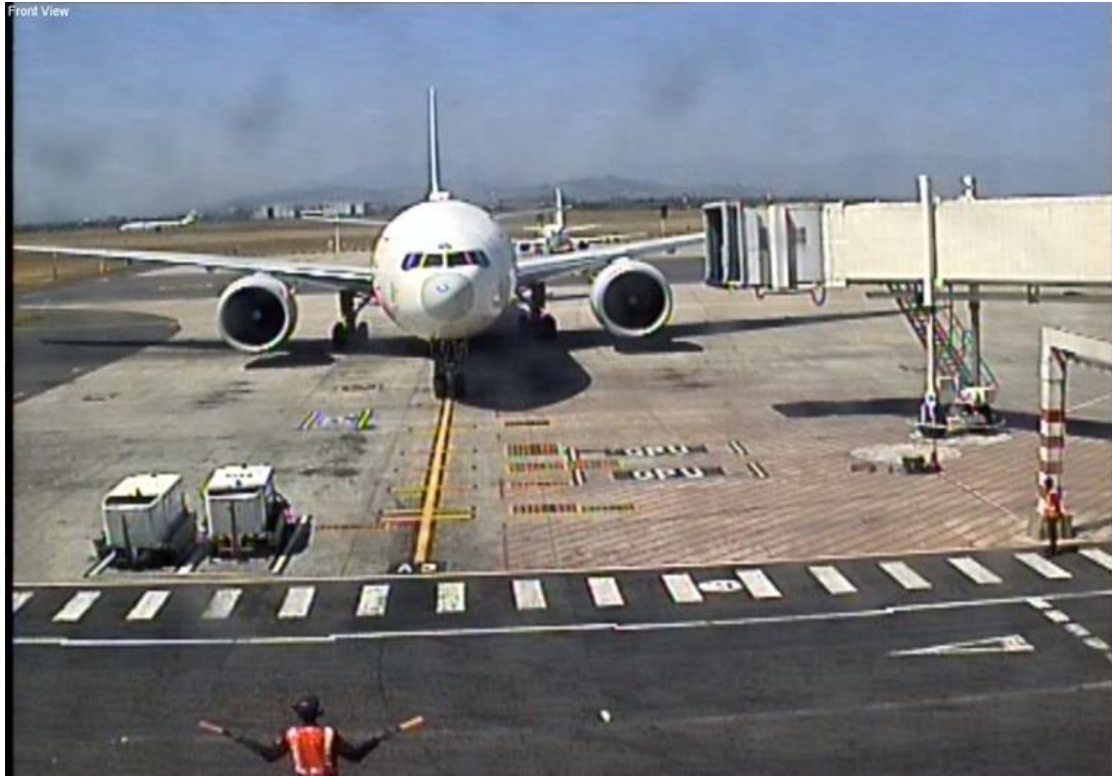
Figure 4: A still image of the aircraft being marshalled into parking bay A3.
(Source: Aerodrome Licence Holder)

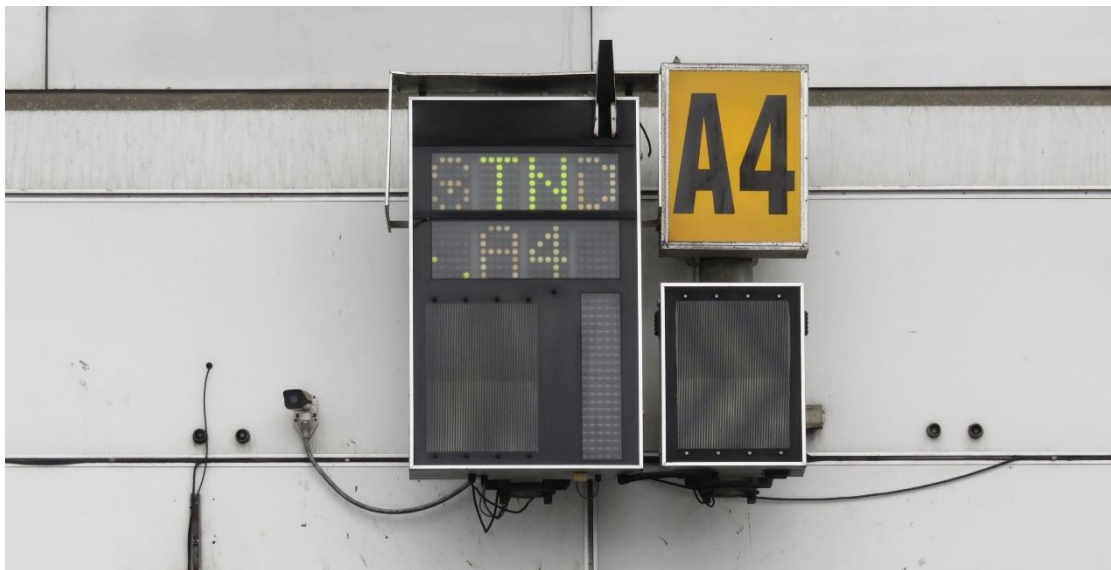
Figure 12: Close-up view of the display unit at parking bay A4.

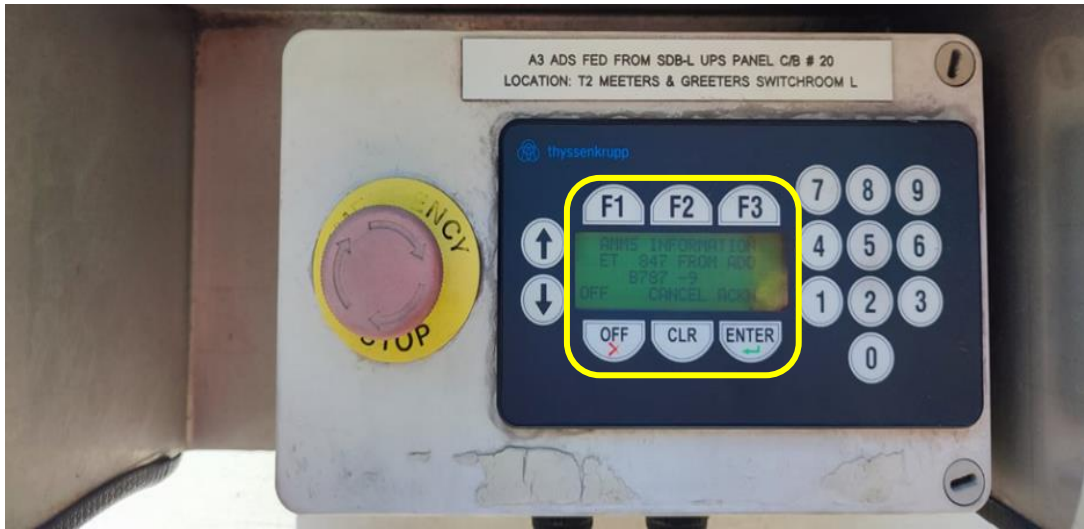
Figure 16: A view of the ADS panel at parking bay A3. (Source: Aerodrome Licence Holder)

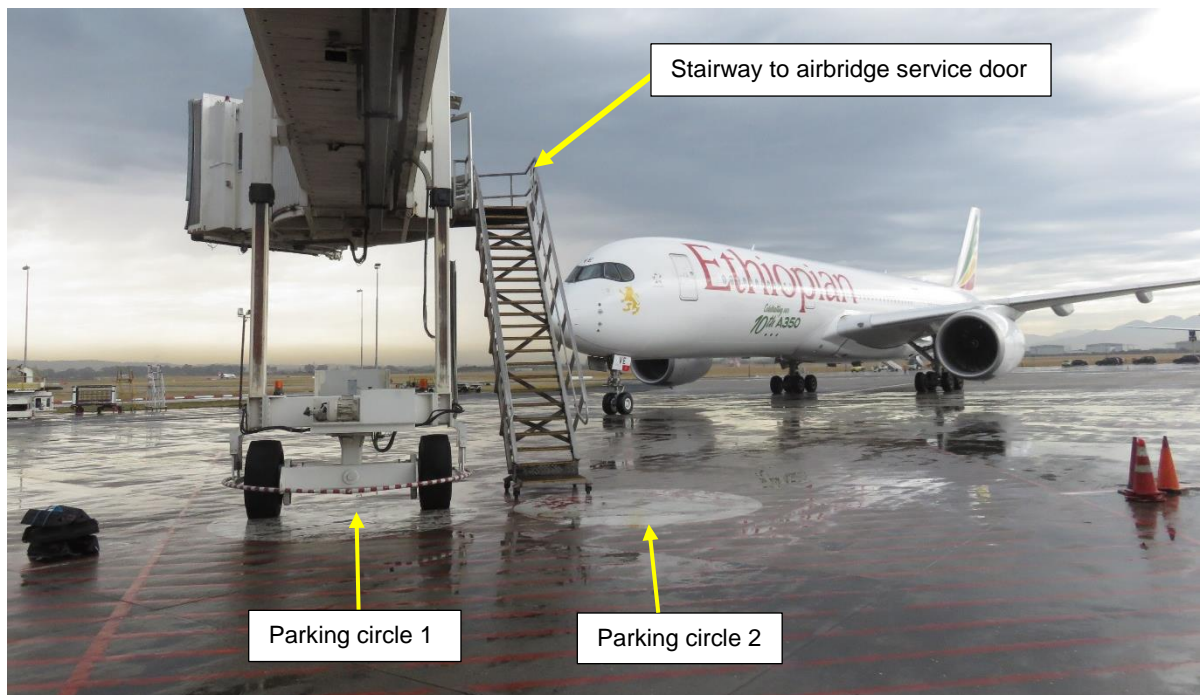
Figure 17: A view of the airbridge parked in parking circle 1, with an aircraft taxiing into A3. (This photograph was taken on 2 November 2022 by the investigator)
