Section/division Accident and Incident Investigations Division

LIMITED ACCIDENT INVESTIGATION REPORT

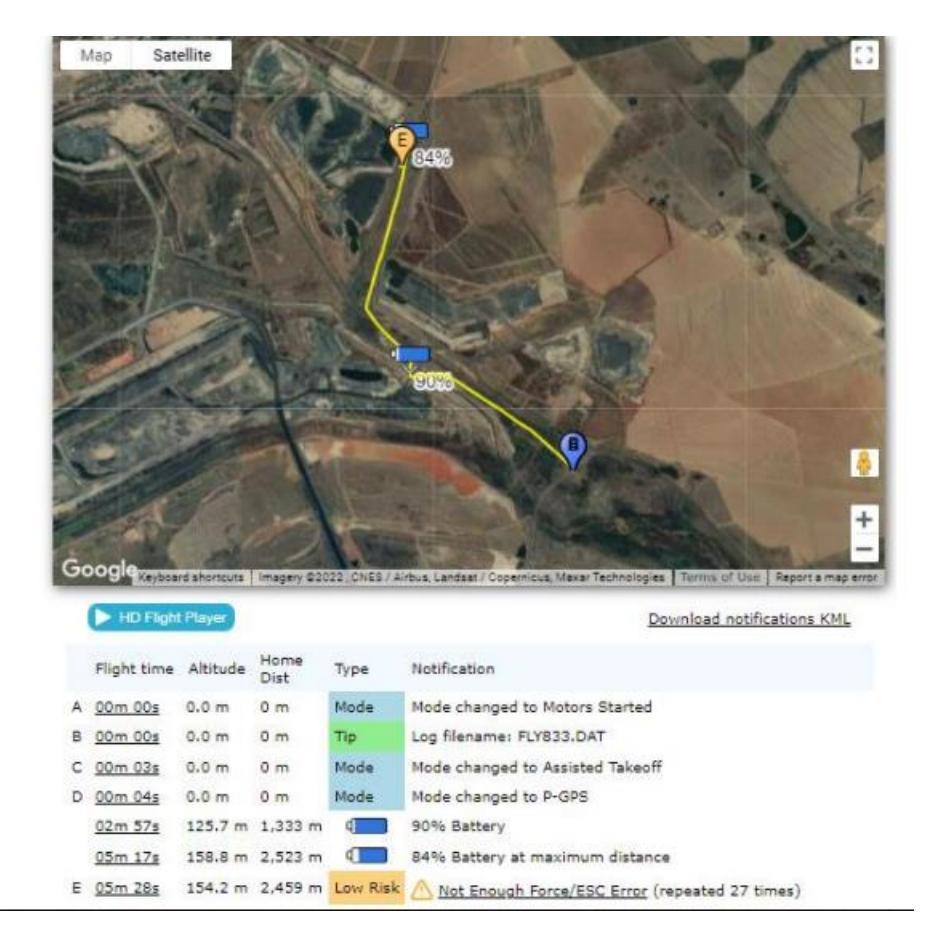
- The investigation found that there was compass interference with the drone, which was caused by a motor spooling up and interfering with the internal compass of the drone.

• The drone took off at 00:04 seconds. At 05:17 seconds it reached the furthest point of the mission; and at 05:23 seconds it started to spin uncontrollably and later crashed.

Figure 4 – Airdata. Note the RPA giving an ESC warning during the flight. The RPA starts spinning as it reaches the 5-minute mark.

- Right back motor was spinning at 100%.
- The Electronic Speed Controller (ESC) thrust warning appeared during the flight, likely due to that the root cause of the accident was because of the ESC or motor failure on the right back motor.
