ZS - DHA. PIPER TRI-PACER.
VAN RHYNSDORP - 20 JUNE 1953

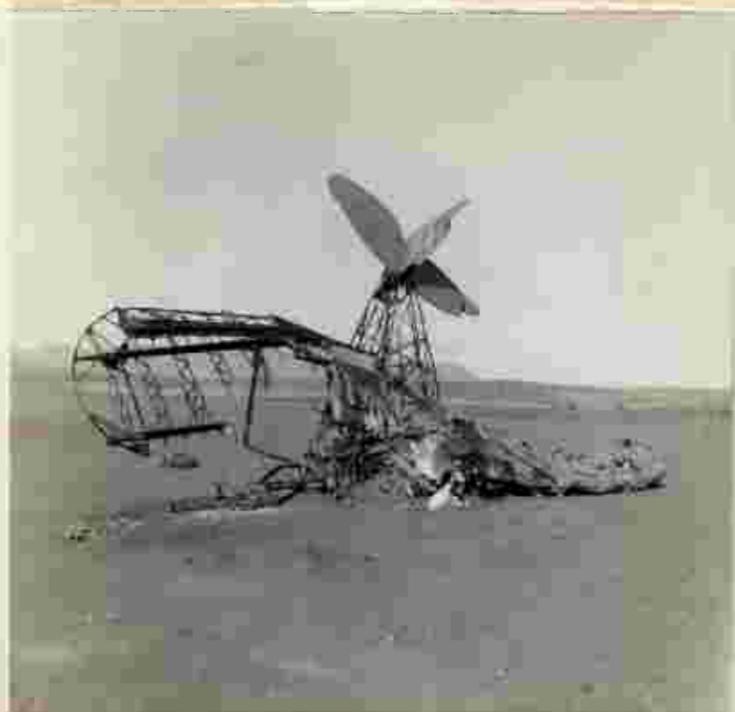
5. Main wreckage showing crumpled port mainplane
and fire damage to starboard mainplane
