**LIMITED OCCURRENCE INVESTIGATION REPORT – FINAL**

<b>Reference Number</b>	CA18/2/3/10304						
<b>Classification</b>	Accident	<b>Date</b>	8 May 2023		<b>Time</b>	2147Z	
<b>Type of Operation</b>	Remotely Piloted Aircraft System – Surveillance (Part 101)						
<b>Location</b>							
Place of Departure	Vryheid, KwaZulu-Natal Province		Place of Intended Landing	Vryheid, KwaZulu-Natal Province			
Place of Occurrence							
GPS Co-ordinates	Latitude	27° 41' 58" S	Longitude	30° 51' 22" E	Elevation	4990 ft	
<b>Aircraft Information</b>							
Registration	ZT-XNI						
Make; Model; S/N	Arace Sirin (Serial Number: 0032)						
Damage to Aircraft	Substantial		Total Aircraft Hours	690.18			
<b>Pilot-in-command</b>							
Licence Type	Remote Pilot Licence (RPL)		Gender	Male		Age	28
Licence Valid	Yes	Total Hours	539.6		Total Hours on Type	539.6	
Total Hours Past 90 Days	171.6		Total Flying Past 90 Days on Type	171.6			
<b>People Controlling</b>	1	Injuries	0	Fatalities	0	Other (on ground)	0

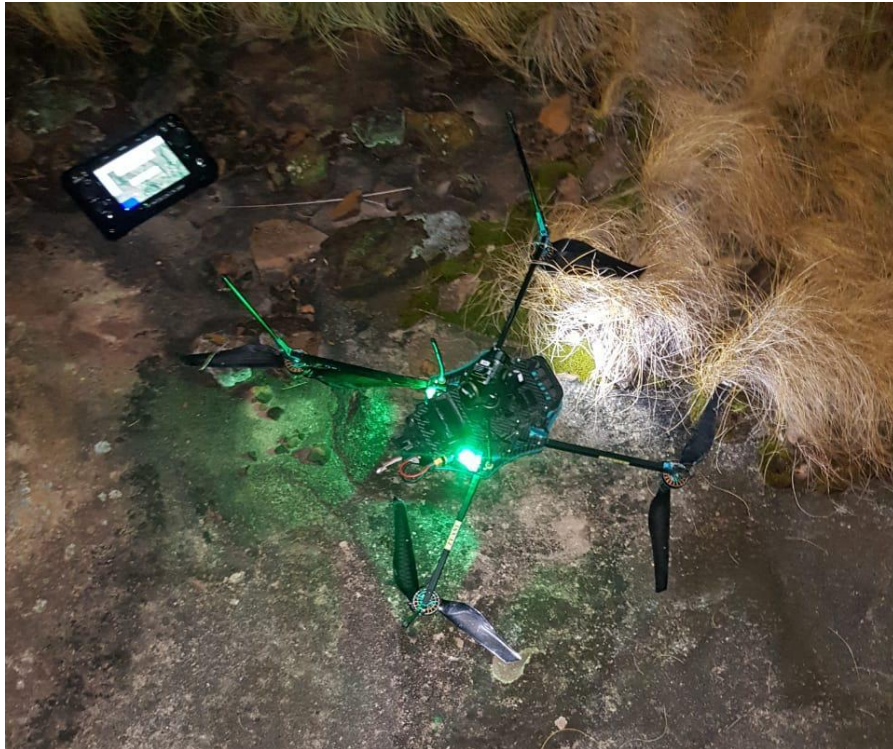
<b>What Happened</b>							
<p>On Monday evening, 8 May 2023, a remote pilot aircraft (RPA) Arace Sirin with registration ZT-XNI was engaged in an aerial surveillance flight in Vryheid, KwaZulu-Natal province. Visual meteorological conditions (VMC) by night prevailed at the time of the flight. The flight was conducted under beyond visual line of sight (BVLOS) rules and under the provisions of Part 101 of the Civil Aviation Regulations (CAR) 2011 as amended.</p> <p>The pilot reported that he conducted a pre-flight check with no anomalies noted and launched the RPA in attitude (ATTI) mode with 98% battery power at approximately 2127Z. The pilot then switched to 'loiter mode' to commence the mission and climbed to 80 metres (m) above ground level. Thereafter, he descended the RPA to 69m AGL and switched back to ATTI mode for 1.2 kilometres after spotting suspects; however, the pilot lost the Command and Control (C2) link with the RPA. He then activated the return-to-launch (RTL) function, but the RPA engaged 'auto land'. The pilot reported the last known location to dispatch and requested assistance with the recovery of the RPA. The RPA was recovered and had sustained damage to the landing gear and propeller. There were no reported injuries to persons on the ground.</p>

**Figure 2:** The RPA post-accident. (Source: Operator)

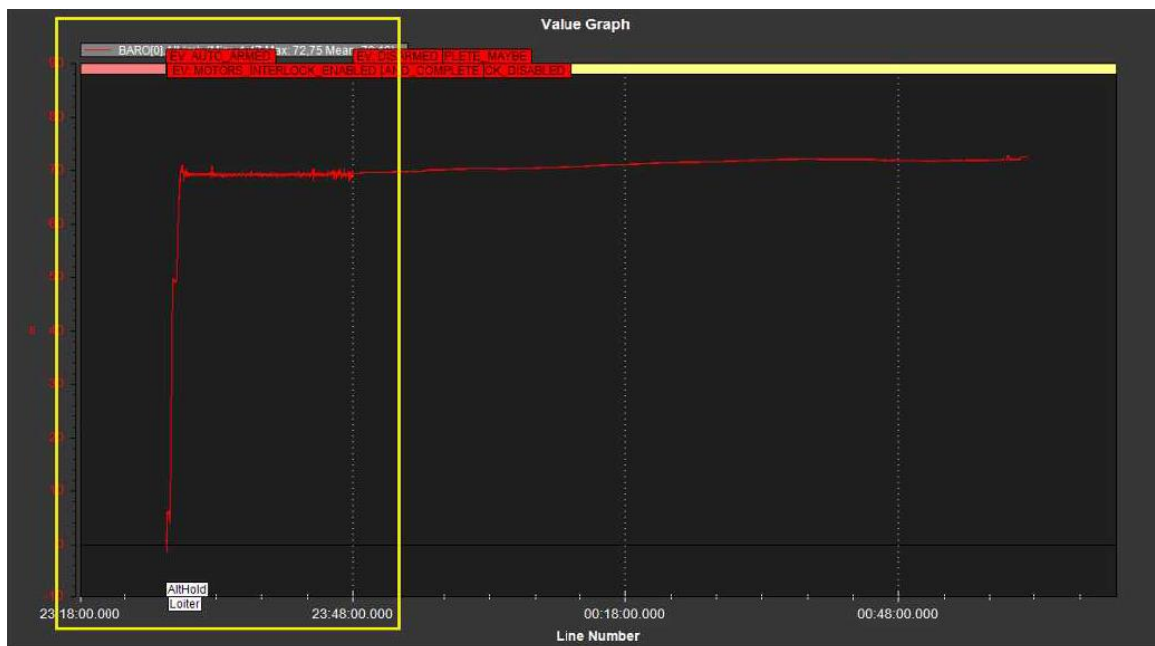
Sequence of events as per the flight log:

At 21:27Z: the pilot armed the aircraft in 'alt hold' mode and ascended to 22 feet (ft) above ground level (AGL).

At 21:27Z: the pilot switched to 'loiter mode' and ascended further to 230 ft AGL and commenced the operation.

At 21:47Z: 20 minutes into the flight the pilot flew into a mountain.

**Figure 3:** The graph shows that the aircraft did not descend or land. (Source: Operator)
