LIMITED OCCURRENCE INVESTIGATION REPORT – FINAL

| Reference Number | CA18/2/3/10324 | | | | | | |
| Registration | ZS-MVI | | | | | | |
| Make; Model; S/N | Cessna Aircraft Company, T210M (Serial Number: 210-62409) | | | | | | |

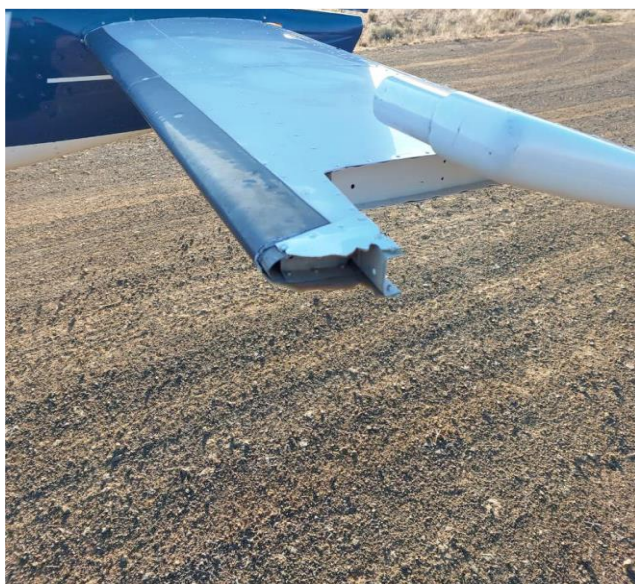
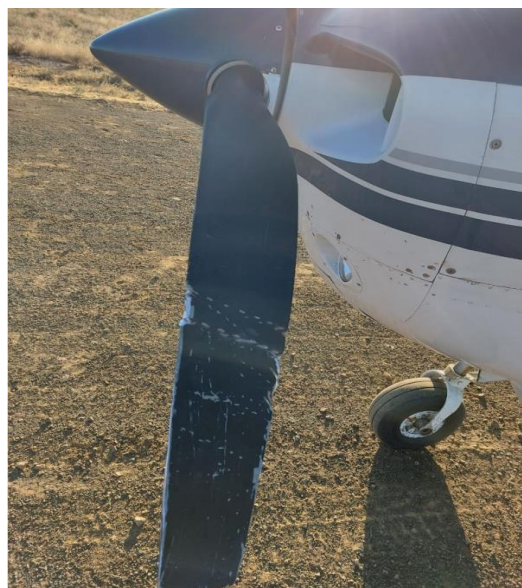
Note: The gate is opened for arriving aircraft but usually left closed for cattle not to go through.
The barbed wire fence and the supporting poles entangled the spinning propeller and caused damage to the propeller blades, both wings and the empennage. The occupants were not injured.

Figures 2 and 3: Damage sustained by the aircraft. (Source: Operator)

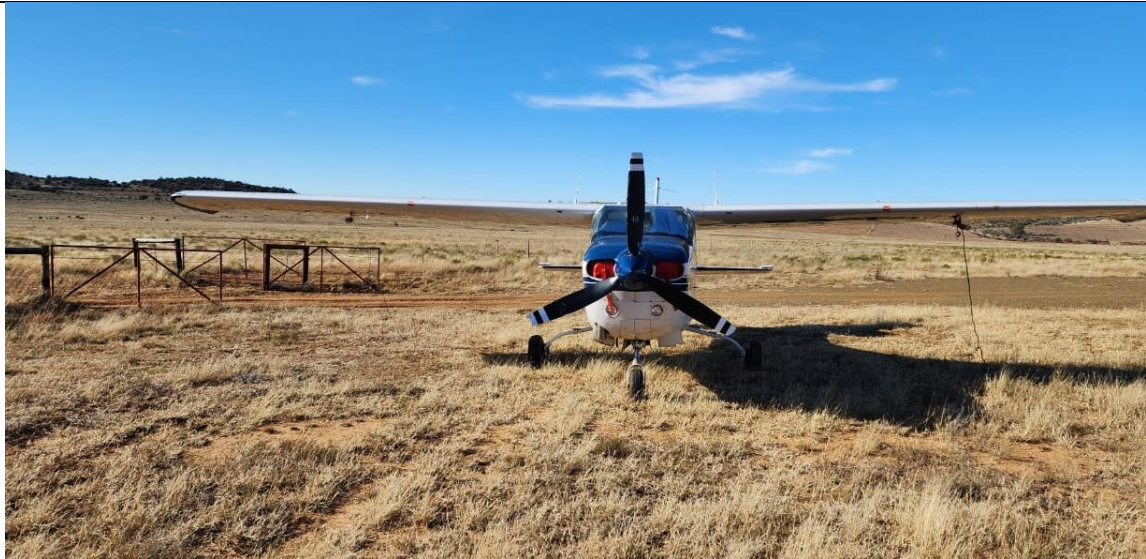
Figure 4: The gate along the airstrip. (Source: Operator)

The aircraft impacted the gate (which ran across the runway) that was still closed on their arrival.
