## AIRCRAFT ACCIDENT REPORT AND EXECUTIVE SUMMARY

| | | | | <b>Reference:</b> | | CA18/2/3/10641 | |
| <b>Aircraft Registration</b> | ZU-JBR | <b>Date of Accident</b> | 26 February 2026 | | <b>Time of Accident</b> | 0518Z | |
| <b>Type of Aircraft</b> | ICP Savannah S | | <b>Type of Operation</b> | | Private (Part 94) | | |

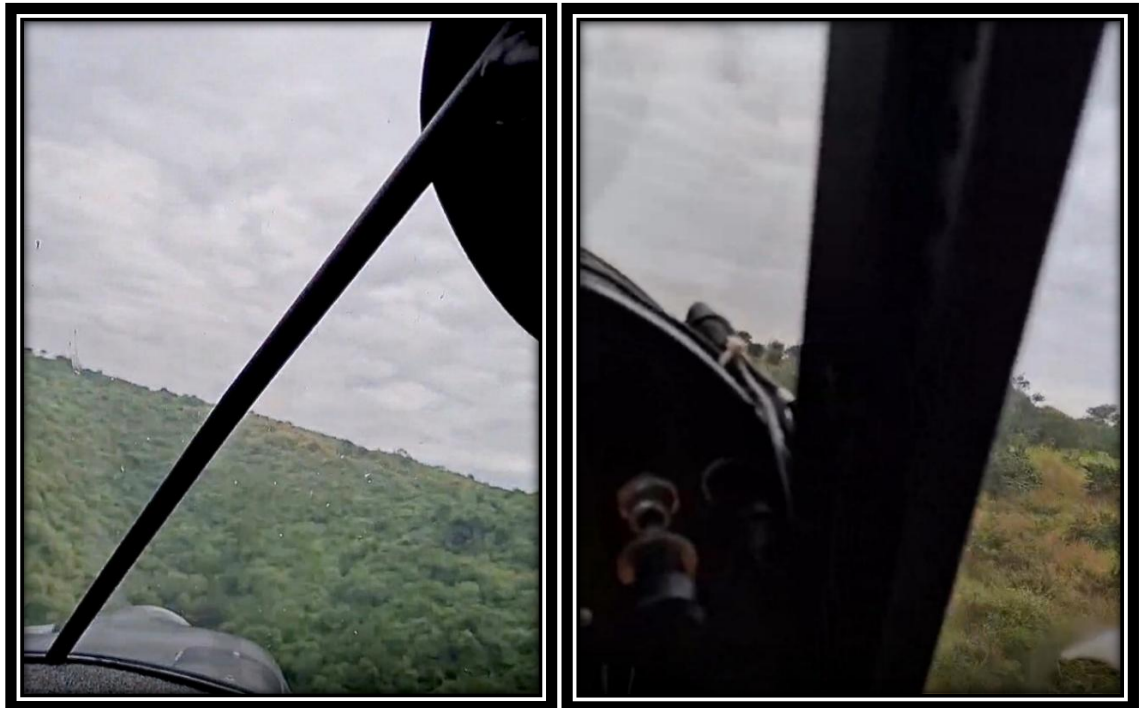
- 1.1.4. A video footage recorded on a cellular phone by the passenger during the flight showed the aircraft flying low above the trees with the nose pitched up to clear the rising terrain (see Figure 1). Between 27 and 32 seconds into the recording after the pilot had cleared the terrain and levelled off, the aircraft's nose suddenly pitched up as the aircraft climbed (see Figure 2). At the same time, the aircraft banked abruptly to the right and the right wing struck a tree (*the propeller remained visibly in the video and was rotating during the accident sequence [see Figure 3]*); this

**Figure 1:** A video footage still of the aircraft flying at a low altitude (left).

**Figure 2:** A video footage still showing an attempt to pitch the nose upwards (right).

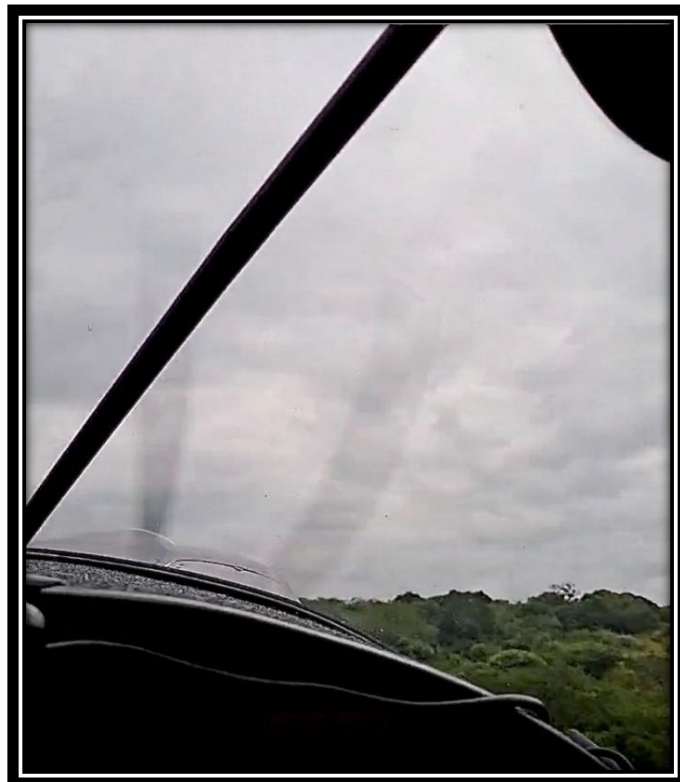
*indicated that the engine was producing power before impact with the tree. The propeller stopped rotating upon impact with the ground).*

**Figure 3:** A video footage still of the rotating propeller.

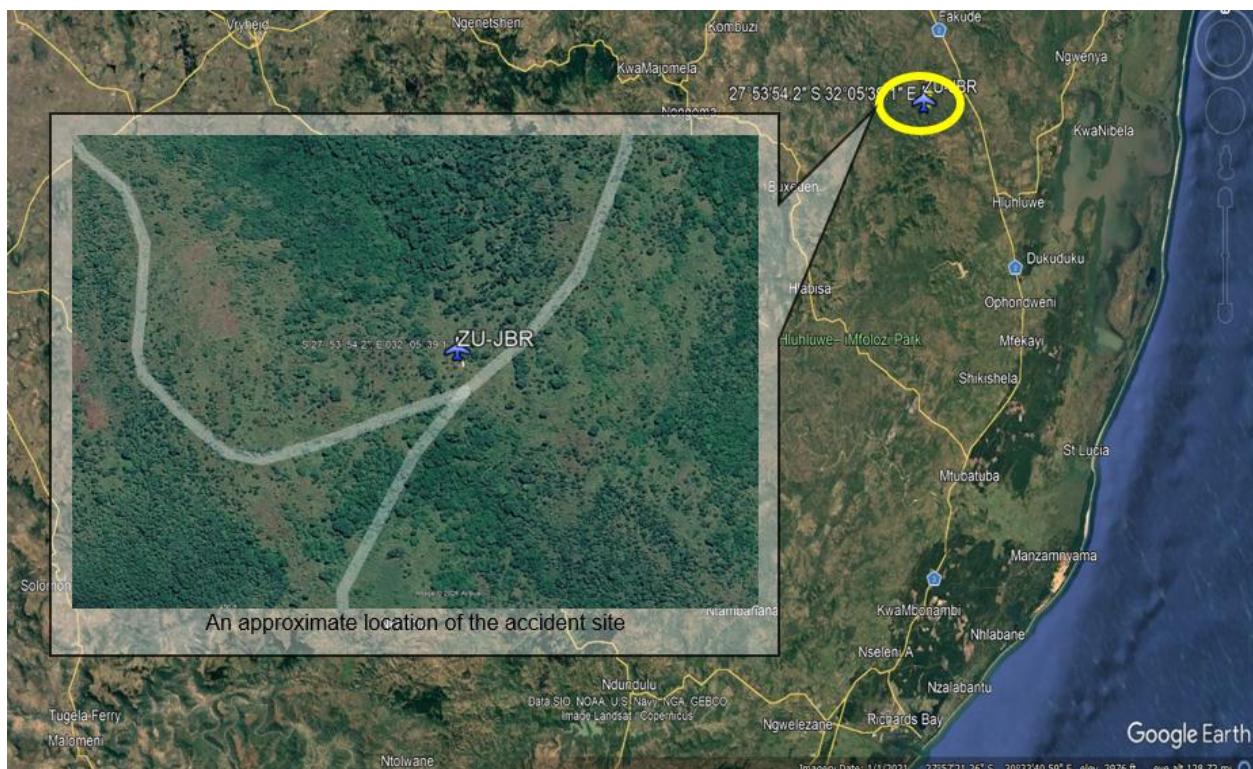
**Figure 4:** An aerial view of the approximate accident site (yellow circle). (Source: Google Earth)

- 1.1.5. The aircraft descended into a bush-covered terrain, struck several other trees before it rested approximately 10 metres (m) from the road and the perimeter fence.
- 1.1.6. The passenger sustained serious injuries whilst the pilot suffered minor injuries. Both occupants were transported to a hospital in Richards Bay. The aircraft was substantially damaged during the accident sequence.
- 1.1.7. The accident occurred on a bushy terrain on the border of Thanda Private Game Reserve, approximately 12 nautical miles (nm) north-west of FAHL at Global Positioning System (GPS) co-ordinates determined to be 27°53'54" South 024°44'19" East, at an elevation of 1 608 feet (ft).

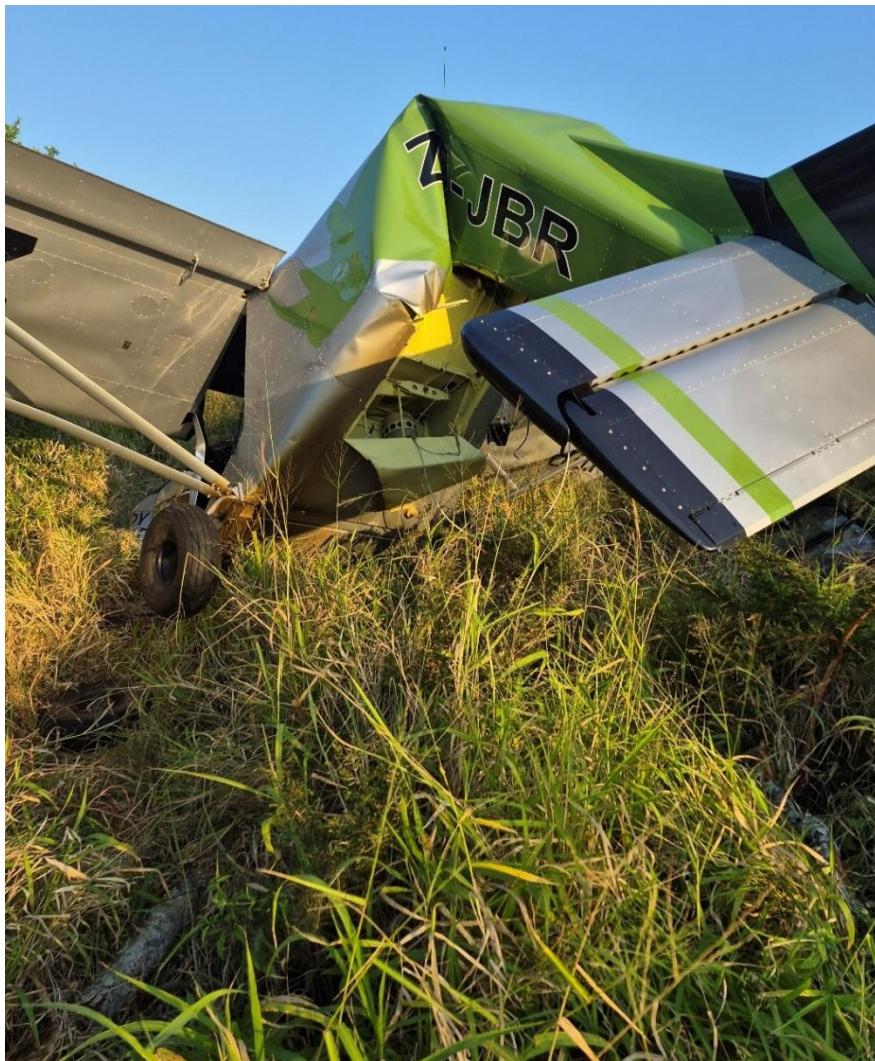
1.3.1. The aircraft was substantially damaged during the accident sequence.

**Figure 5:** The aircraft at the accident site.

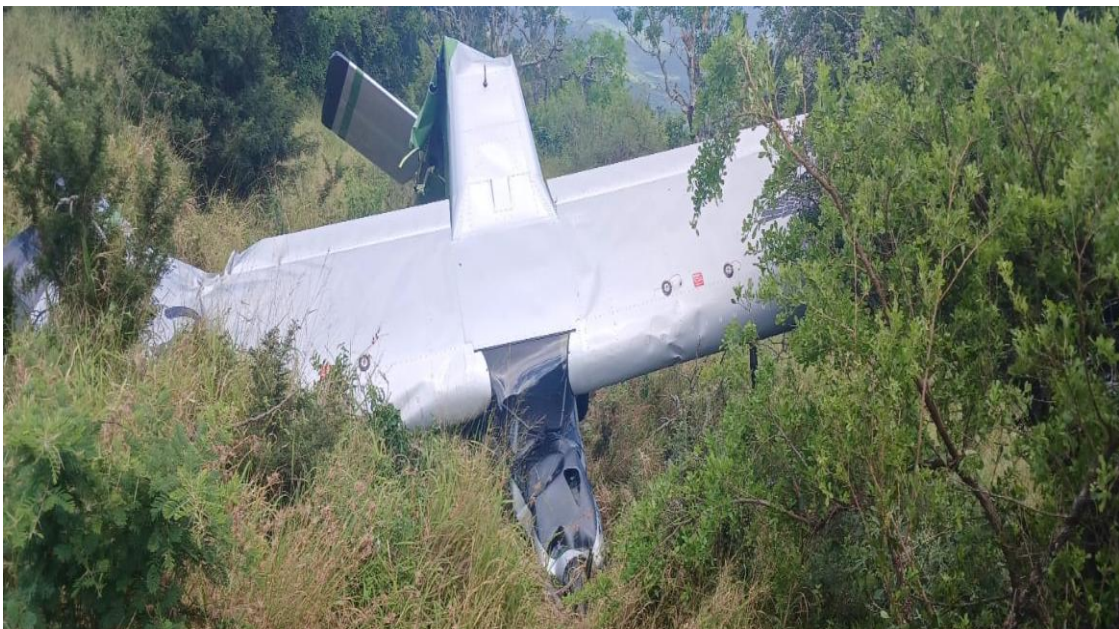
**Figure 6:** The substantially damaged aircraft.

- 1.12.1. During the initial impact, the aircraft's right wing impacted a tree and the aircraft descended on to a terrain covered with thorn trees, further impacting trees before it crashed hard on the ground with the nose gear first. The severity of the impact resulted in the separation of the nose landing

gear from the aircraft. The aircraft rested facing south-east. The damage was substantial and included lower engine cowling, empennage and fuselage, as well as deformed propeller blades.

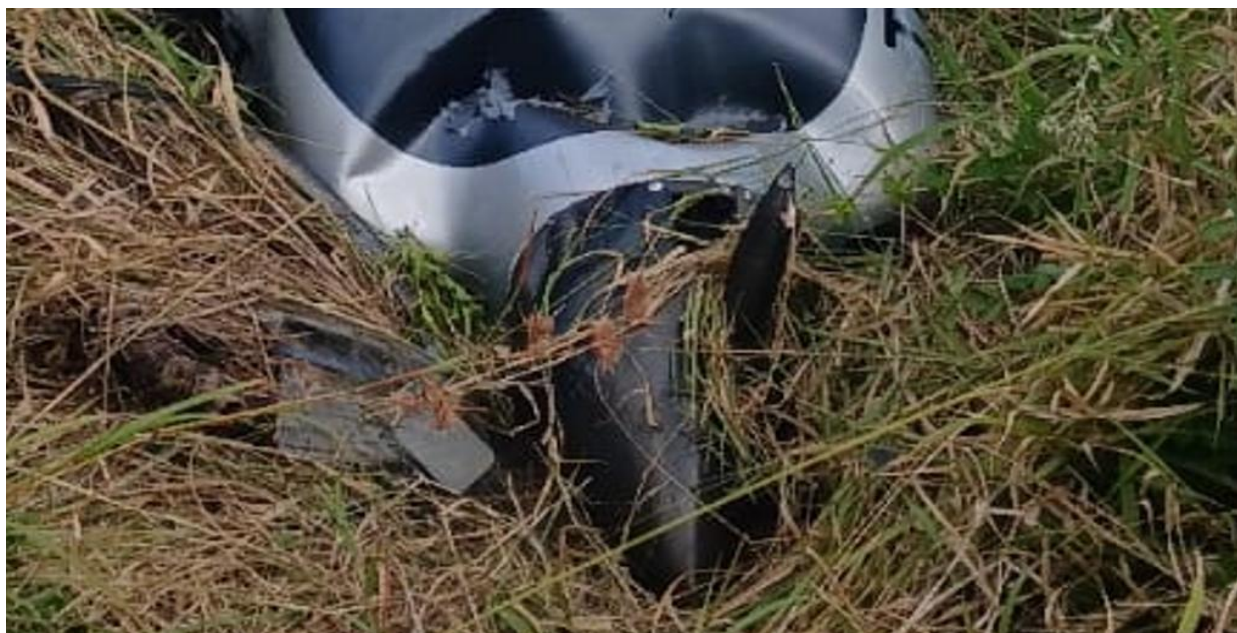
**Figure 7:** The fractured and separated propeller blade roots.

- 1.12.2. The propeller blades had fractured and separated during the accident sequence. The nature of damage, including the blade fractures and the associated impact signatures, was consistent with the propeller rotating under power at the time of the initial impact with the tree. Such damage is typically indicative of significant rotational energy being transmitted through the propeller system, supporting the submitted video footage that the engine was producing significant power and had not ceased operating before the initial impact.

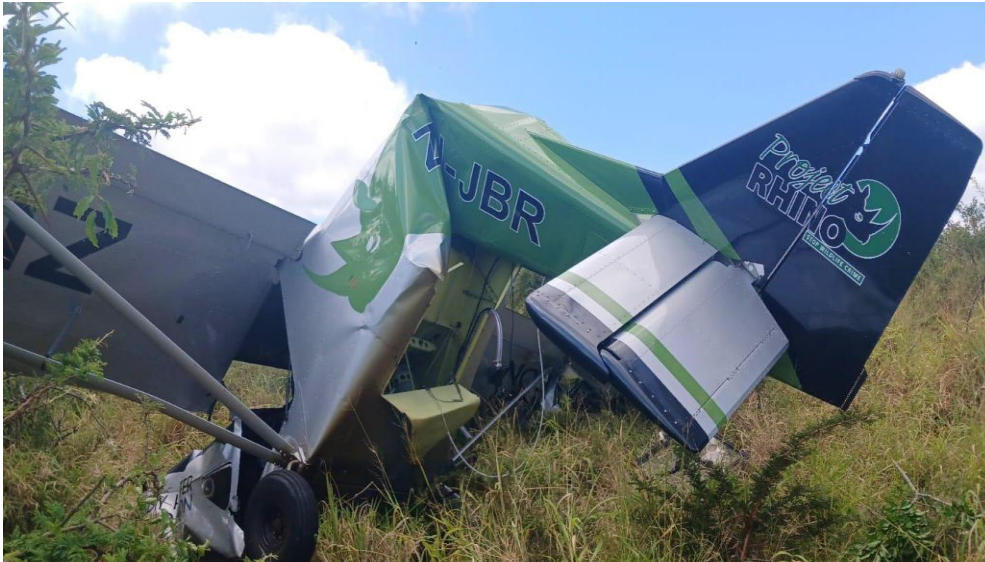
**Figure 8:** The resting position of the aircraft.
